## British Gliding Association - Technical News Sheet

<b><u>Issue 1-2006</u></b>	<b><u>Date: 2 March 2006</u></b>
----------------------------	----------------------------------

## British Gliding Association Aircraft Inspection

Number: 042/07/2004	Issue: 3
------------------------	-------------

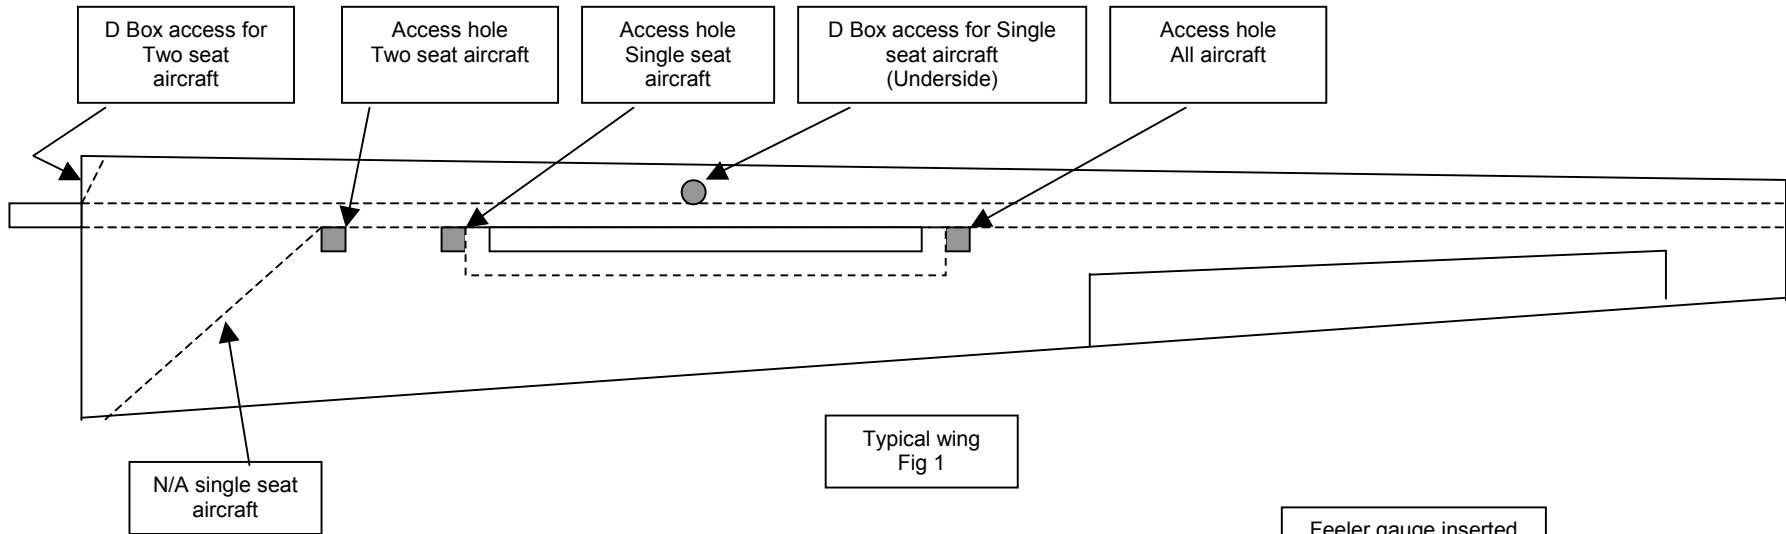
Single seat aircraft: Adjacent to the rear face of the main spar immediately inboard and outboard of the air brake box. See fig 1.

Two seat aircraft: Adjacent to the rear face of the main spar immediately outboard of the air brake box and at the drag spar intersection with the main spar. See fig 1.

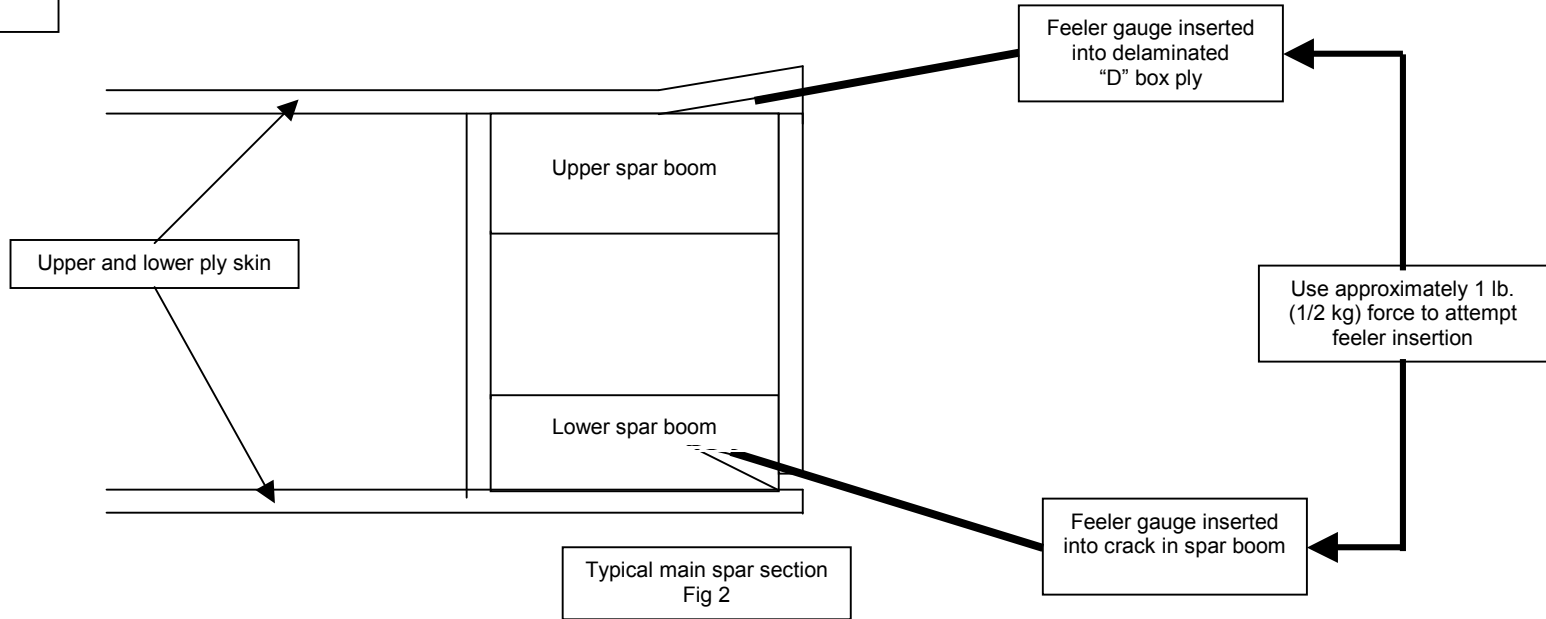
Using a 005/010" (0.12/0.25mm) feeler gauge, try to insert into the glue joint parallel to the wing top surface. See fig 2.

Check for cracks running into the spar booms by trying to insert the feeler at 45° to the spar. Apply a force of approximately 1 lb. (1/2 Kg) See fig 2.

**If the feeler gauge can be entered more than 3/16" (4mm) or any evidence of glue failure is observed the aircraft must not be flown. All the fabric must be removed and a complete aircraft structural survey carried out. An inspection report must be submitted to the CTO for further instructions.**
