British Gliding Association Aircraft Inspection

Number:
042/07/2004

Subject: Structural inspections

Applicability: Schleicher Ka 1, Ka 2, Ka 2B, Ka 3, Rhönlercher II (Ka 4), Ka 6 series, K7, K7 conversions, K8 series, K10, ASK 13 series, ASK 14, ASK 16, ASK 18 series and all variants of each type.
(This inspection is strongly recommended for the motor glider types listed above)

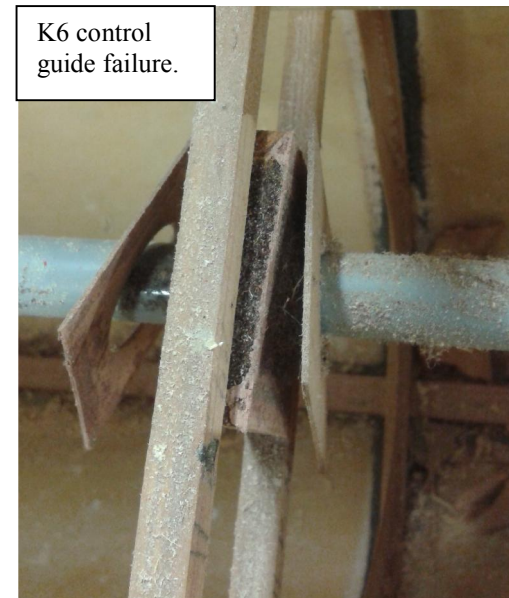
K6 control
guide failure.

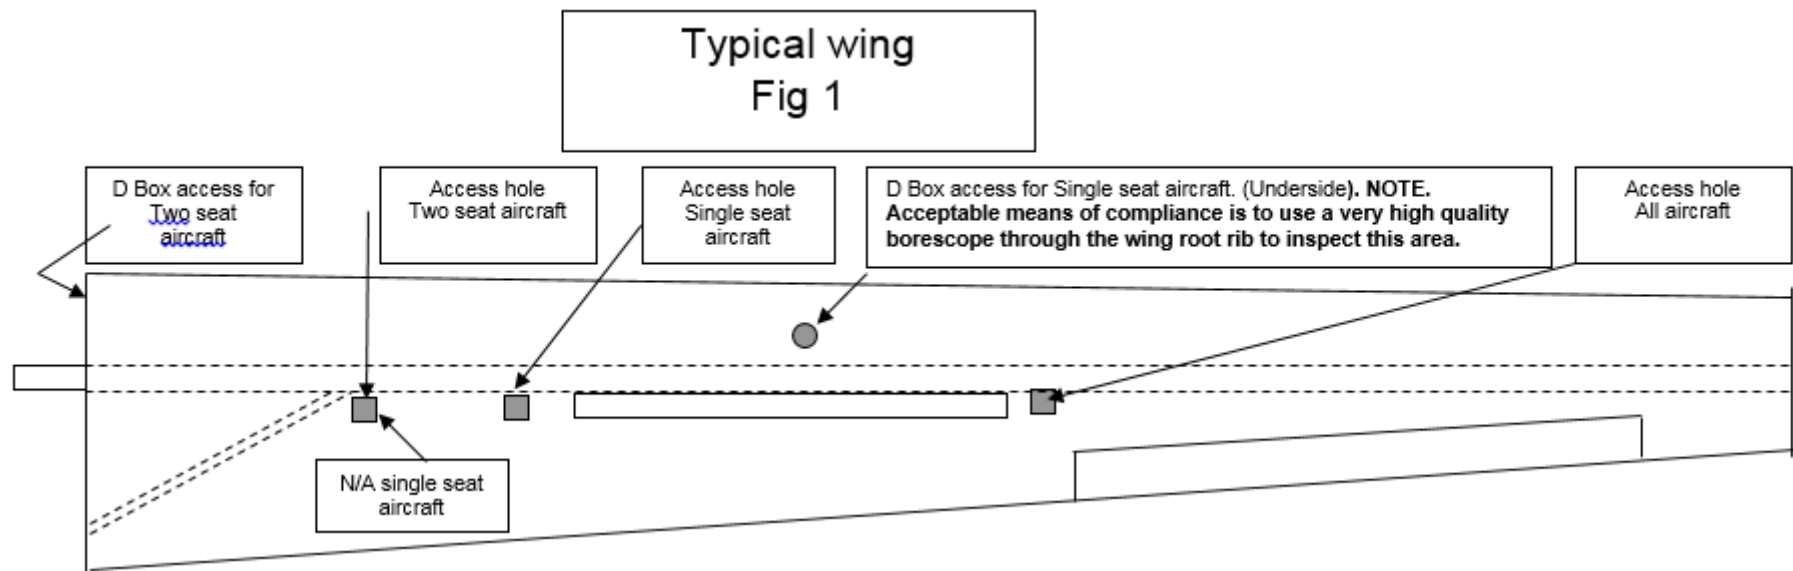
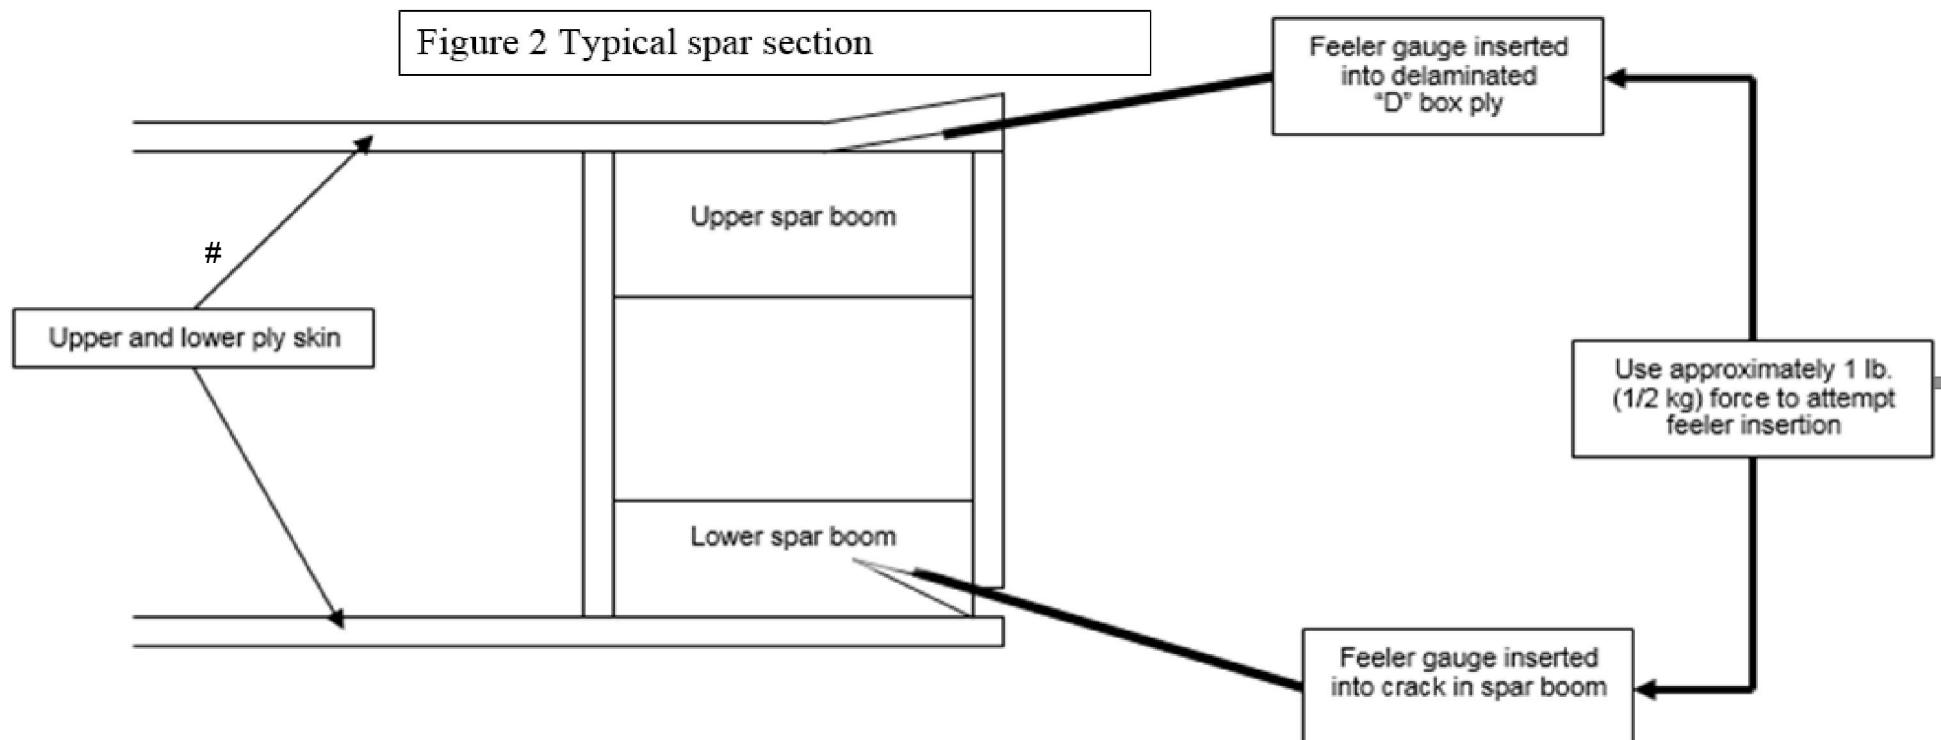
Single seat aircraft: Adjacent to the rear face of the main spar immediately inboard and outboard of the air brake box. See fig 1.

Two seat aircraft: Adjacent to the rear face of the main spar immediately outboard of the air brake box and at the drag spar intersection with the main spar. See fig 1.

Check the integrity of all visible glue joints. Check the adhesion of the D box and other ply skin as accessible, visually and by the following method. Using a 005/010" (0.12/0.25mm) feeler gauge, try to insert into the glue joint parallel to the wing top surface. See fig 2.

Check for cracks running into the spar booms by trying to insert the feeler at 45° to the spar. Apply a force of approximately 1 lb. (1/2 Kg) See fig 2. It may be necessary to locally remove some glue spill to access the joints. On some aircraft (Jubi) it may not be possible to carry out the feeler test due to the extended ply skin. On these aircraft only, a close visual examination will suffice.

If the feeler gauge (or a very thin sharp knife blade) can be entered more than 3/16" (4mm) or any evidence of glue failure is observed the aircraft must not be flown. All the fabric must be removed and a complete aircraft structural survey carried out. An inspection report must be submitted to the CTO for further instructions.

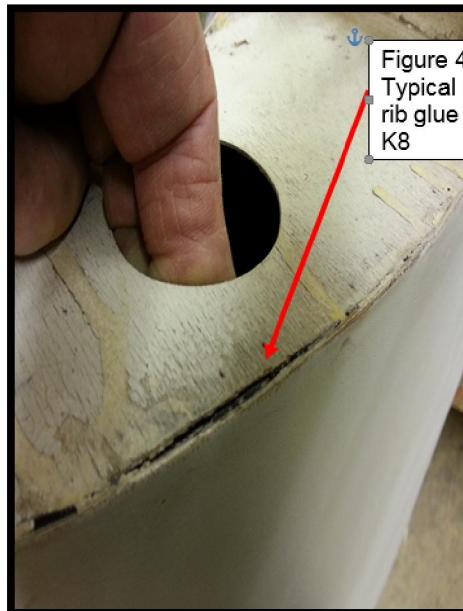
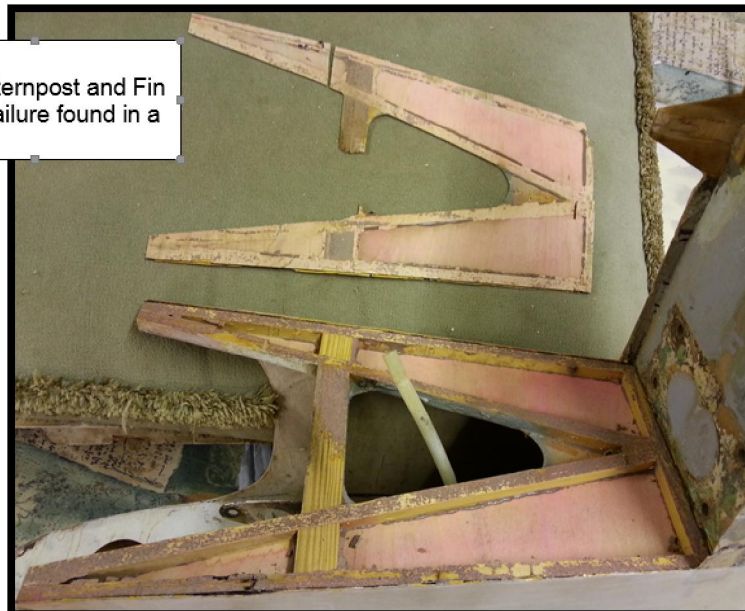
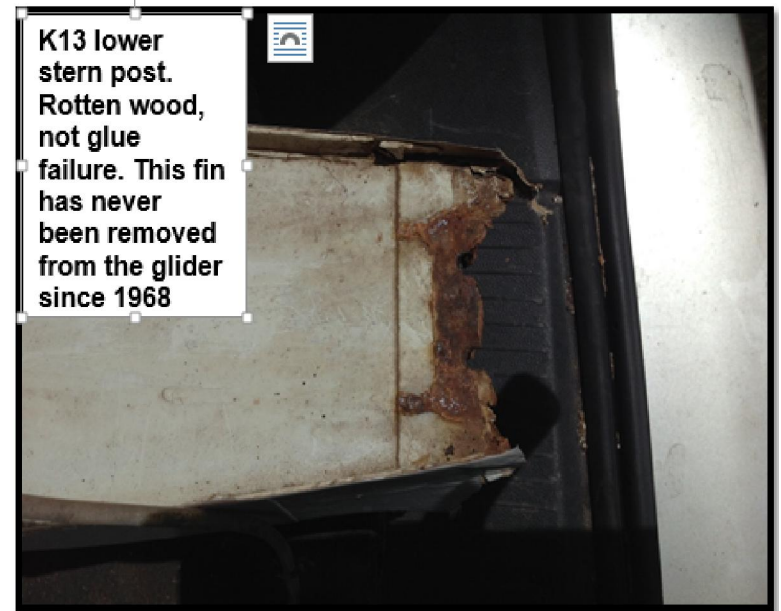
Figure 4.
Typical sternpost and Fin
rib glue failure found in a
K8

Remove the fin (does not require much fabric work) This must be done on all types apart from K6 and K14 types (Indicate on the form returned to the BGA when the fin was last removed) as checking in situ gives very poor access and finger pressure has to be applied, to ensure that the glue joints still have the required high strength. Inspect base of fin rib and put some pressure on it pulling it away from the fin. Check the entire stern post both sides by applying gentle pressure to the plywood that bonds onto the stern post spar. Apply gentle but firm pressure to shear web plywood away from the spar caps to ensure there is no disbonding over the entire length. You are looking for any sign of disbonding or rotten wood (especially at base of fin). Apply significant pressure to the elevator drive mount to ensure that rib is completely bonded. Note, often the bolts that hold the fin onto the fuselage are rusty and should be replaced.

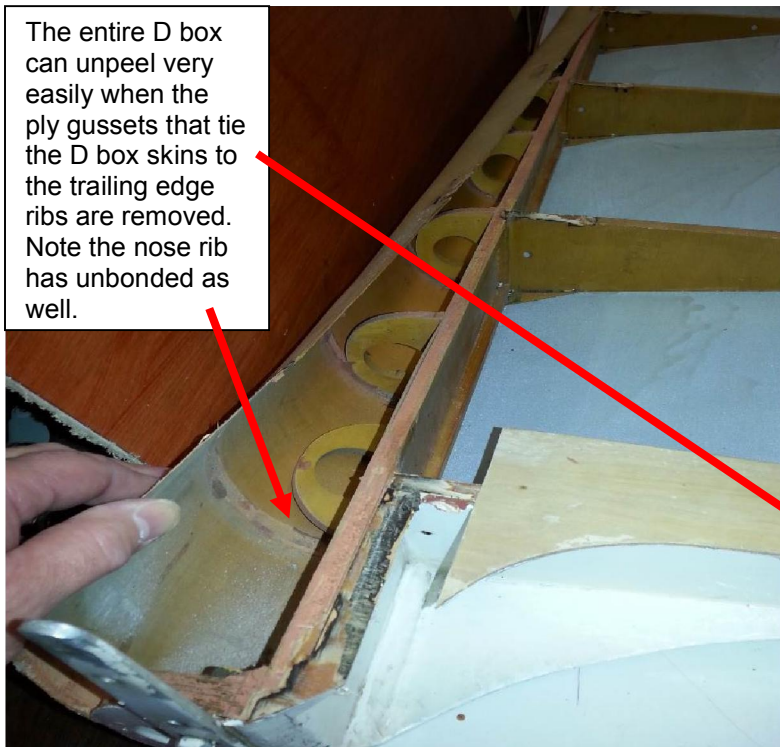
The entire D box can unpeel very easily when the ply gussets that tie the D box skins to the trailing edge ribs are removed. Note the nose rib has unbonded as well.

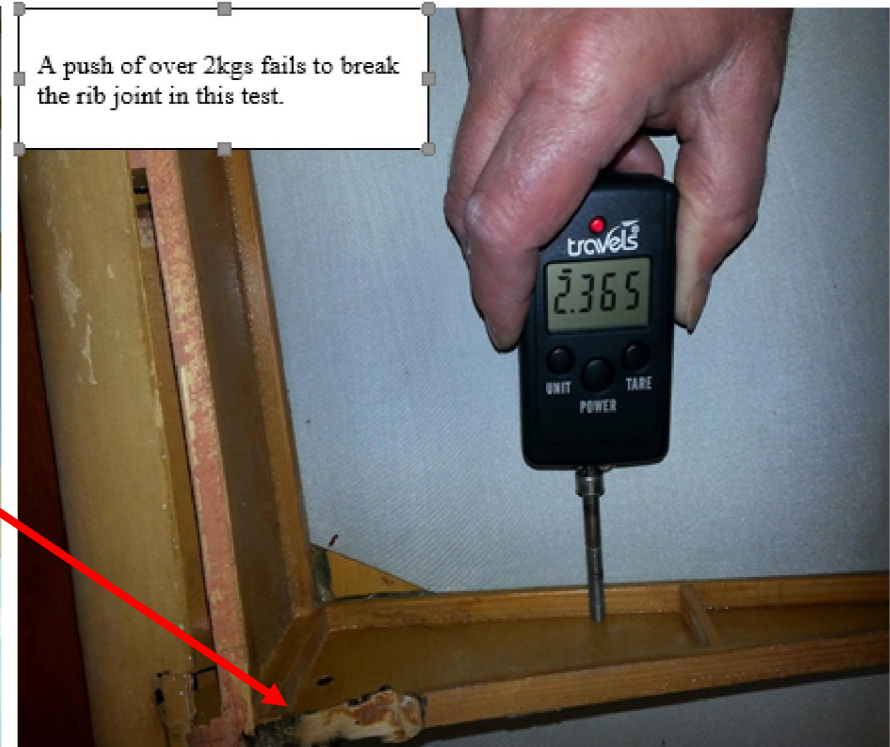
A push of over 2kgs fails to break the rib joint in this test.
