British Gliding Association Aircraft Inspection

Number: 003/08/2000	Issue: 1
------------------------	-------------

Date: 19th August 2000

- Subject: Ka8 Suspect Elevator drive disconnection
- Applicability: Schleicher Ka2, 2b, 6, K7 & K8 (US 7G1, 7G3, 7G4)
- Accomplishment: By 30th September 2000 and Annually at C of A inspections.

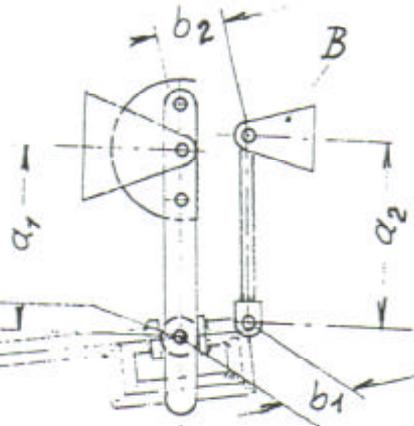
1. Correct make:

Must be in center.
or ballbearing
some what lower

$a_1 = a_2$

$b_1 = b_2$

b2 may be wider until
4 mm, in no case
smaller. Check it with
a pair of compasses.
Therefore disassemble
one half of elevator.

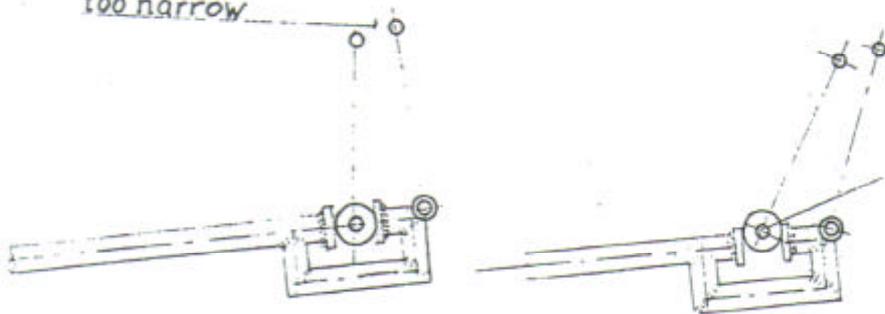
3. Parallelogram gearing not correct:

too narrow

goes out at deflection
"push".

The inverse case can be, but is not so serious.
