## British Gliding Association Aircraft Inspection

| Number:<br>010/12/2000 | Issue:<br>1 |

Subject: ASK 13 and ASK 18 Elevator Engagement

Applicability: Schleicher ASK 13 and ASK 18

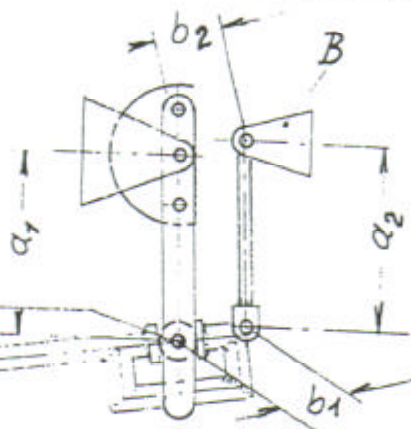
1. Correct make:

Must be in center.  
or ballbearing  
some what lower

$$a_1 = a_2$$

$$b_1 = b_2$$

b2 may be wider until  
4 mm, in no case  
smaller. Check it with  
a pair of compasses.  
Therefore disassemble  
one half of elevator.

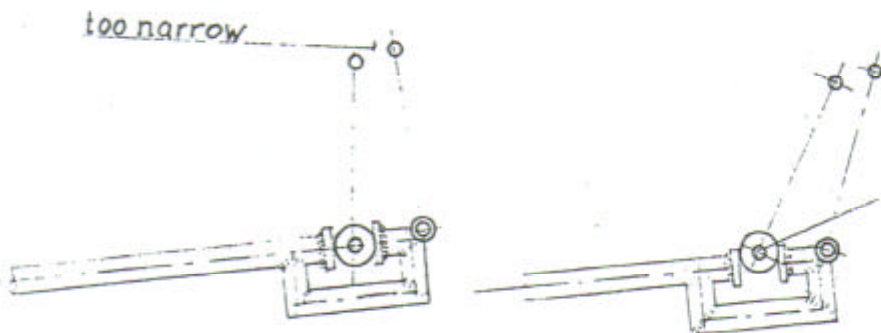
3. Parallelogram gearing not correct:

too narrow

goes out at deflection  
"push".

The inverse case can be, but is not so serious.
