British Gliding Association
Aircraft Inspection

Number: 029/05/2002	Issue: 1
------------------------	-------------

Date: 24th May 2002

- Subject: Rudder drive torque tube inspection and modification
- Applicability: Slingsby T49 Capstan series
- Accomplishment: Part "A" – As soon as possible or at latest at next C of A inspection
Part "B" – At each C of A inspection

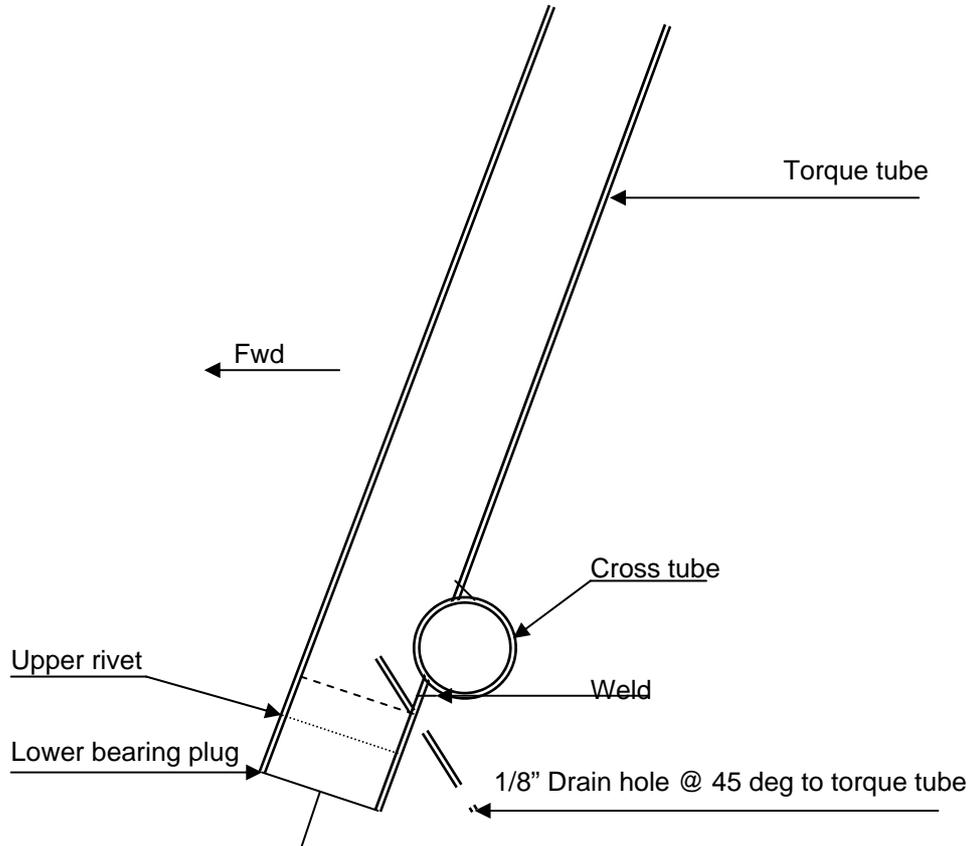
Slingsby T49 Capstan Rudder Torque Tube – Drain hole location

- Reason: One in-flight failure and another with severe corrosion. The failed tube showed no external signs of corrosion through the paint
- Instructions: Part "A"

Position drain hole at the rear edge of the torque tube above lower bearing plug upper aft retention rivet and below cross tube weld. Angle the drain hole upward at an angle of approximately 45 degrees to clear the top of the lower bearing plug. The drain hole will be close to the upper aft rivet head but should not cut into it.

Drill the drain hole 1/8" or 3mm diameter

Remove all sharp edges and burrs
