British Gliding Association Aircraft Modification

Number: 035/02/2003	Issue: 1
------------------------	-------------

- Subject: Safety modifications to flight control systems
- Applicability: Aviastroitel Me7 and AC4 series all serial numbers
- Accomplishment: Part 1 and 2 – Before next flight

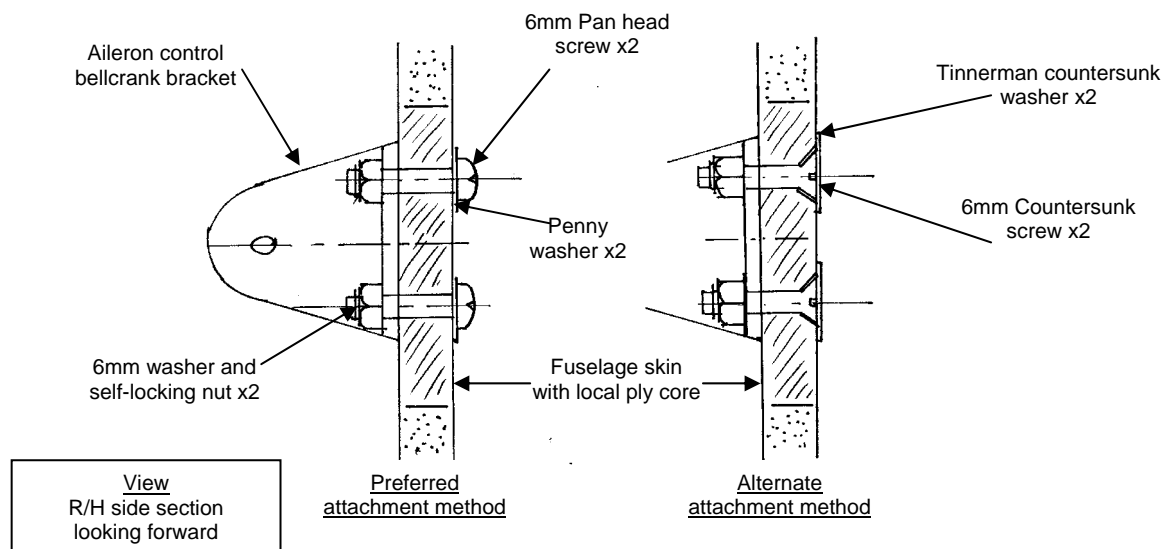
Figure 1

Attachment of Aileron Bellcrank bracket located in centre section fuselage R/H side.

1. Remove bellcrank pivot bolt and withdraw bellcrank to provide access to bracket attachment screws.
2. Remove upper and lower attachment self-tapping screws.

3. Drill 6mm holes for attachment bolts. It is recommended that an assistant hold a suitable piece of wood against the fuselage external skin to prevent drill break out when drilling through the outer gel coat.

4. Install suitable aircraft grade 6mm pan head screws with an 18mm o/d min. penny washer under the head from the outside. Install plain washers and new self-locking nuts on the inside. Ensure inside washers are clear the remaining self-tapping screw head, scallop washers if necessary. All hardware used must be of aircraft grade steel and plated.

5. Tighten sufficiently to secure but not so that the composite structure is crushed. 1½ complete threads must protrude through the nut.
6. Refit bellcrank and any other components removed for access.

7. Carry out duplicate inspection of refitted aileron control components.

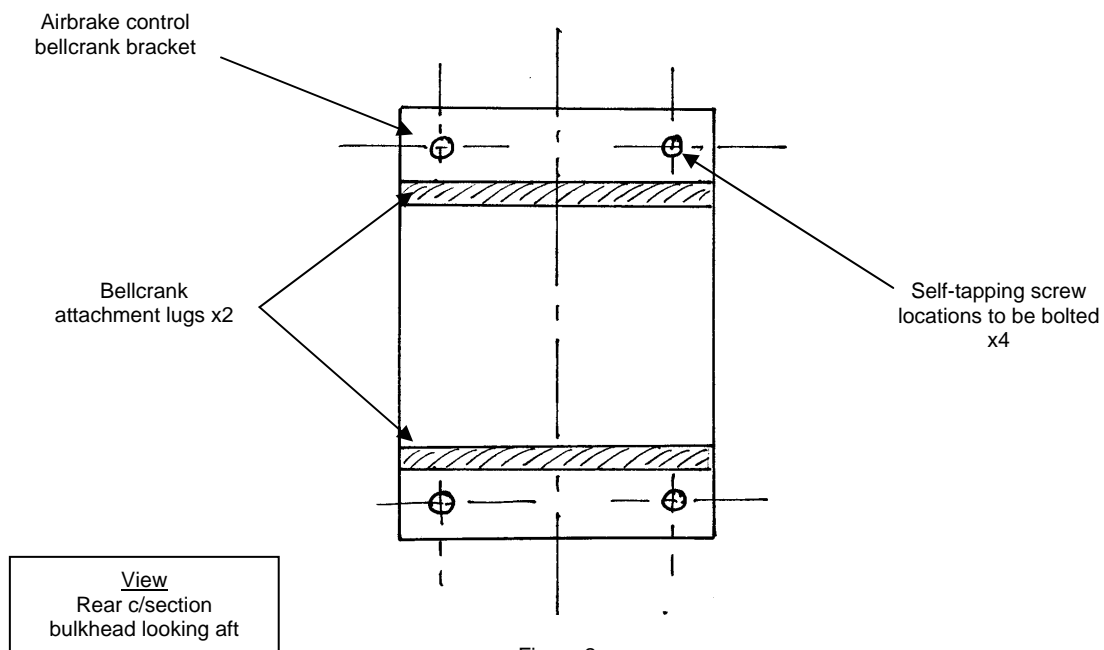
Figure 2

Attachment of Air Brake bracket located on centre section rear bulkhead forward face.

1. Remove vertical pivot bolt on air brake bellcrank and withdraw bellcrank if necessary.
2. Remove the 4 corner retaining self-tapping screws.
3. Drill 5mm holes for the attachment bolt in the original self-tapping screw locations. If possible, hold a piece of wood against the rear face of the bulkhead to prevent drill break out and give a clean hole through the laminate.
4. Install a 5mm hex bolt with plain washer on the forward face and install an 18mm o/d min washer and new self-locking nut on the rear face at each of the four positions. All hardware used must be of aircraft grade steel and plated.
5. Tighten nuts sufficiently to secure but not so that the composite structure is crushed. 1½ complete threads must protrude through the nut.
6. Refit removed airbrake bell crank and any other removed components.
7. Carry out duplicate inspection of refitted airbrake controls.

- It is permissible, as access to the rear of the bulkhead is very restricted, to install the bolts from the rear.
- 6mm bolts may be used provided that minimum hole edge margins are maintained.
- Any previously installed hardware that does not comply with the minimum requirements as stated above may only continue to be used after approval from the CTO.

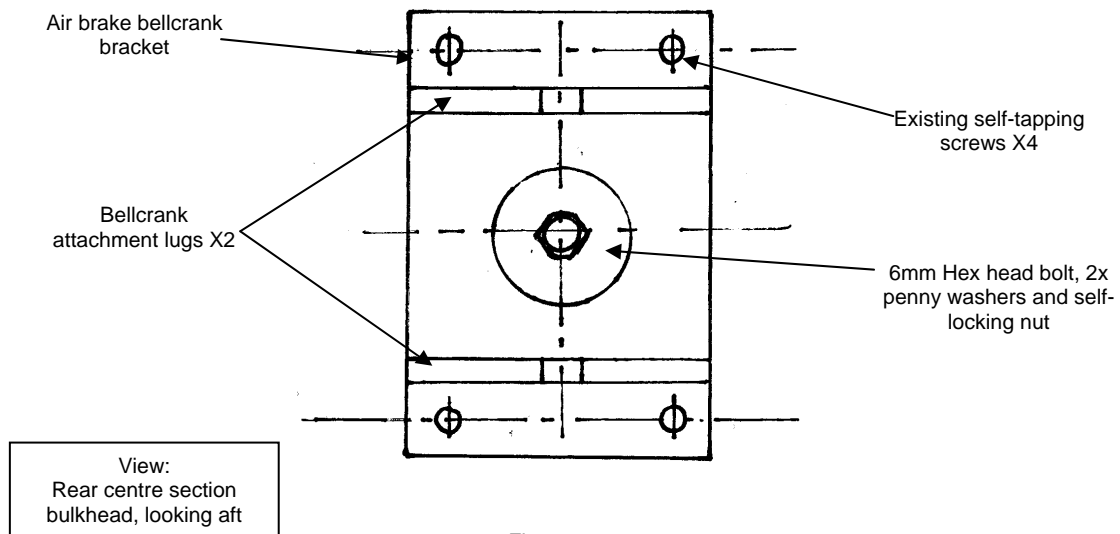
Figure 3

Attachment of Air Brake bracket located on centre section rear bulkhead forward face.

1. Remove vertical pivot bolt on air brake bellcrank and withdraw bellcrank. To gain sufficient access the bellcrank may have to be removed completely.
2. Mark the centre of the bracket midway between the two lugs and centrally between the edges.
3. Drill 6mm hole for the attachment bolt. If possible, hold a piece of wood against the rear face of the bulkhead to prevent drill break out and give a clean hole through the laminate.
4. Install a 6mm hex bolt with 18mm o/d penny washer and install an 18mm o/d penny washer and new self locking nut. All hardware used must be of aircraft grade steel and plated.
5. Tighten nut sufficiently to secure but not so that the composite structure is crushed. 1½ complete threads must protrude through the nut.
6. Refit removed airbrake bell crank and any other removed components.
7. Carry out duplicate inspection of refitted airbrake controls.

- It is permissible, as access to the rear of the bulkhead is very restricted, to install the bolt from the rear.
- Any previously installed hardware that does not comply with the minimum requirements as stated above may only continue to be used after approval from the CTO.
