APPLICABILITY NOTICE

Subject: Structural inspections

Applicability: Schleicher Ka 1, Ka 2, Ka 2B, Ka 3, Rhönlercher II (Ka 4), Ka 6 series, K7, K7 conversions, K8 series, K10, ASK 13 series, ASK 14, ASK 16, ASK 18 series and all variants of each type.
(This inspection is strongly recommended for the motor glider types listed above)

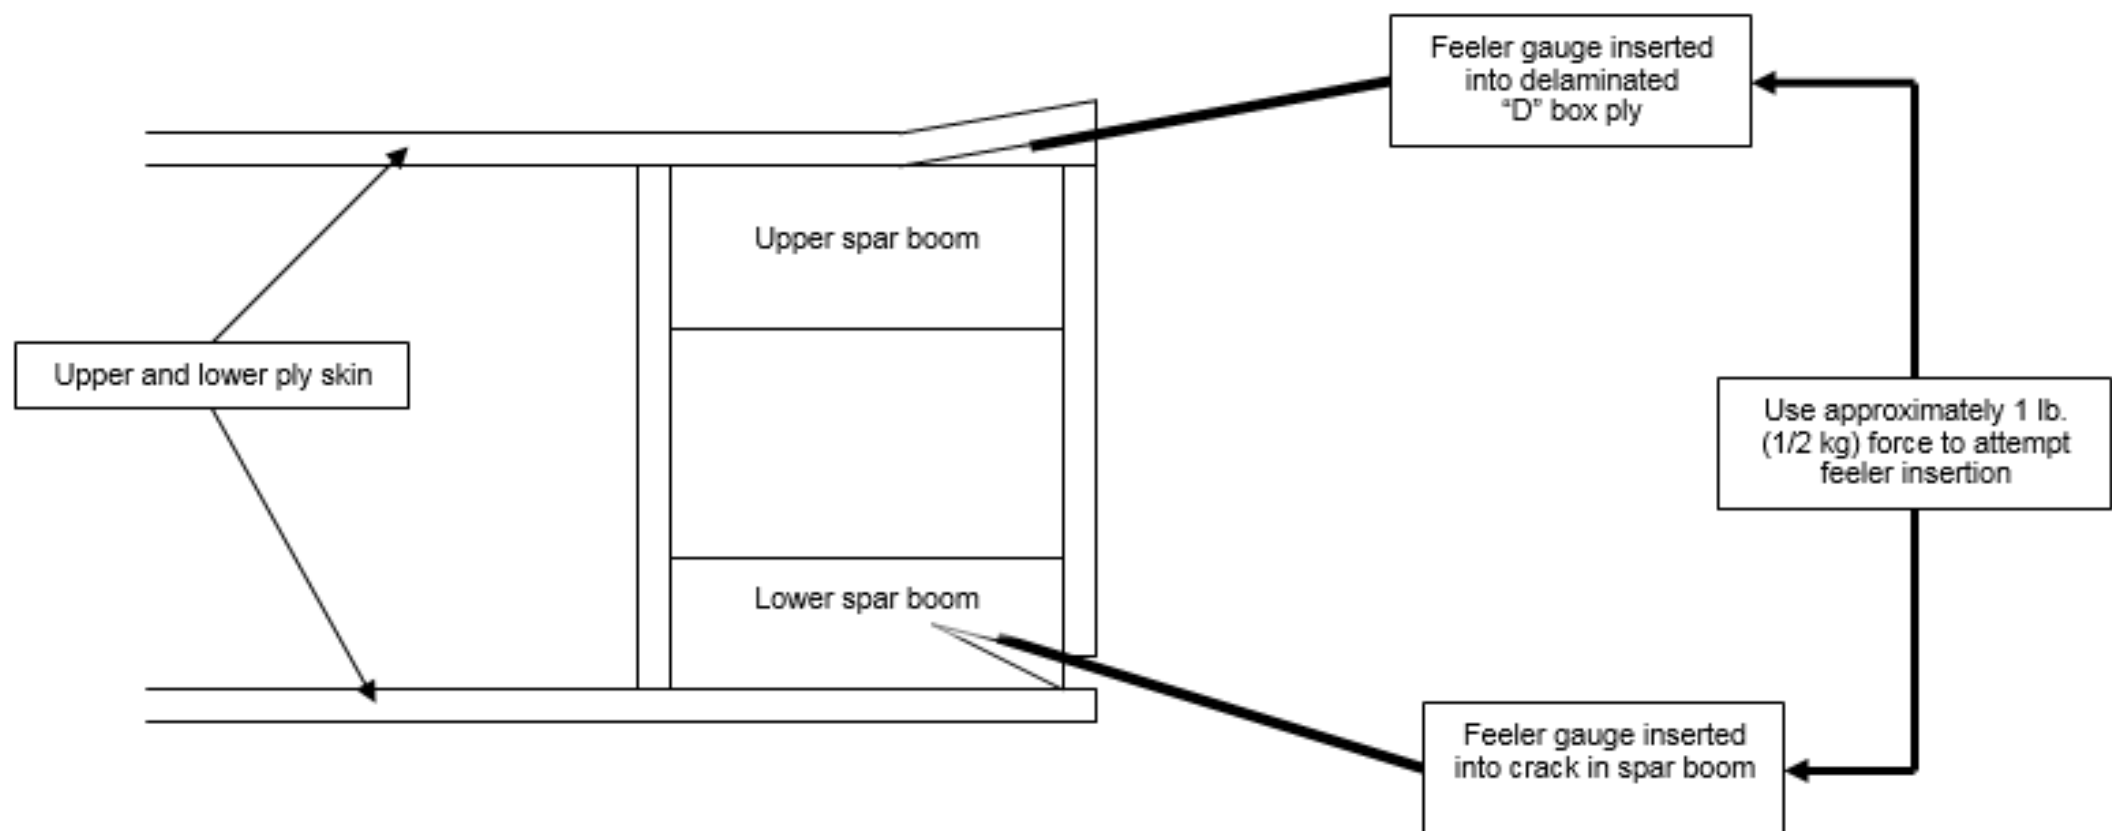
Figure 3

G Elevators. See figure 1 for images of previous glue failure found.

Typical elevator glue failure after root rib fell off and spar “D” was removed due to it not being bonded. Note the pink Kaurit glue in this instance

Check trailing edge is straight and solid. Apply pressure to every rib over its entire length to ensure there are no broken sticks. The root rib requires gentle but significant pressure trying to pull it out of the spar.

Using a feeler gauge (as in figure 2) check for any disbonding of the spar to D box skins on the root end of the spar where you have access (including inside the D box tunnel)

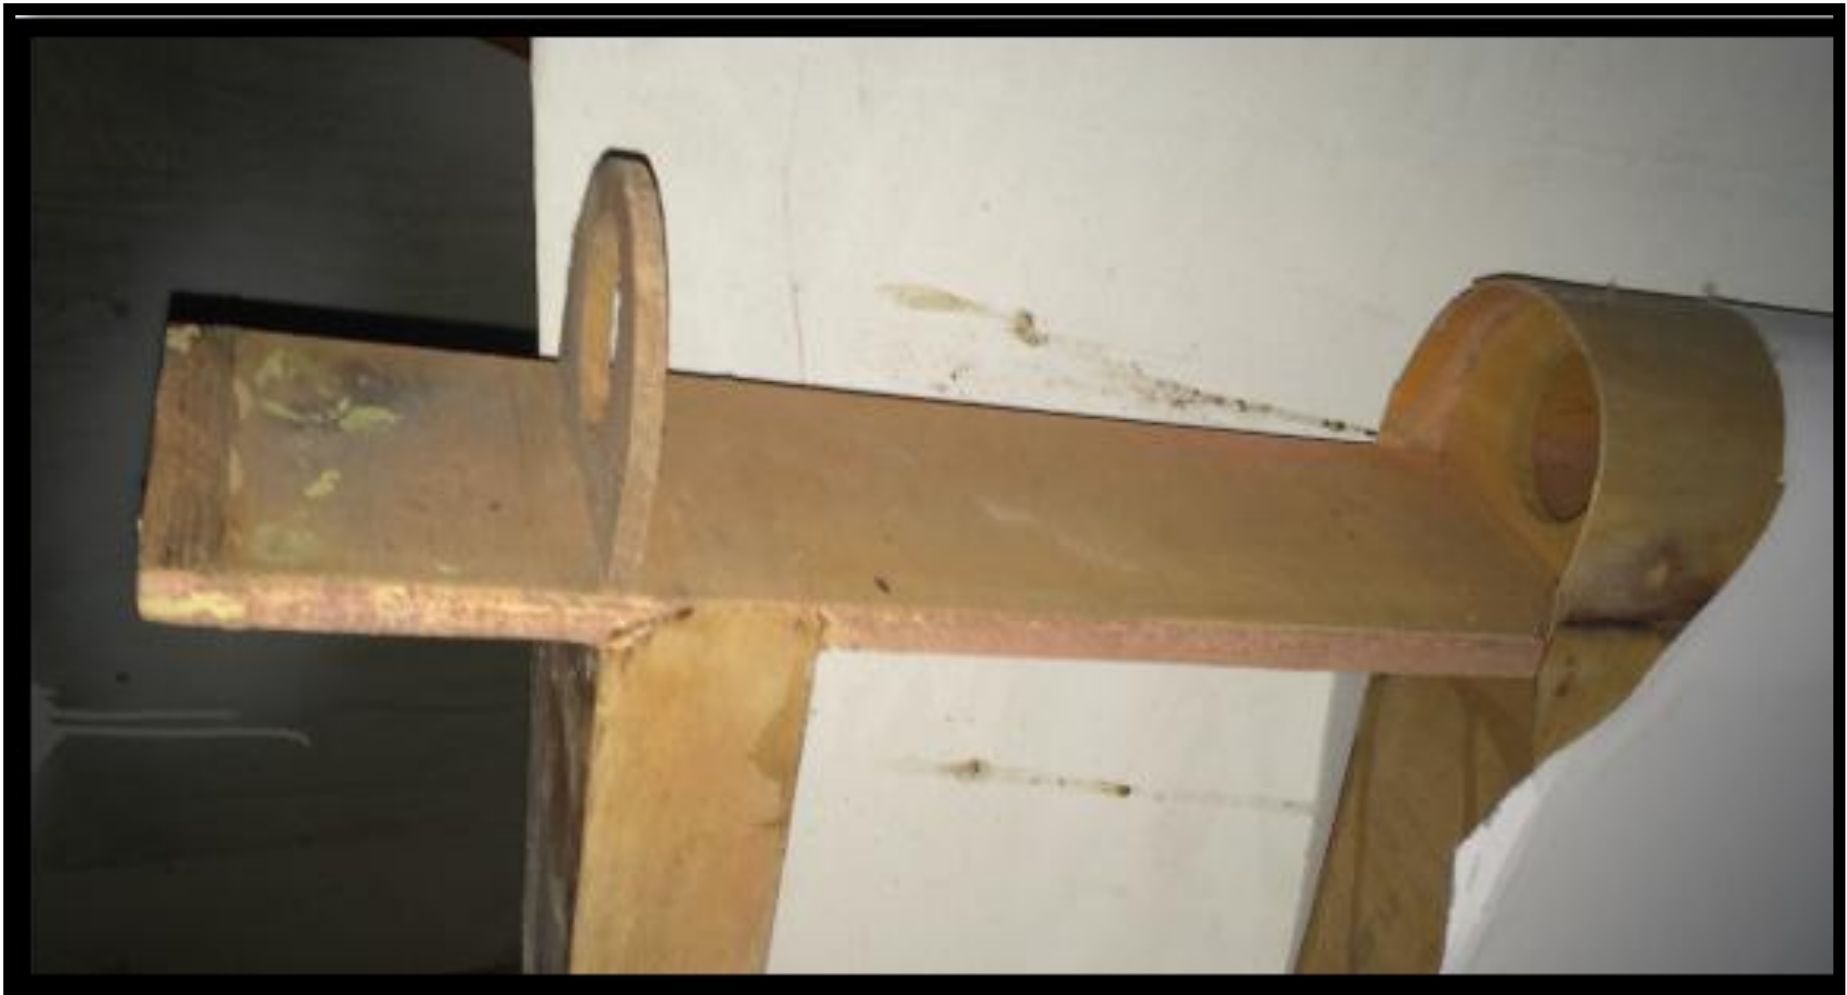
Figure 4 Typical Sternpost and base rib glue failure

D Fin inspection. You must remove the fin at the next annual after 1st March 2015. If performing the inspection during a fuselage recover then the fin is always to be removed (except K6s) where they are not bolted on) See figure 4 for images of glue failure found previously

Remove the fin (does not require much fabric work). Removal must be done on all types apart from K2, K6 and K14 types that are glued on rather than bolted. (Indicate on the form returned to the BGA when the fin was last removed). Gentle pressure has to be applied to see if the glue joints still have the required high strength. Inspect base of fin rib and put some pressure on it pulling it away from the fin and trying to insert a feel gauge (as in Figure 2) between the base rib and Fin skin. Check the entire stern post both sides by applying gentle pressure to the plywood that bonds onto the stern post spar. Apply gentle but firm pressure to shear web plywood away from the sternpost spar caps to ensure there is no disbonding over the entire length. You are looking for any sign of disbonding or rotten wood (especially at base of fin). Apply significant pressure to the elevator drive mount to ensure that rib is completely bonded. Note, often the bolts that hold the fin onto the fuselage are rusty and should be replaced. On the K2, K6 and K14 in addition to the above make sure you apply some gentle pressure to all the internal parts, feeler gauge check the keel member and tail skid mount as well.
