B.G.A. TECHNICAL COMMITTEE

TECHNICAL NEWSHEET

TNS 9/10/83

PART 1 AIRWORTHINESS 'AGGRO' (Please add to the 1983 Pink Pages)

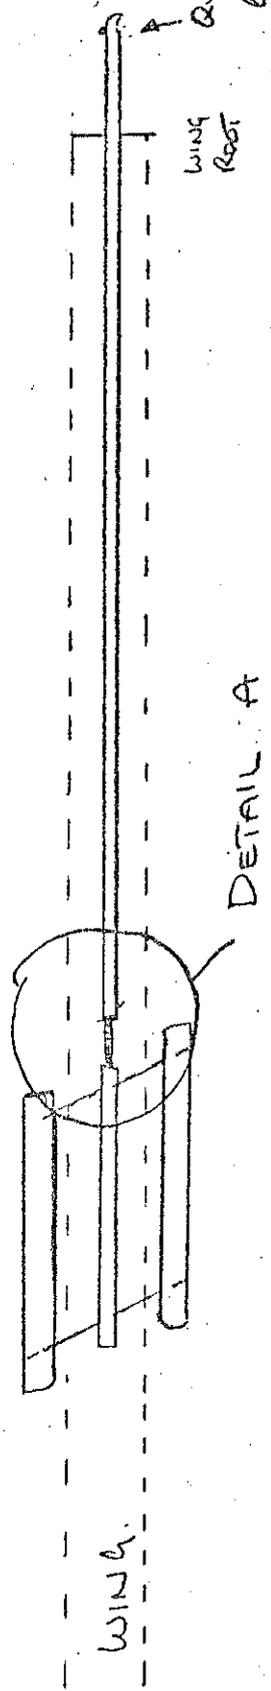
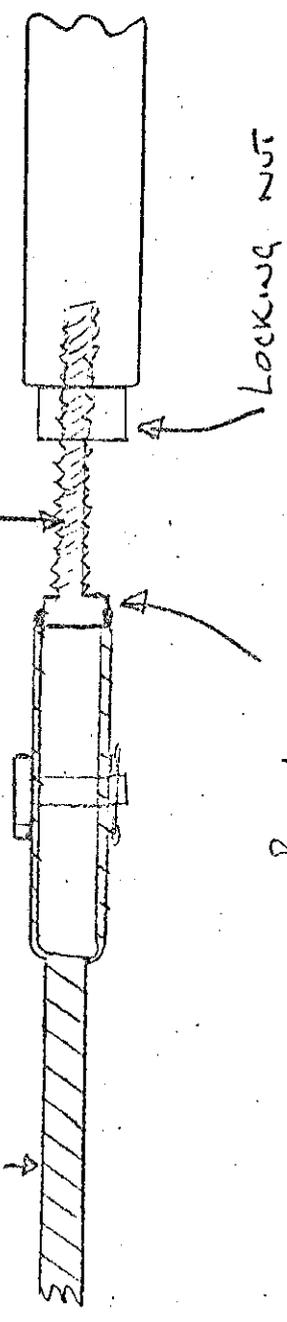
OPEN CIRCUIT
AIR BRAKE

- This type of structural deterioration may occur in any glider of similar construction.
- 1.6. OPEN CIRRUS speed brake rod failure Sketch kindly provided by Mark Darby attached herewith, explains the problem.

LOCATION OF FAULT: X-SECTION THROUGH STD WING
LOOKING AFT

FRACTURE OCCURRED
HERE

"AIRBRAKE YOKE-BAR"

BOLT WELDED
TO FORK-END.

AIRBRAKE TORQUE-TUBE / FORK-END FAILURE. SCHEMP-HIRTH OPEN CIRCUIT (MSN# 2)
HARR DARGY (SUSSO) 11/14/83

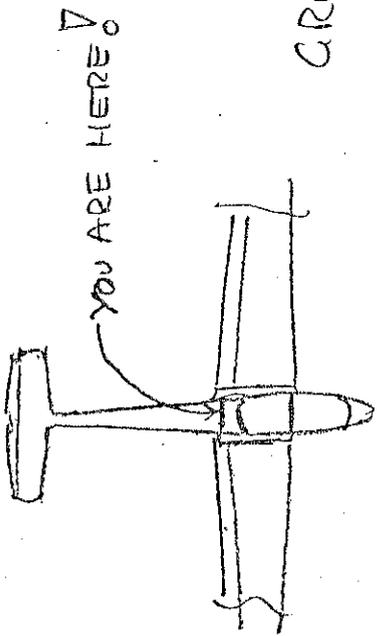
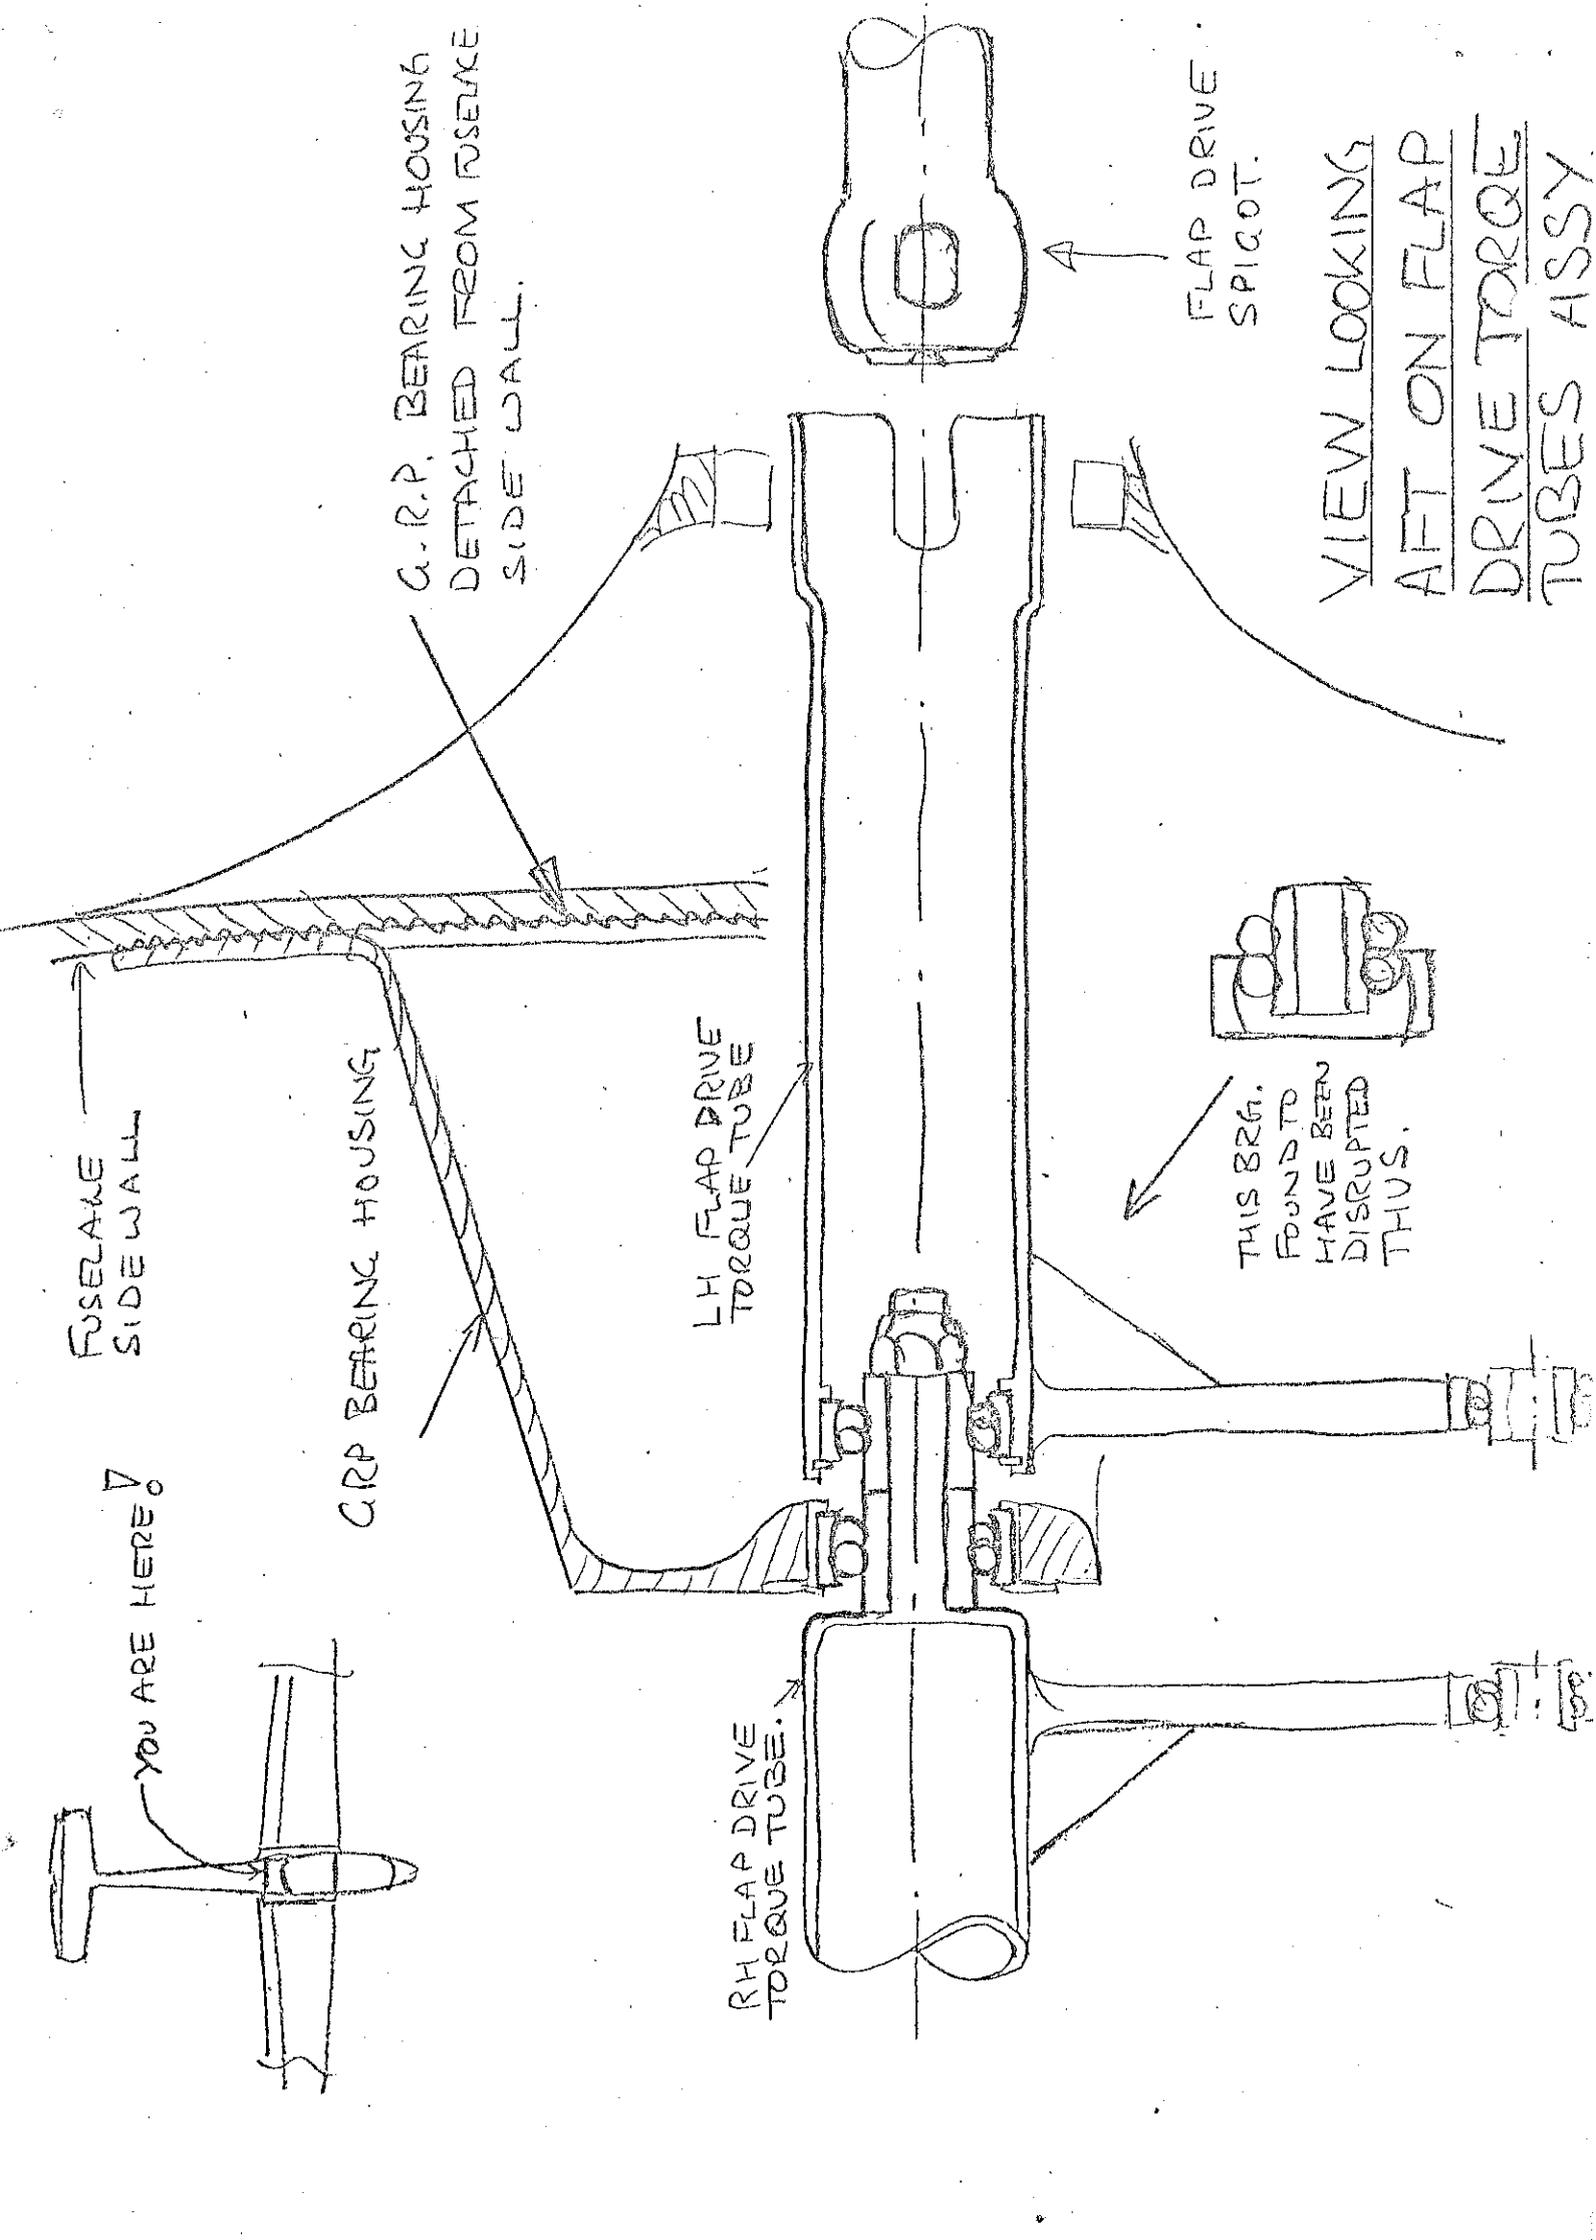
VIEW LOOKING AFT ON FLAP DRIVE TORQUE TUBES ASSY.

- 1.9. KESTREL 19 Flap Flutter The attached report and sketch by Chris Batty is self explanatory.
 - 1.10. ASW 20L - Flap disconnected Wing mounted female connector had not engaged fully on the fuselage mounted ball, and became detached when landing-gear was retracted. (Reported by Tim Macfadyen).

After the event the g.r.p. moulding which provides the flap torque shaft bearing was found to be almost completely detached from the inside of the fuselage. The resulting flexibility provided enormous flap backlash. On dismantling the mechanism the double row self aligning bearing at the end of the L.H. torque tube was found to be disrupted as shown in sketch.

The L.H. flap drive bearing has received a substantial overload in the inwards direction to cause the outer ring to spring over the ball array. This load can only be reacted by the g.r.p. moulding carrying the centre bearing in a direction which will "unpeel" it from the fuselage wall. It is suggested that the L.H. wing was entered to the fuselage with the flap in a different position to that of the cockpit lever. The flap drive spigot then abutted the slotted end of the torque tube instead of entering the slot. The resulting end load disrupted the bearing and dismounted the g.r.p. bearing housing.

In view of the detail design of the mechanism it is surprising that this has not occurred on an aircraft previously. Other Kestrels have been seen to have the g.r.p. mounting partially peeled from the fuselage sidewall, indicating that they have been loaded during rigging, but their level of attachment has still been satisfactory. A fairly major re-design of the mechanism would be required to overcome this mode of failure. In view of the absence of other reported incidents, and the major but not catastrophic nature of the flutter, it is concluded that a design change is unnecessary.

G.R.P. BEARING HOUSING DETACHED FROM FUSELAGE SIDE WALL.

THIS BRG. FOUND TO HAVE BEEN DISRUPTED THUS.

1. That owners be alerted to the risk of damage during rigging.
2. That inspectors be made aware of the possibility that such damage could exist.
