B.G.A. TECHNICAL COMMITTEE

TECHNICAL NEWSHEET

TNS 1/2/88

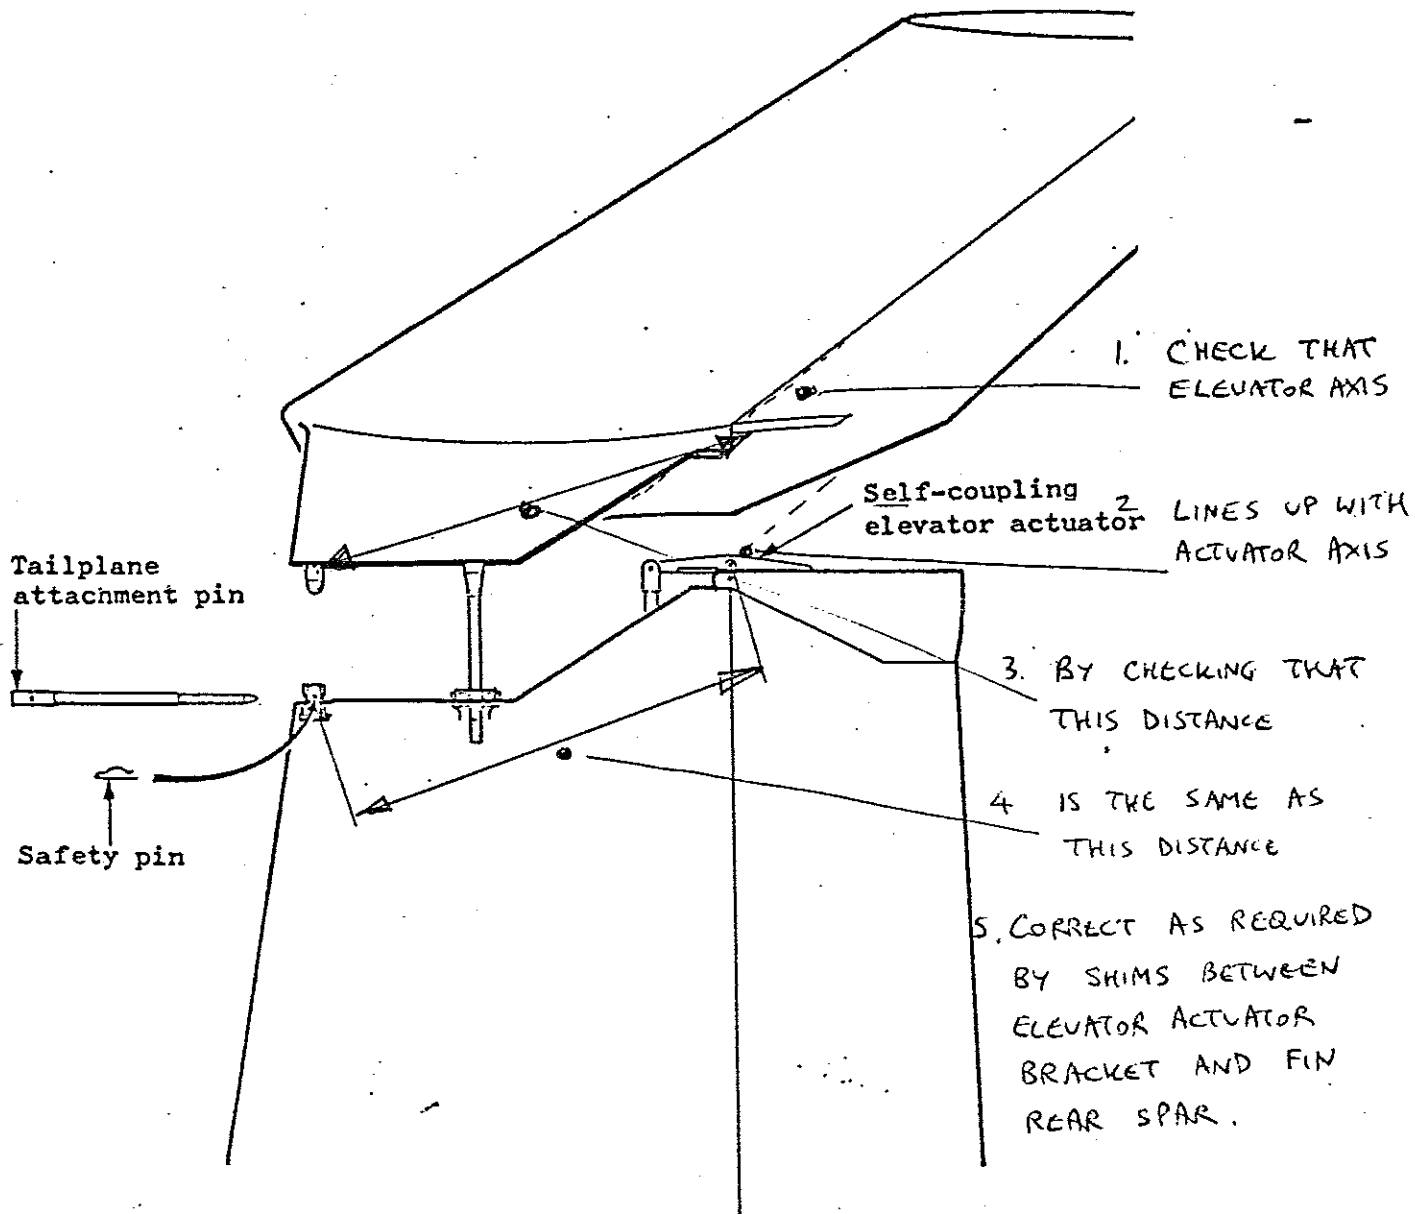
VEGA ELEVATOR DRIVE ALIGNMENT

- 1.1 Slingsby T.65 "Vega". Tailplanes attachments. Further reports have been received of cracks in the G.R.P. securing the tailplane attachments. Inspect frequently, particularly after any incidents. CHECK ALIGNMENT OF THE ELEVATOR ACTUATOR, as per sketch attached. (Reported by Peter Taylor & J.H. Odell).

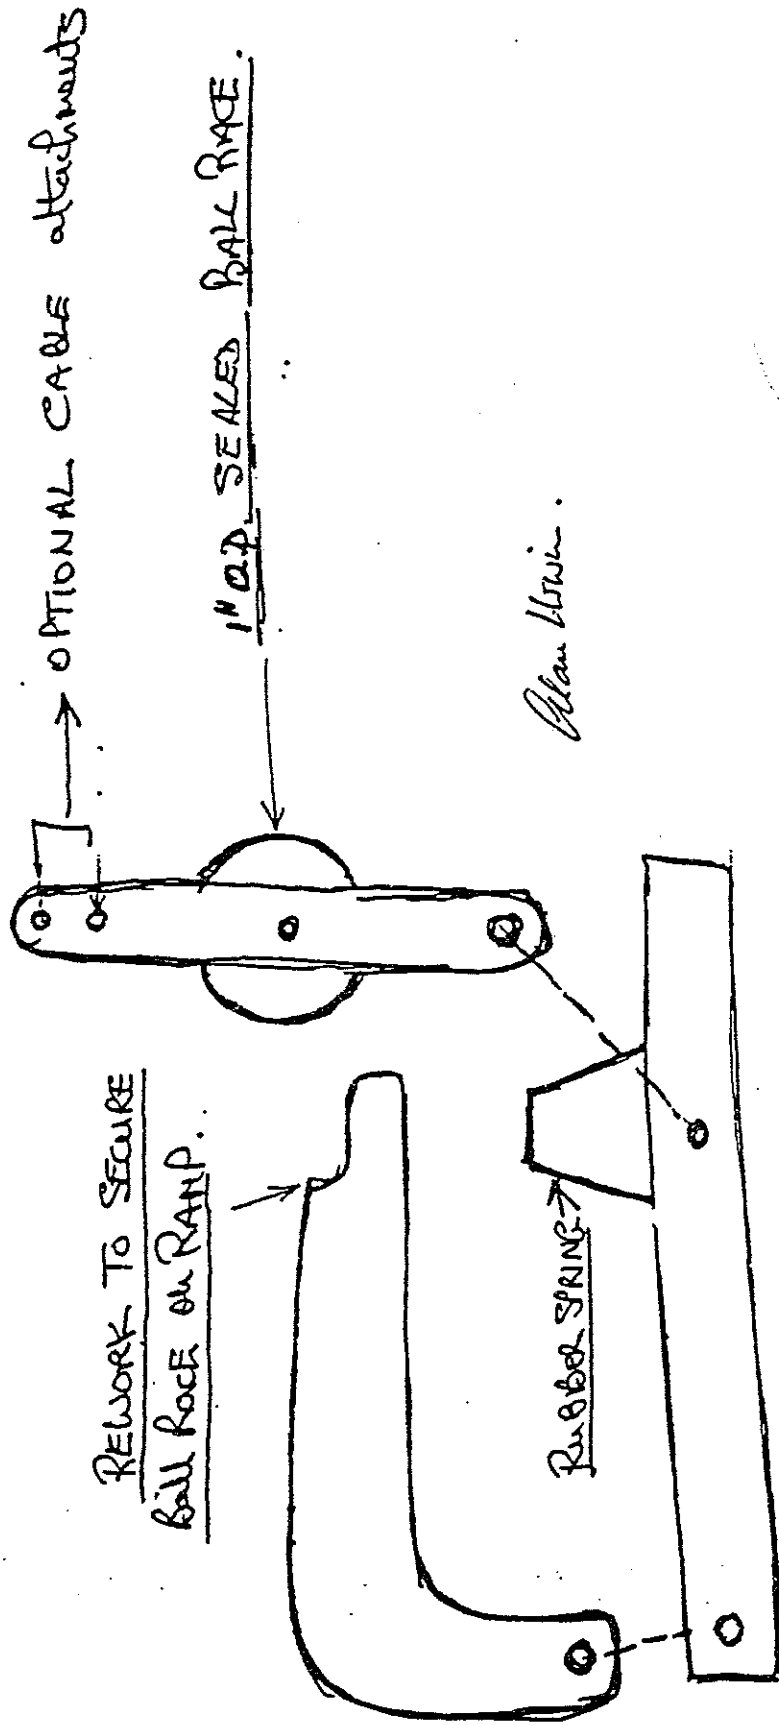
Schweitzer Type Hook (MODIFIED), BGA MOD/T/1/85.

To improve the operation of Schweitzer Type Tow Hooks, (normally used for both Banner and Glider Towing), when used for Glider Towing, by replacing the roller by 1" O.D. sealed ball race.

The pull-off loads to release the tow cable under tension are reduced from 95lbs (approx) to 25lbs (approx).

with 1" O.D. Sealed Ball Race - to reduce the Release I.D. (By 75% under tension approx).

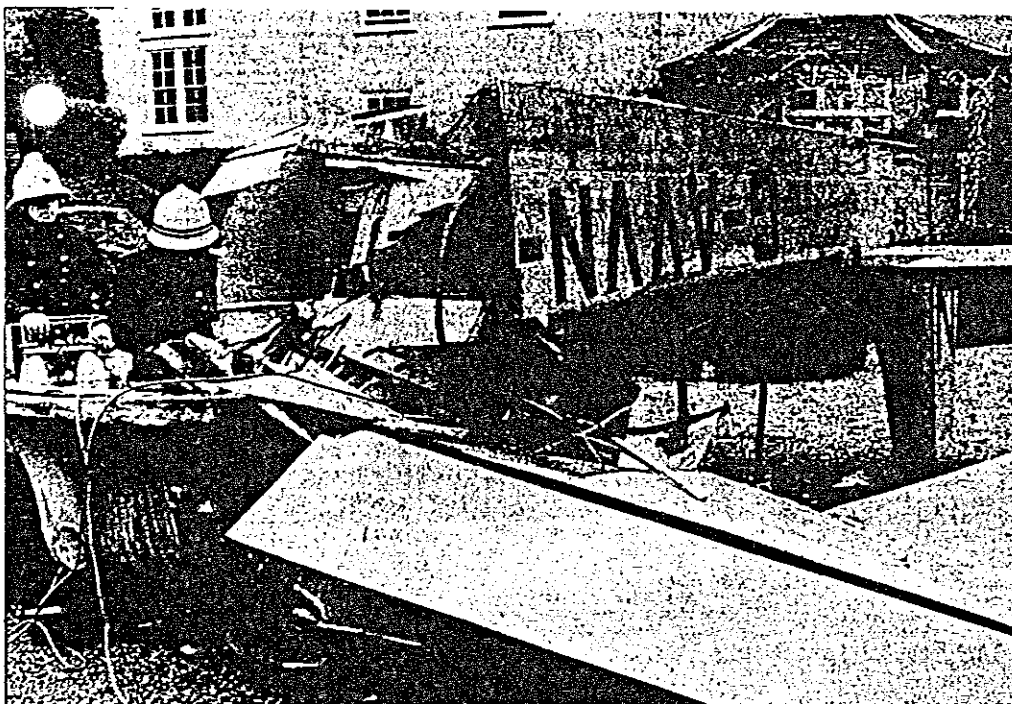
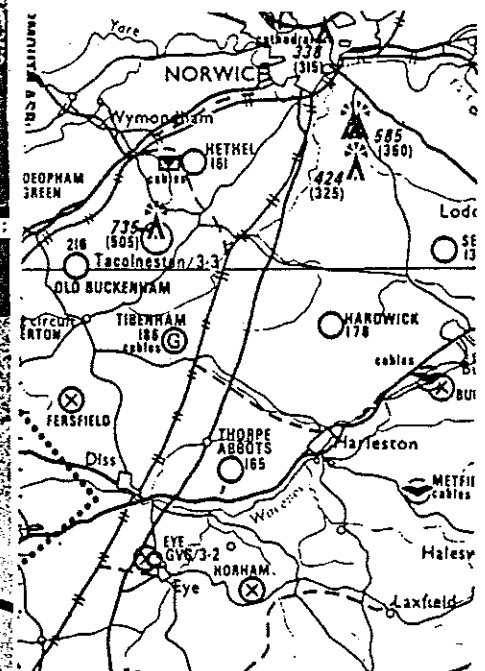
Photo - Eastern Daily Press

At 11.21 hours the aircraft took off, on the westerly runway, towing a glider with two persons on board. Following a left turn, and climb to 2000 feet, the glider was released on an easterly heading about 2.5 nm to the south of the airfield. It was reported that on all previous tows, the pilot had taken the gliders to the north, returning to the airfield on a southerly heading. After release, the aircraft instead of turning north, continued south easterly and was seen orbiting in the vicinity of Thorpe Abbots Airfield which is about five nautical miles to the south south-east of Tibenham. It left the area in a westerly direction and was next seen orbiting Eye Airfield, which is about 7.5 nm south of Tibenham. The aircraft was seen flying down the south westerly runway at such a height that the tow rope touched the ground. It then turned left and climbed out to the north. Shortly before 11.45 hours, the aircraft was seen heading south and descending. At a height of about 50 feet agl, the nose was seen to rise sharply and the aircraft was reported to have turned over, striking the ground seconds later about 25 yards from the main building of an hotel, killing the pilot, the sole occupant.

Examination of the wreckage indicated that the aircraft had struck the ground and at an angle of about 70 deg nose down, with the wings almost level at an airspeed of about 80 knots. The heading at impact and the position of the tow rope indicated that the aircraft had rotated about 250 deg to the right during its final descent. This was consistent with a spin entry to the right at low altitude. There was no evidence of a failure of the flight control system before impact. The fuel tank was ruptured but there was evidence of some fuel present at impact. The only fuel found in the remainder of the system was a small amount in the carburettor bowl. The electric fuel pump was found on. The fuel cock was found in the OFF position. It was found to be difficult to move and a test using the Clubs other Condor and a female pilot of similar build, revealed that while strapped in she could with difficulty reach it, but could not move it. This could have been a factor in the pilot losing control.
