BRITISH GLIDING ASSOCIATION

TECHNICAL COMMITTEE

TECHNICAL NEWSHEET 1/2/89

PART 1 AIRWORTHINESS "AGGRO"

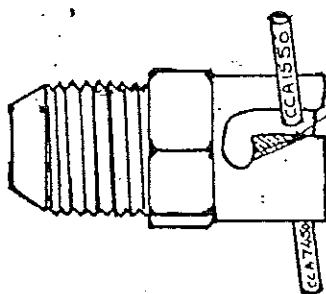
Investigations have proved that, in some cases, the problems have been due to the Curtis drain valve, on the bowl of the fuel filter, located between the fuel cock and the engine driven fuel pump, being inadvertently locked in the open position after carrying out a water check during a pre-flight inspection.

NOTE: It is not possible to dismantle the Curtis Valve in any way.

In order to prevent a re-occurrence of the above problem, modify all Curtis drain valves, part number CCA 1550 (Piper P/N 492-022) and CCA 7450 (Piper P/N 492-100), located between the fuel cock and the engine, as indicated in the sketch below, taking care not to damage the spring in the process.

Carefully file off shaded area of slot sufficiently to prevent the valve locking in the OPEN POSITION. Vendor part number CCA 1550 (Piper P/N 492-022) and CCA 7450 (Piper P/N 492-100).

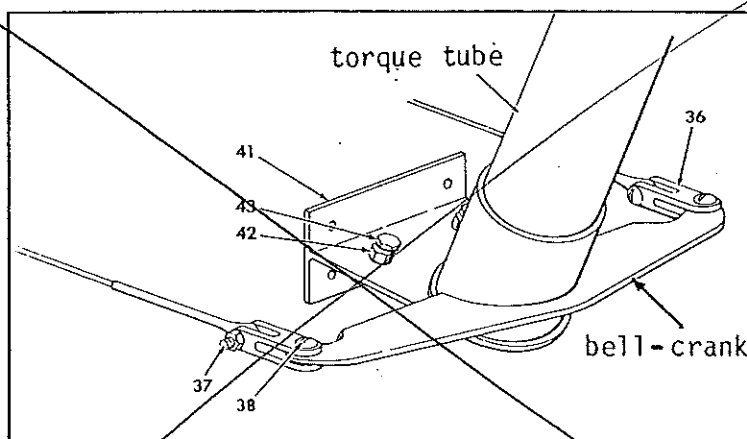
## E3. RUDDER TORQUE TUBE CRACKED

During inspection of the rudder torque tube in accordance with CAA AD 001-02-85 and the Gulfstream American Service Bulletin No ME-21, three longitudinal cracks were found in the torque tube beneath the bell crank. The 1979 aircraft has flown a total of 1150 hours.

The torque tube was removed and replaced.
