B.G.A. TECHNICAL COMMITTEE

TECHNICAL NEWSHEET

TNS 9/10/89

**PART 1 AIRWORTHINESS "AGGRO"**

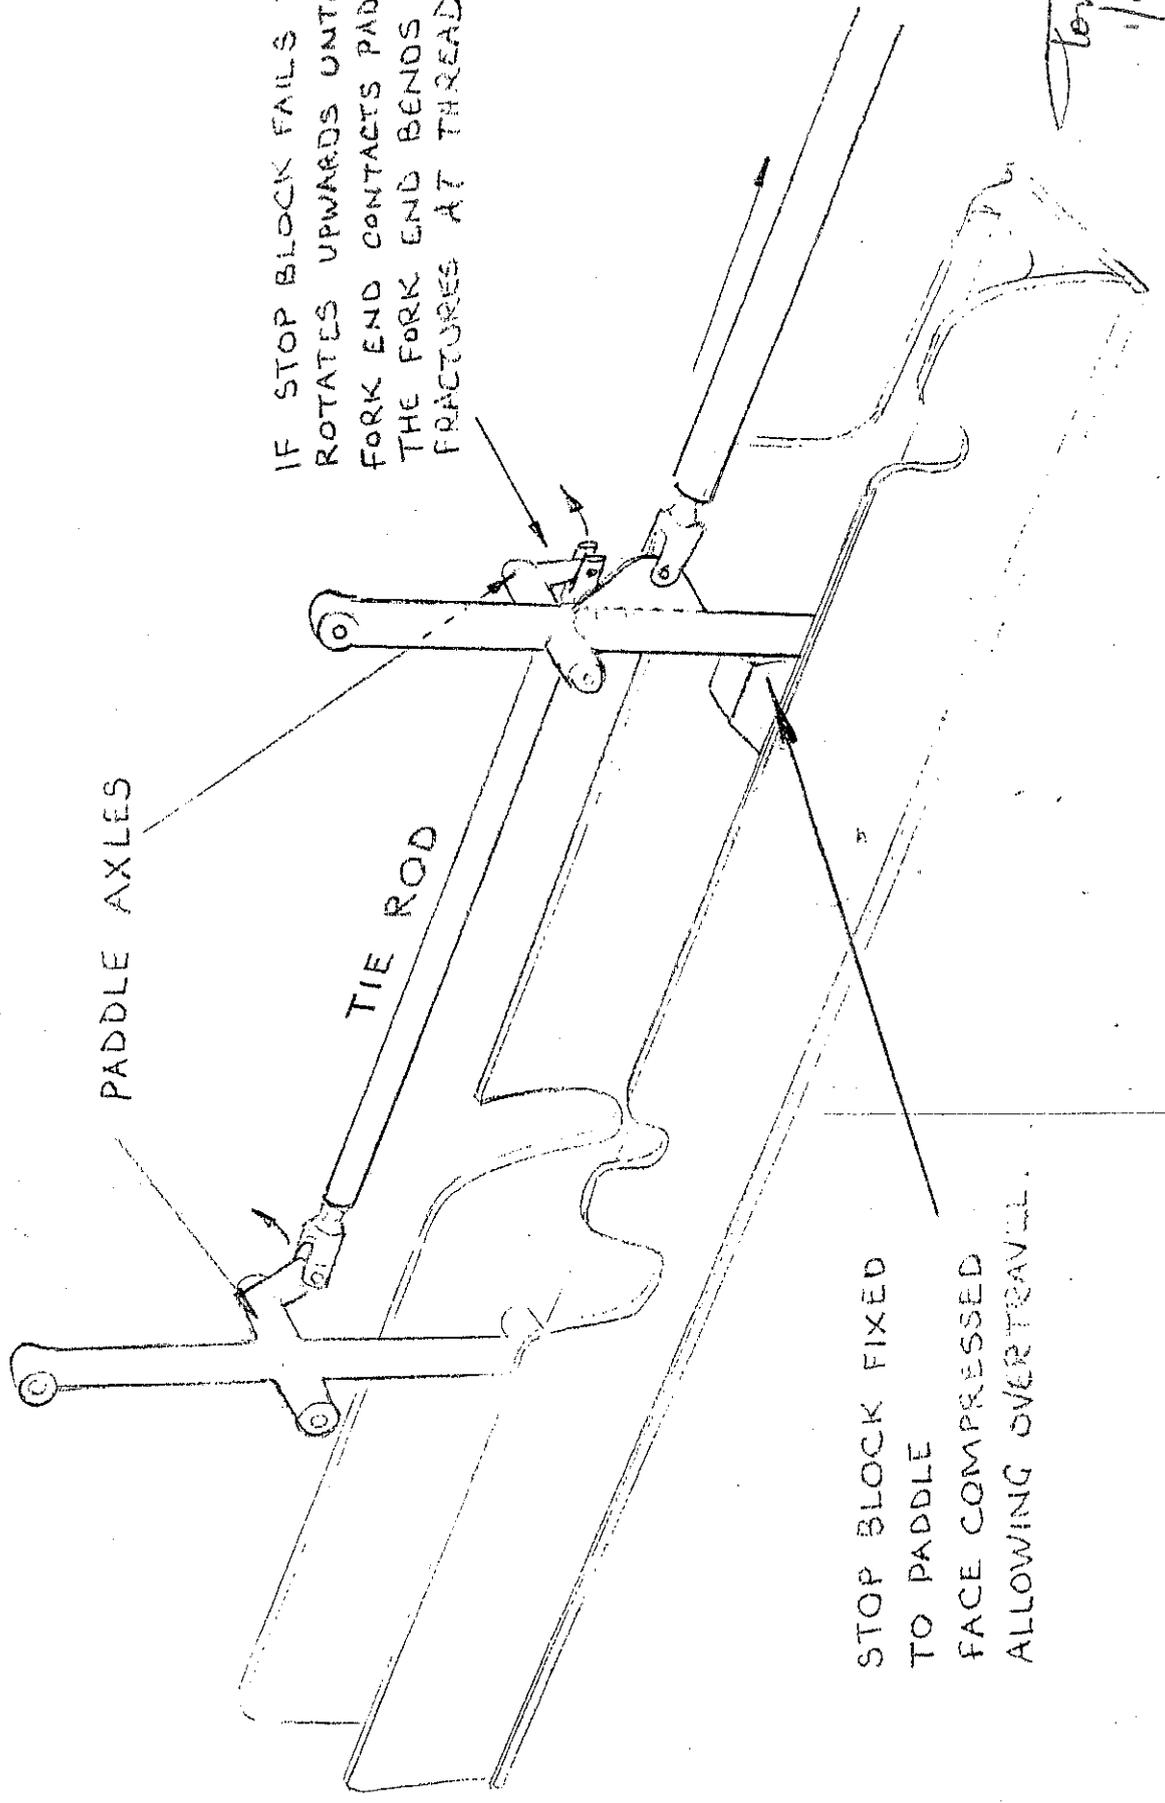
BOCIAN 1D AIRBRAKE PROBLEM.

IF STOP BLOCK FAILS THE ARM ROTATES UPWARDS UNTIL DURAL FORK END CONTACTS PADDLE AXLE. THE FORK END BENDS AND FRACTURES AT THREAD.

STOP BLOCK FIXED TO PADDLE FACE COMPRESSED ALLOWING OVERTRAVELL.

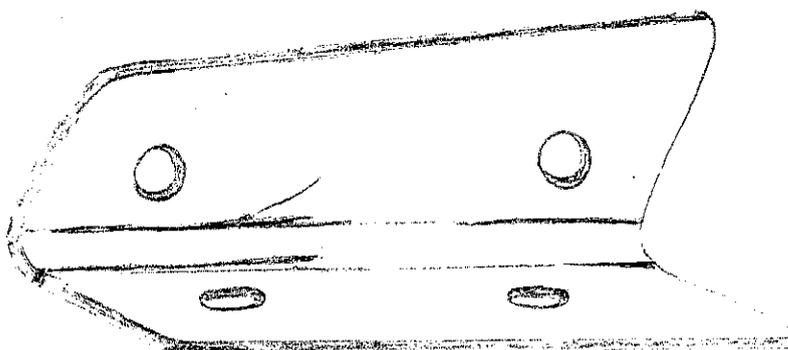
GROB ACRO HOOK MOUNTING BRACKET

During a rear Tost hook change on Grob Acro R58 the front mounting brackets supporting the hook assembly in its floor mounted box were found cracked along the former marks, produced presumably during the bending process, leaving only 30% of the bend intact.

These cracks were not apparent during the last servicing in May, however, with the hook still fitted, the cracks would perhaps be difficult to see.

The diagram below indicates the cracking.

Due to a pressing requirement for the glider, replacements were manufactured by club engineers using suitable material bent around bars. Genuine Grob spares will be fitted on receipt of spares.

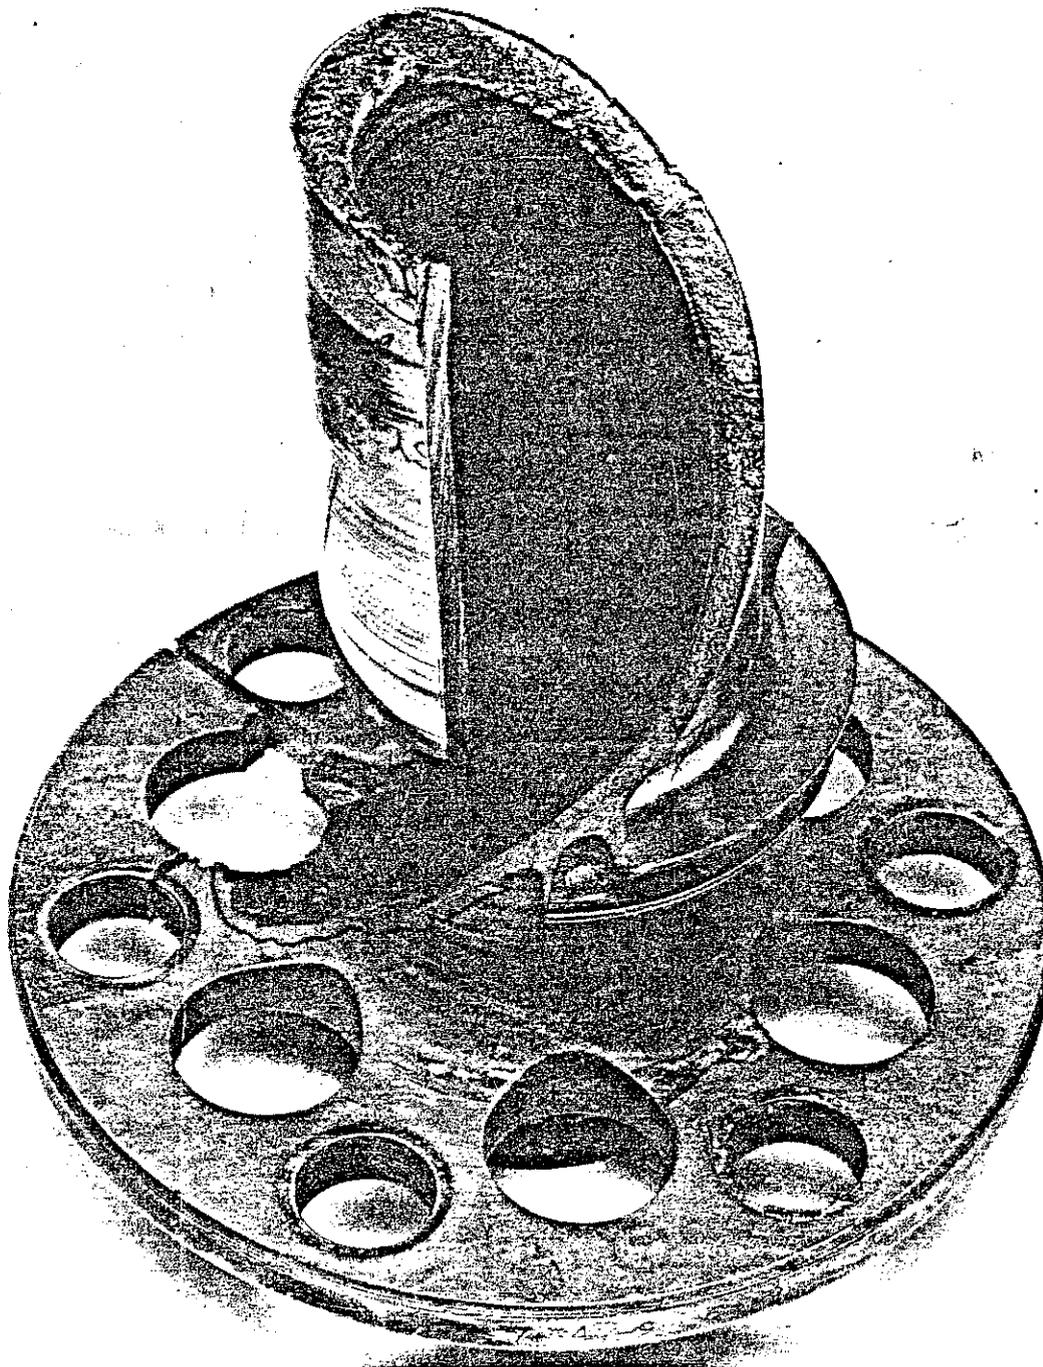
The engine had been sent to the overhaul shop to rectify reported oil leak from the crankshaft prop flange area. On dismantling, the crankshaft was found to be cracked; the crack extending from a lightening hole in the propeller flange in a spiral of 400° to the first crank pin throw.

Laboratory examination has revealed that the crack originated in a corrosion pit 1½" up the bore of the crankshaft and propagated in torsional failure. The corrosion was heaviest where a layer of grease ended, it is presumed that the grease was being used as a corrosion inhibitor.

CAA is grateful to those who sectioned the crankshaft and enabled us to produce this quite graphic photograph.

Unfortunately, many greases are hygroscopic, i.e. they attract and trap moisture and it is thought that the grease used was one of these. Therefore, it is recommended that water repellent greases or sprays should be used and that it is strongly suggested to look very carefully at the crankshaft nose if an oil leak is present. The leak might not necessarily be due to an oil seal problem.

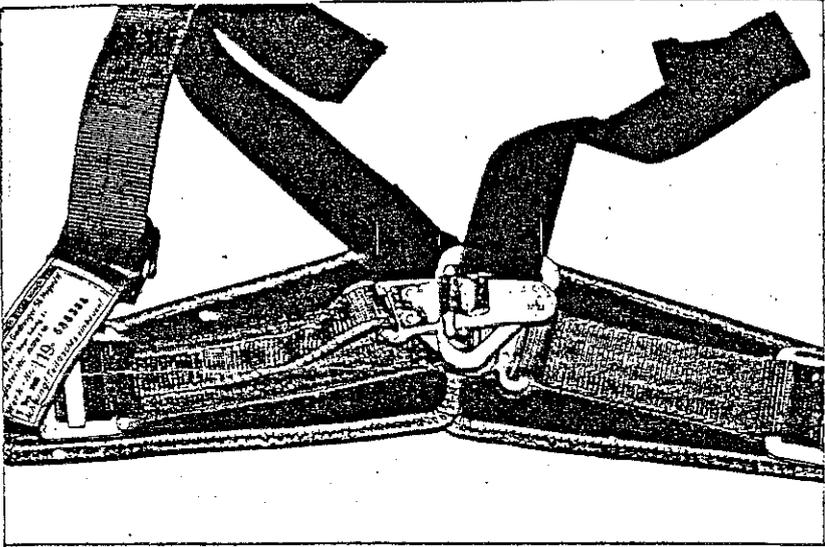
Figure 1

Original Gadringer FB19 harness system with large abdominal pads which overlap in the centre. The pad overlap keeps the buckle halves properly aligned ensuring immediate disengagement when the peg is withdrawn.

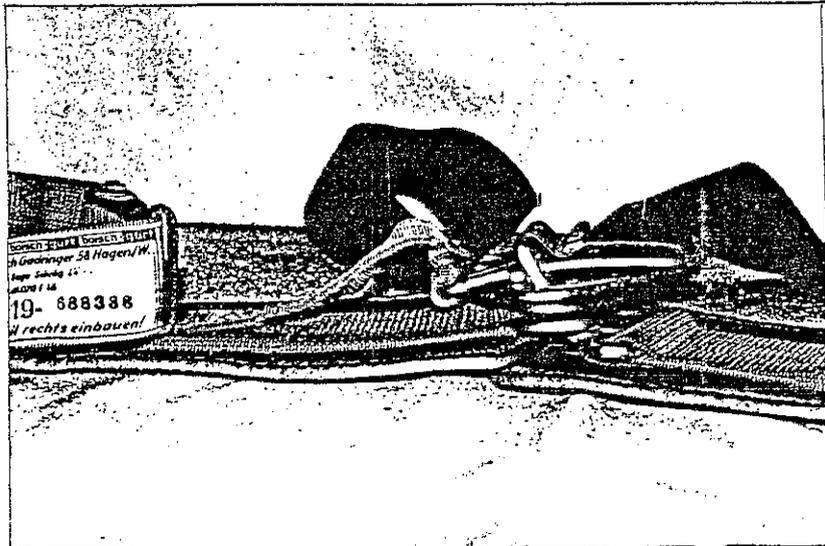
Figure 3

Shows pad overlap and all four straps correctly assembled with proper alignment controlled by the pads.

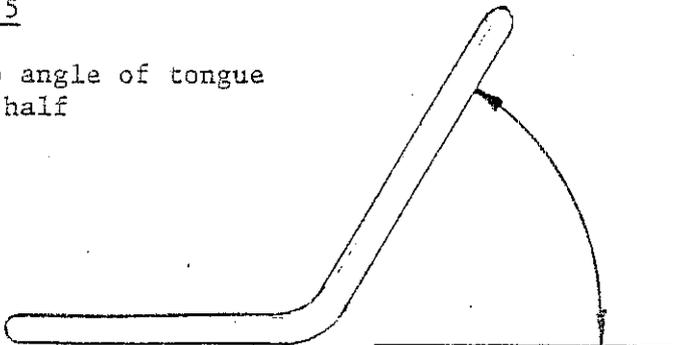
Bend up angle  $57^\circ \pm 2^\circ$  measured at  $90^\circ$  to the tongue fold line.
