BGA TECHNICAL COMMITTEE

TECHNICAL NEWSHEET 7/8/96

PART 1 Airworthiness "AGGRO"

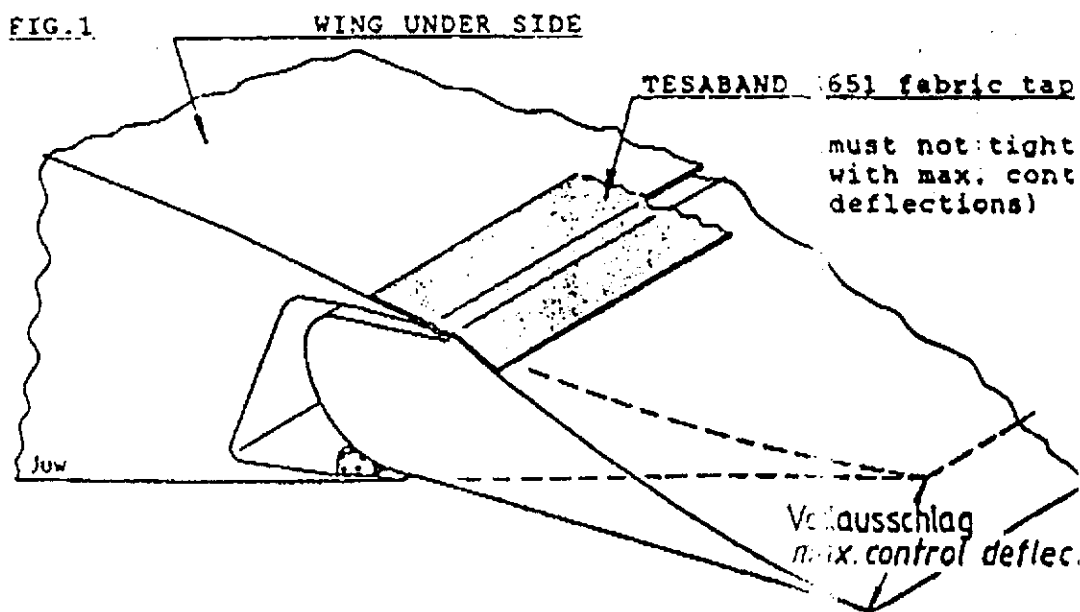
FIG.1

1. Prior to the next take-off it must be checked whether the control surface gap on the wing under side is equipped with a sealing, i.e. either
 - 1.1 with the factory-standard, plastic-treated fabric-tape TESABAND 4651, white, 38 mm wide (see Fig.1); in that case the plastic coat on the fabric must not be damaged, discolored or even weather-worn; the tape must not tighten at full control surfaces deflections.
 - or
 - 1.2 with the pre-curved steel strip (0,07 mm thick) or the pre-curved plastic tape (MYLAR 0,25 mm thick) respectively; in that case check that both require absolutely Teflon sealing tape underneath for the purpose of sealing the gap and reducing the friction (see Fig. 2).

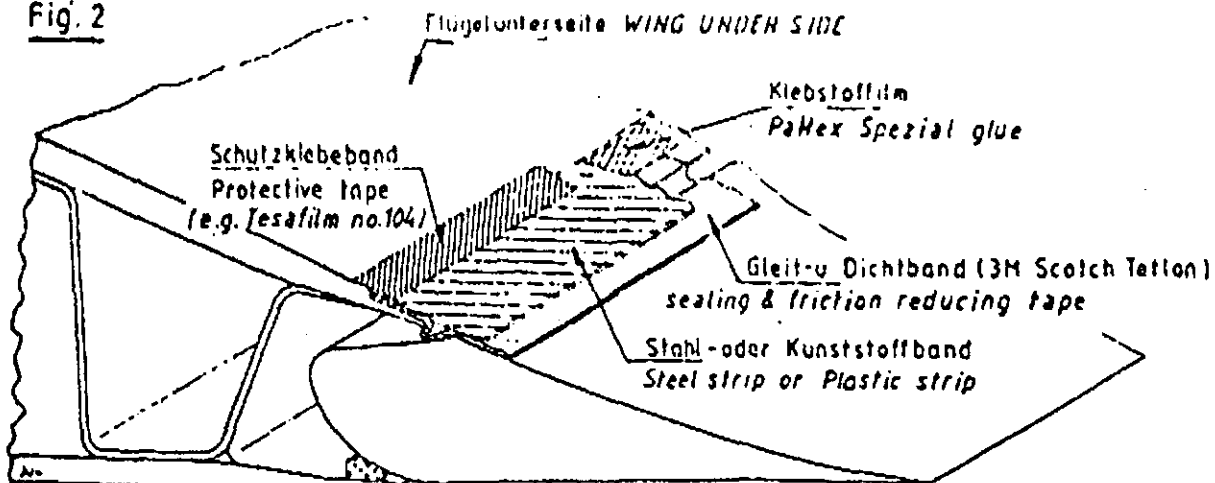
Fig. 2

- 2.2 In case of the elastic lip sealing: this has to be renewed as shown in Fig.2, following the Maintenance Instruction J, Issue III; alternatively, the elastic lip sealing can be new applied instead of the above TESA tape sealing.

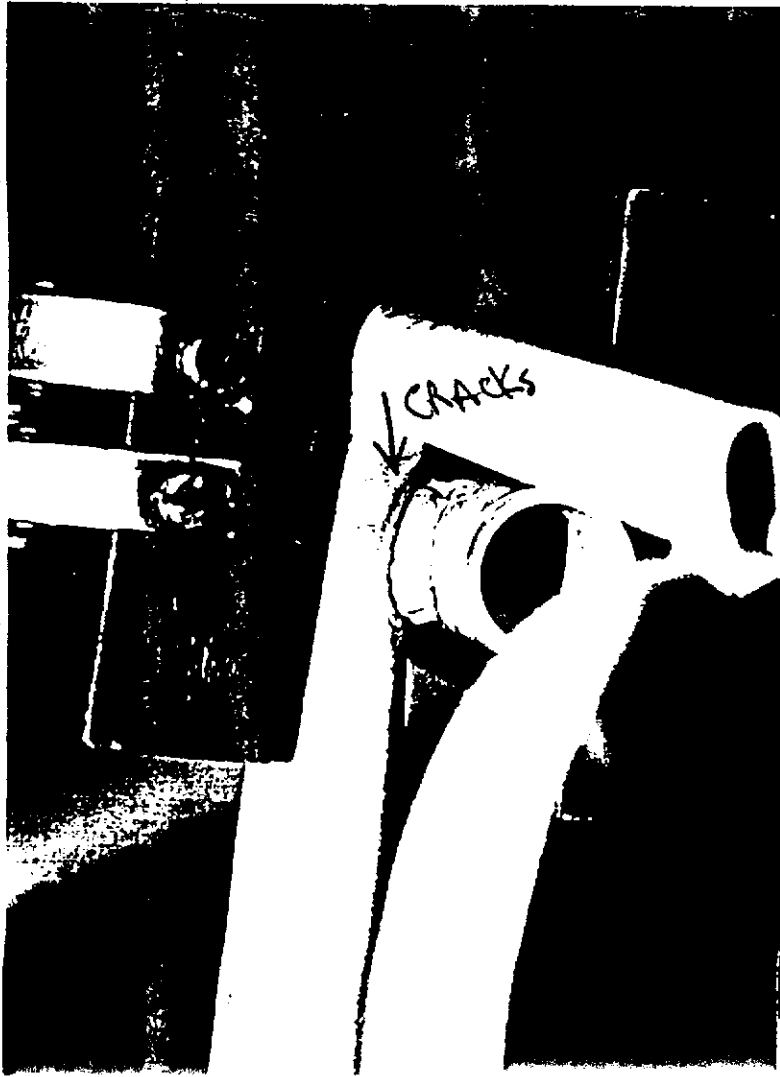
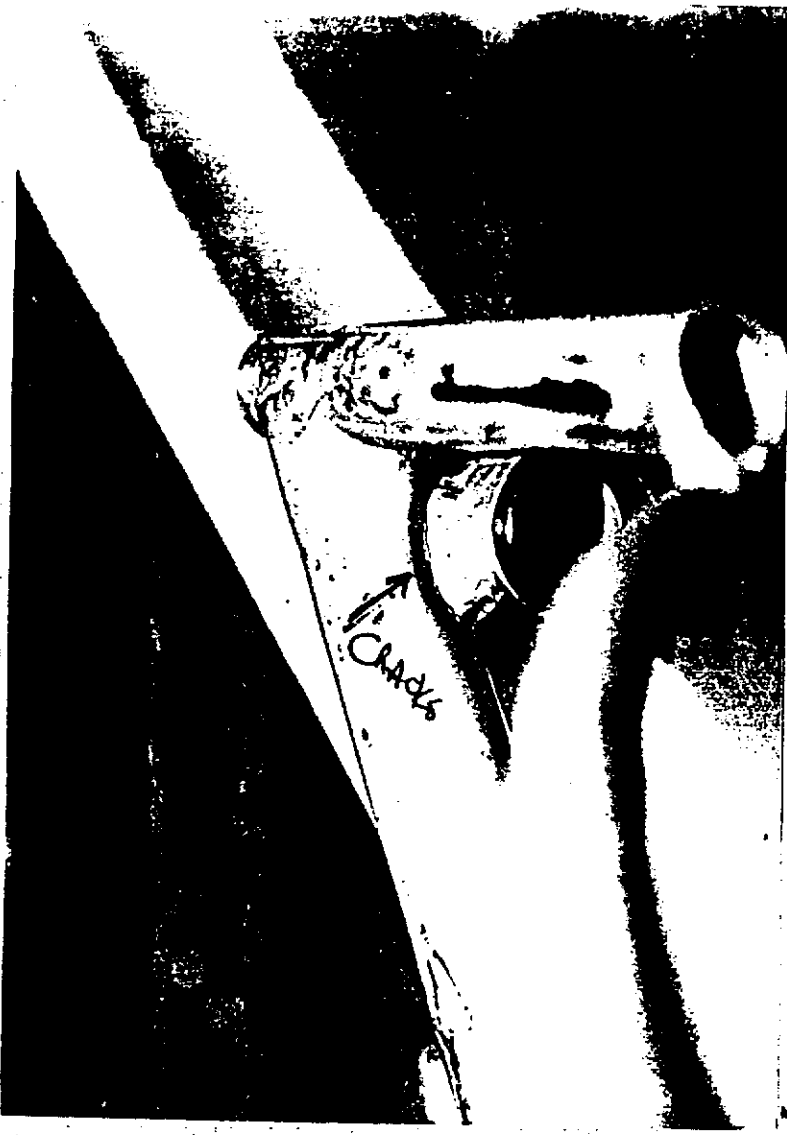
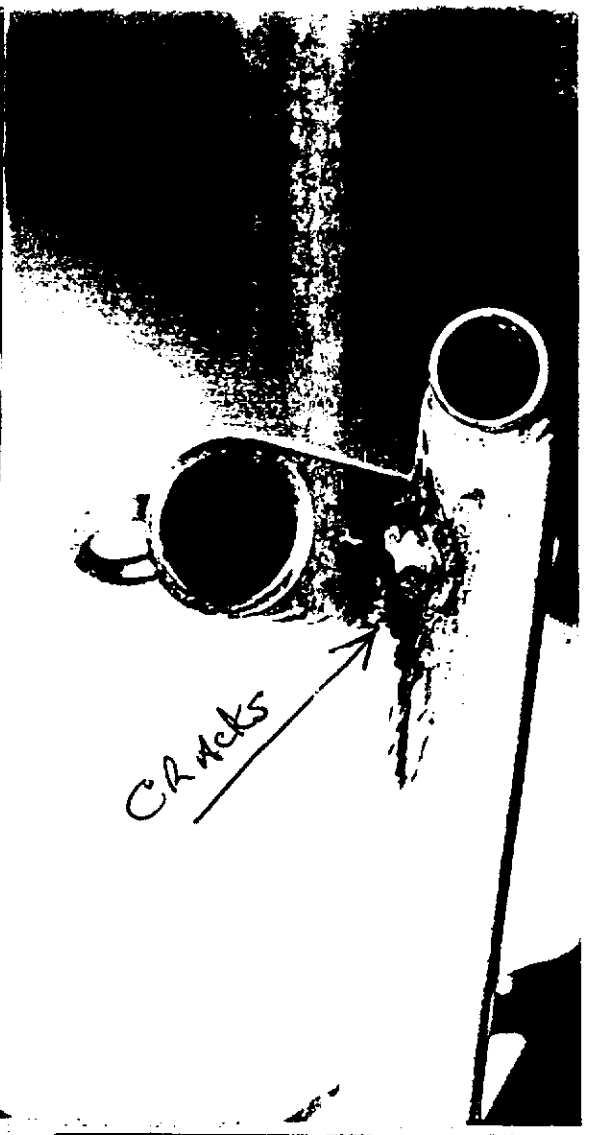
PEGASUS / ASW 19 / ASW 20 Rubber Pumps.

- 1.4. Bocian Trim Tab becomes disconnected causing elevator oscillation. Check for security at the tab. (Highland G.C.)
- 1.5. CRACKS in Rudder Pedals.(Pegasus/ASW19/ASW20) Photos illustrated the problem. (from Richard Kimberley).
