BGA TECHNICAL COMMITTEE

TECHNICAL NEWSHEET 3/4/97

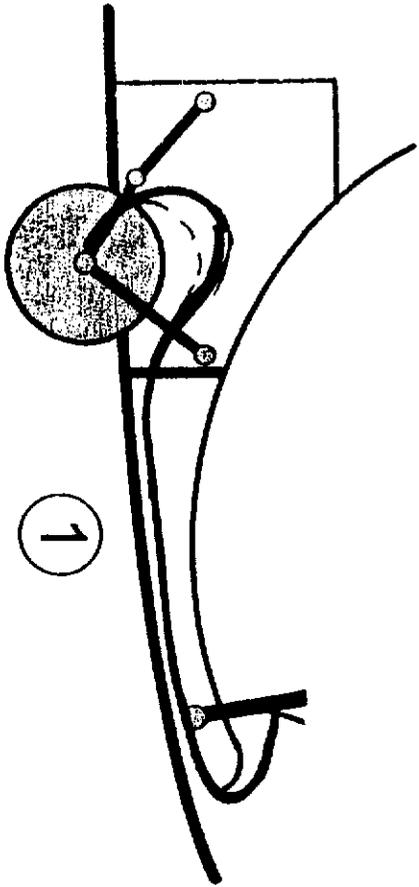
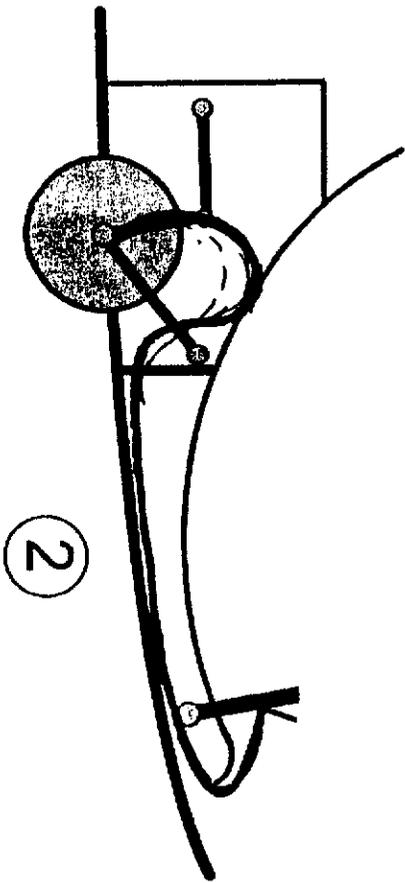
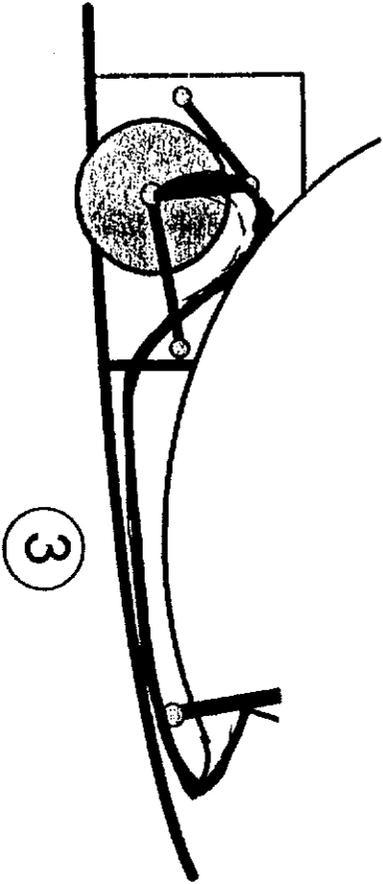
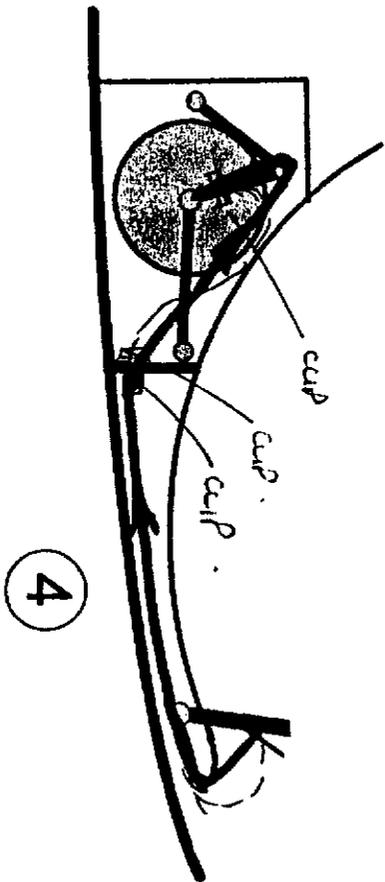
- 1.7. **LIBELLE (STD) H.201**. Elevator control restricted by interference between the wheel brake cable and the undercarriage system when retracted - (Sketch herewith from R. Baines - Burn G.C.).

The glider was subsequently inspected by removing the floor pan and the u/c wheel box cover. It was seen that the wheel brake cable could foul on the port leg of the u/c structure during the latter stages of retraction. The foul was self induced, positive and self locking at the knuckle. By simple manipulation, it was also possible to trap the cable behind the knuckle pivot nut/bolt. In either case, the fouling and subsequent retraction gave the same 'stick pulled forward' result as noted in flight. When retraction was complete, the control column would not travel back beyond the central position. The u/c leg was marked and the cable kinked at the position of the foul. Enclosed are photographs showing the position of the cable during retraction as noted at the time of the inspection

- Undercarriage retraction, lever travel at about 75%
- Cable sheath fouls on leg end face or nut at knuckle of main u/c port leg

— **CABLE RUN.**
 - - - CHANGE TO RUN.

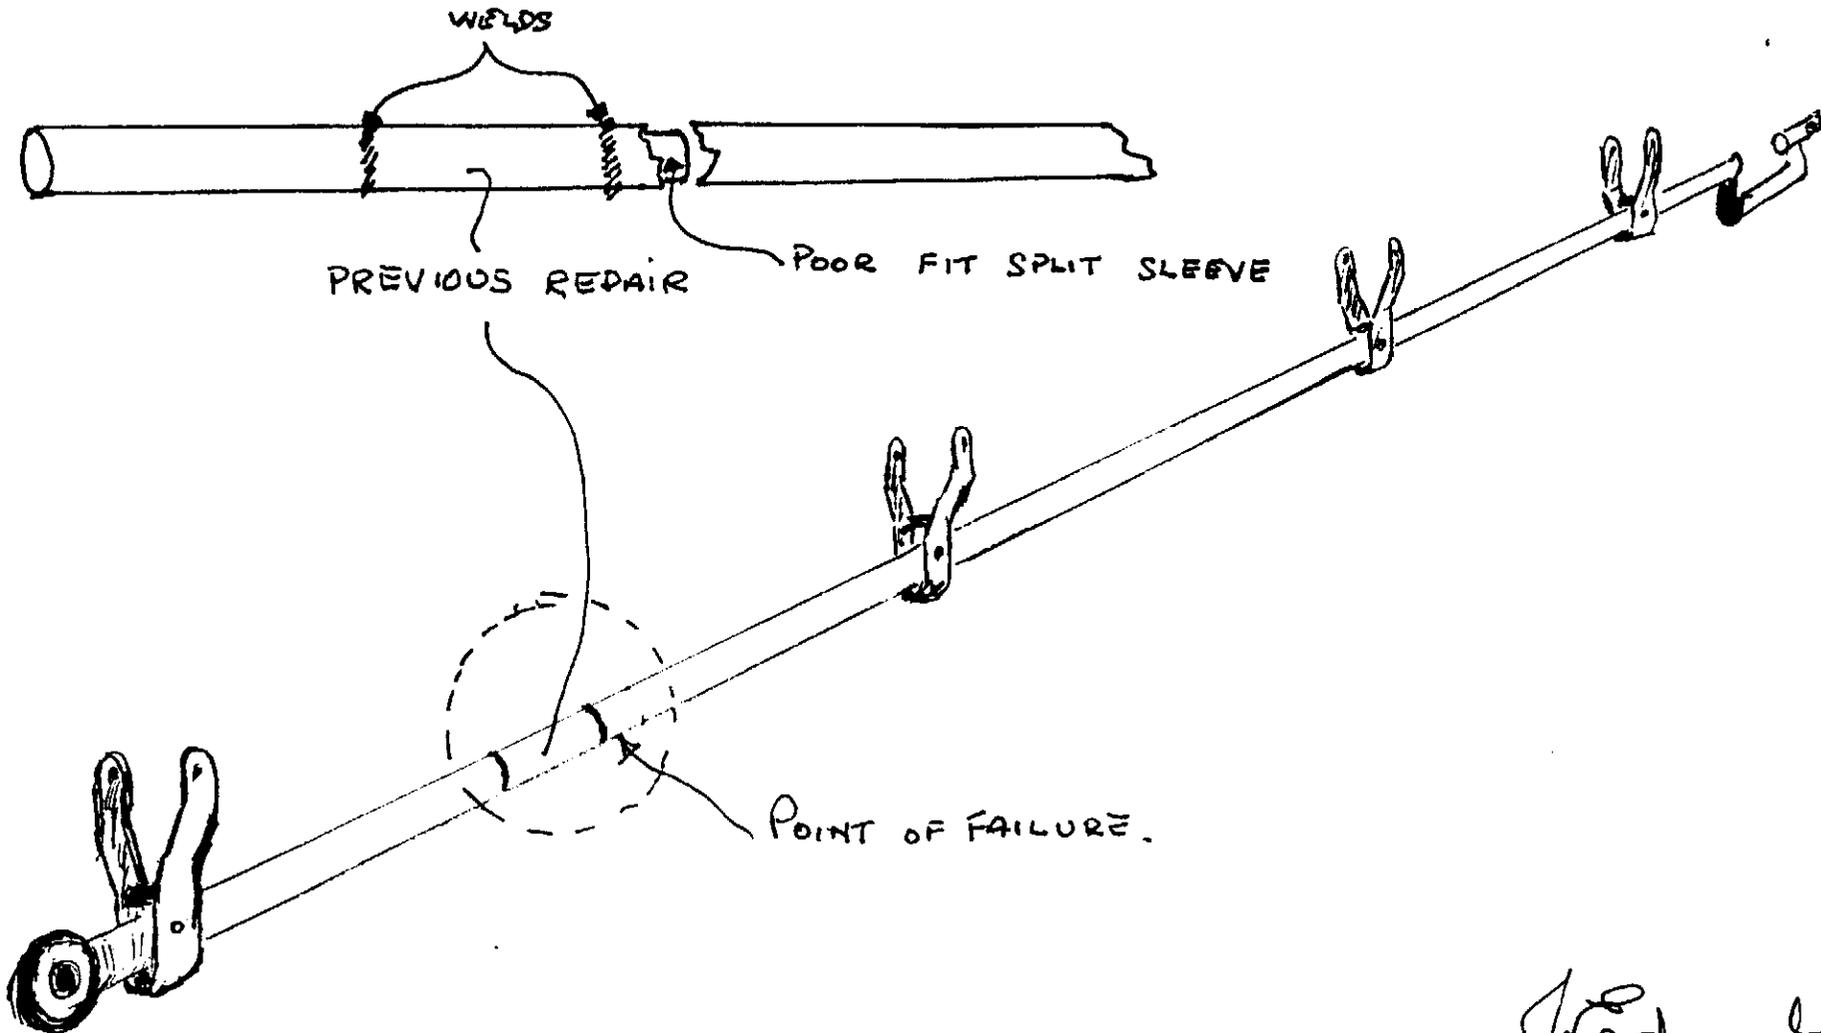
K8 ELEVATOR ROD FAILURE. ON D.I. POSITIVE CHECK

- 1.17 ASW 20 F/101/201 Sailplanes A/D 97-048(A) herewith, requires action on L'Hotellier Connectors!
- 1.18 KA8 Elevator Rod Failure - Sketch from John Edwards identifies the problem.

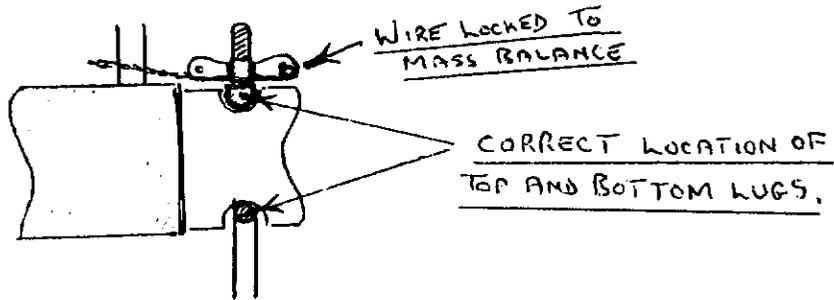
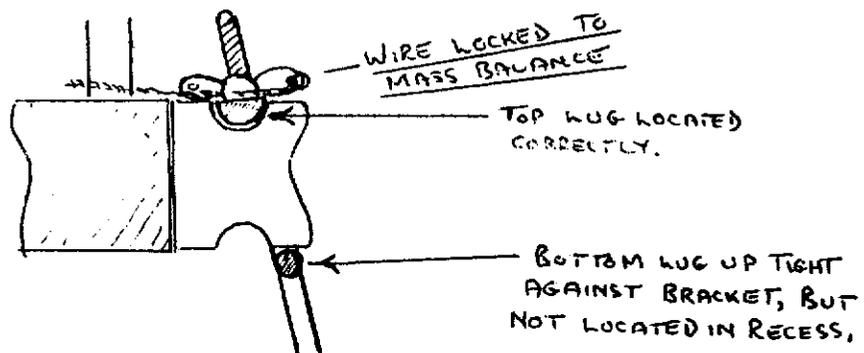
SKYLARK. 3. A. (ELEVATOR).

- 1.9. **SKYLARK 3B - Elevator Misconnected**. See sketch. (Reported by D. Godfrey - Enstone Eagles G.C.).
 - 1.10 **KA13 - Speed Brake Drive System Failure** at torque tube behind the seat. Material failure adjacent to the lug to which the pilots control tube is connected. Inspect for signs of material failure close to the weld. (Reported by RAFGSA Bicester).

I BELIEVE THIS IS WHAT MAY HAVE HAPPENED.

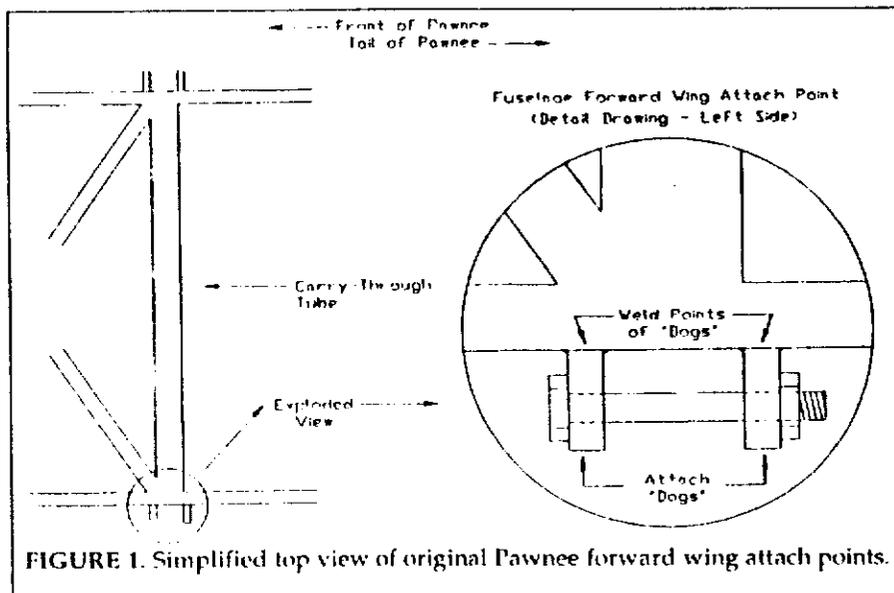
FIGURE 1. Simplified top view of original Pawnee forward wing attach points.

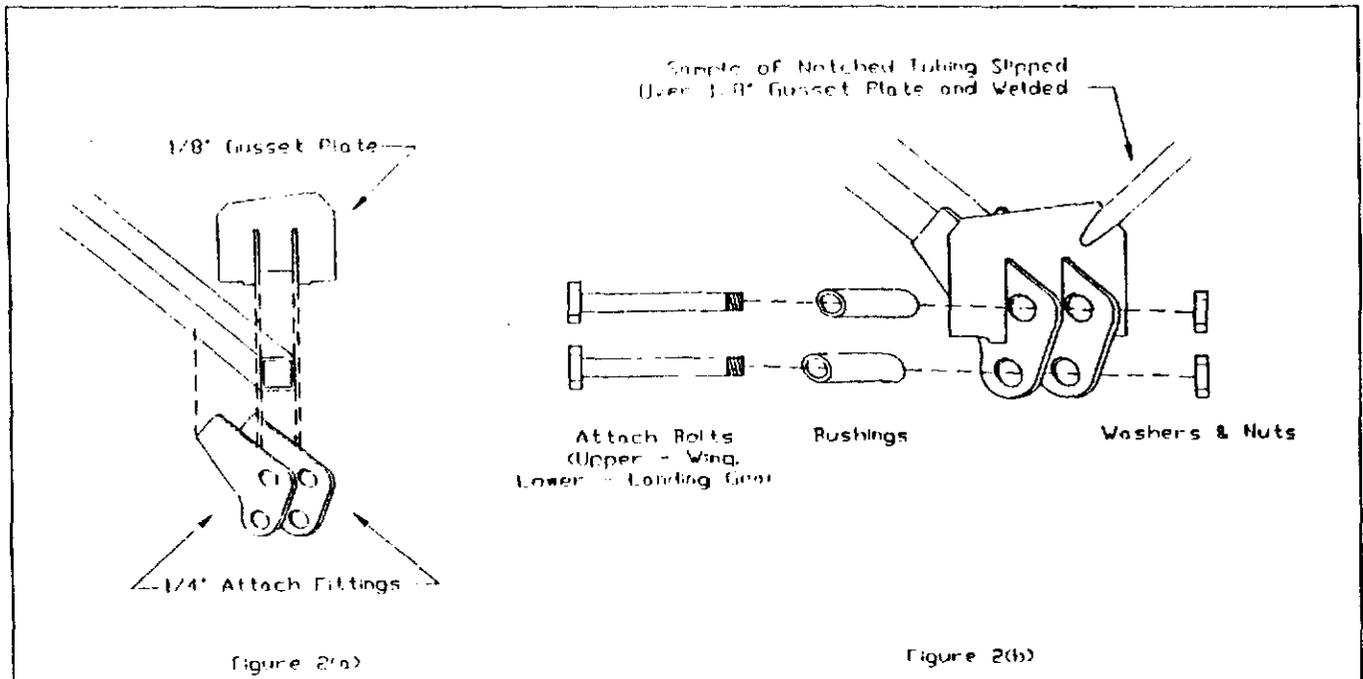
FIGURE 2. Simplified assembly drawings of SIC's new cluster design: (a) Fitting before welding; (b) Assembly of bolts, nuts, and bushing (wing forward spar, landing gear and fuselage tubing not shown.)

To avoid concentrating stress in welds and to provide overall strength, the attach fittings for both the landing gear and the wings were consolidated in one piece [See Figure 2]. These pieces of 1/4" thick chrome-molybdenum steel extend past the plane of the fuselage side and are welded along the carry-through tube, also chrome-moly steel approximately 1/8" in wall thickness. This arrangement transfers the loads produced by the wing and landing gear to the carry-through tube and provides a longer weld between the tube and the attach fittings.
