British Gliding Association - Technical News Sheet

Issue 1-2010**Date: 05/03/2010**

Airworthiness Information

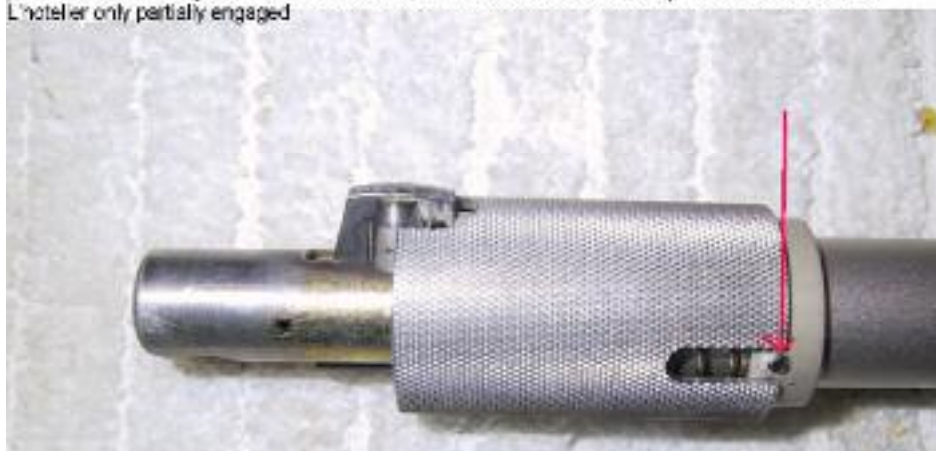
- 10 L'Hotellier connectors with "Wedekind" sleeves** **(Advisory)**
 Reported by Bruno Brown, Sherington Gliding Club

Certain types of Wedekind sleeve locked L'Hotellier connectors can be unsafe due to wear.

With sleeve in the "locked" position, Roll-pin remains in engagement with the anti-rotation slot in the sleeve (arrowed). On G-KXXI this is not the case. If the cam is partially depressed, but with the witness hole remaining visible, then the sleeve can be rotated into such a position as to leave the L'Hotellier only partially engaged.

If wear is found and there is any possibility of even partial disengagement, the coupling must be replaced.
