<b>Aircraft Type and Registration:</b>	Schleicher Ka-8B, FKJ
<b>No &amp; Type of Engines:</b>	N/A
<b>Year of Manufacture:</b>	1977
<b>Date &amp; Time (UTC):</b>	1 June 2002 at 1400 hrs
<b>Location:</b>	Hinton-in-the-Hedges Airfield
<b>Type of Flight:</b>	Private
<b>Persons on Board:</b>	Crew - 1                      Passengers - None
<b>Injuries:</b>	Crew - 1 Fatal              Passengers - N/A
<b>Other Injuries</b>	Free-Fall Parachutist - 1 Fatal
<b>Nature of Damage:</b>	Aircraft destroyed
<b>Commander's Licence:</b>	Silver C Gliding Certificate (Issued 1989)
<b>Commander's Age:</b>	69 years
<b>Commander's Flying Experience:</b>	547 hours Last 90 days - 3 hours Last 28 days - 2 hours
<b>Information Source:</b>	AAIB Field Investigation

## Synopsis

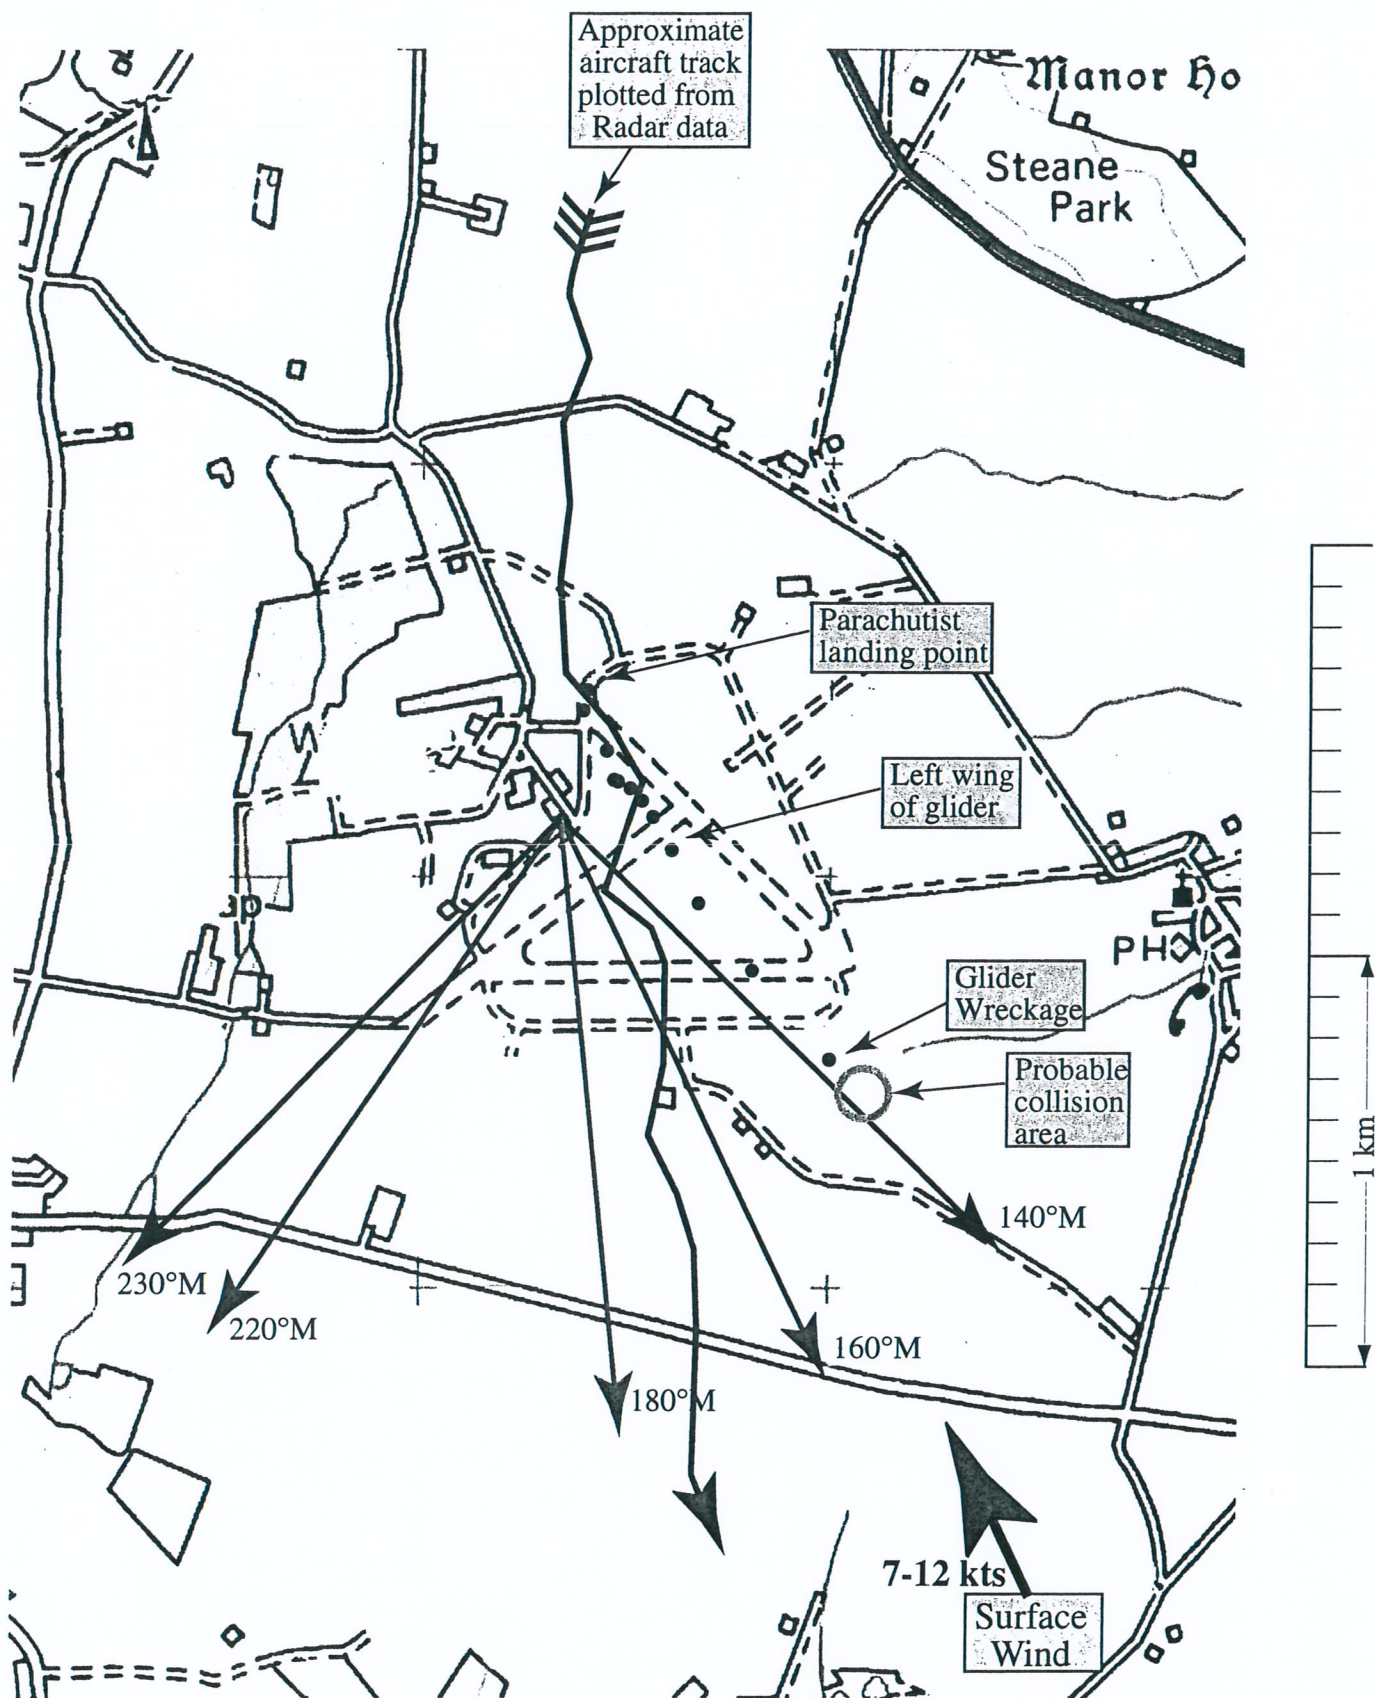
Figure 1 shows the airfield together with the location of the parachutist and the glider wreckage. The height of the collision was estimated to be approximately 2,800 feet based on the evidence from the equipment carried by one of the surviving parachutists. With the known wind direction and strength from that height to the ground, estimates were made of the likely starting point for the parachutist and the items of glider wreckage. This indicated that the collision occurred at or near the position shown on Figure 1.

Evidence from the skydiving centre personnel was that the cone of operation was within an arc bounded by 140° M and 230° M and based on the apex at the location of the DZ controller; this is shown at Figure 1. However, the understanding of the gliding club DI was that the cone of operation was within an arc bounded by 160° M and 220° M; this is also shown at Figure 1. Additionally, the agreement between the two organisations was that no aircraft would 'operate within the airfield boundary' or the 'designated DZ' (cone of operation) except when taking off and landing. The point at which the collision occurred was determined to have been some 180 metres south of the southern perimeter track, on the edge of the cone of operation as understood by the skydiving centre but outside of the cone of operation as understood by the gliding club. Without radar information, it was not possible to determine the exact track of the glider prior to the collision but, from witness evidence, it was tracking from the north. Nevertheless, the important point is that both organisations believed that they were operating in accordance with agreed procedures. However, each had a different interpretation of the exact parameters to be used. Furthermore, the radar track of the Turbolet 410, as shown on Figure 1, indicated that it was tracking slightly east of the apex of the cone of operation, although the accuracy of this track as shown was estimated to have been only within approximately 100m. These aspects contributed in total to the situation whereby the glider and parachutists were in the same area of sky.

Map showing cones' of operation, estimated point of collision and approximate track of parachutists' dropping aircraft
