## Airworthiness Information

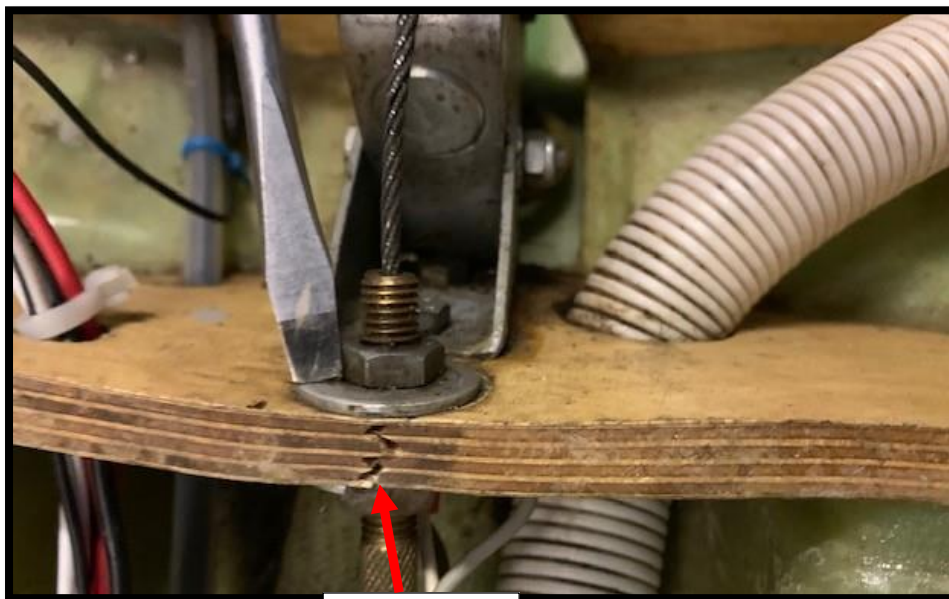
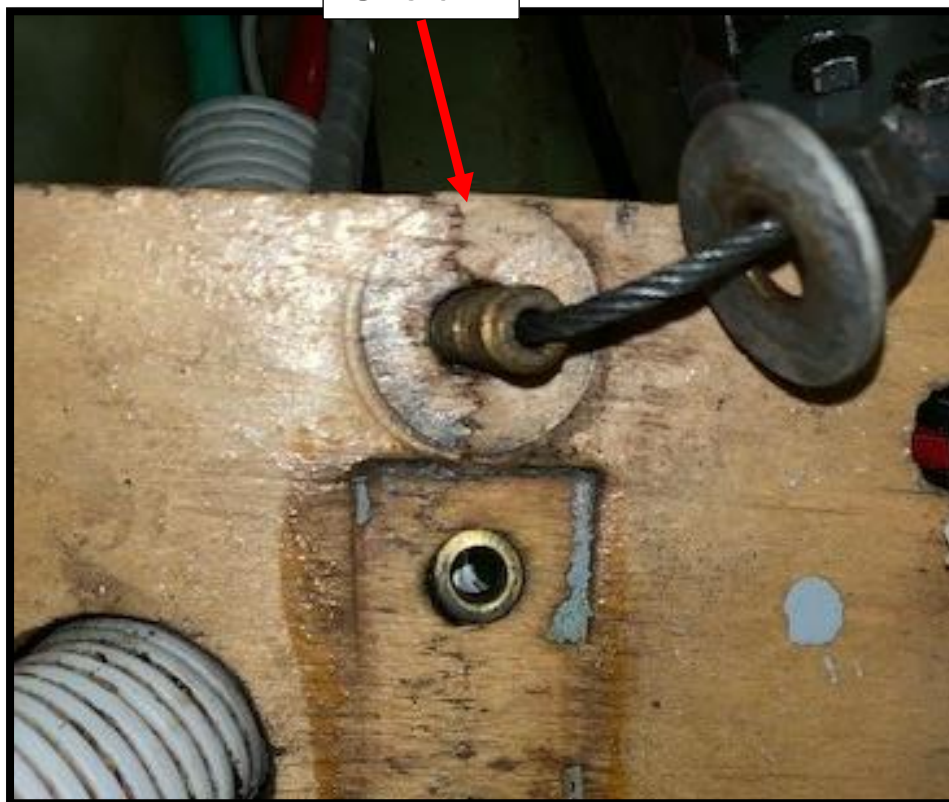
| <b>12. ASW 20 but could apply to others</b><br><a href="https://www.alexander-schleicher.de/wp-content/uploads/2015/02/200_TM17_E_HB.pdf">https://www.alexander-schleicher.de/wp-content/uploads/2015/02/200_TM17_E_HB.pdf</a><br>We have had reports of cracks in the wooden plywood frame that the C of G tow hook is bolted to. See images below. This was an issue well known about in the early 1980s (especially after gear-up landings). | <b>LBA AD 84-43</b> | <b>Mandatory</b> |

The LBA issued an AD in February 1984 to deal with it by reinforcing the hook mounting structure. The mandate was to have this completed by 3000 hours or December 31<sup>st</sup> 1984 (whichever came first). It is clear from the reported cracks some gliders have not complied with this AD.

The AD is poorly worded/translated, but mandates amendments to the Flight and Operations Manual. But in those updates (on page 40g) it says 'A successful reinforcement of the forward tow hook bulkhead of the C of G towhook' which in a roundabout sort of way means you must reinforce the hook. We can understand why some people did not realise hook reinforcement was mandatory.

Crack

The full details are on the Schleicher website. It is found in Schleicher TM17 on page 40g and 40h. This should be taken to be mandatory even if not yet embodied.

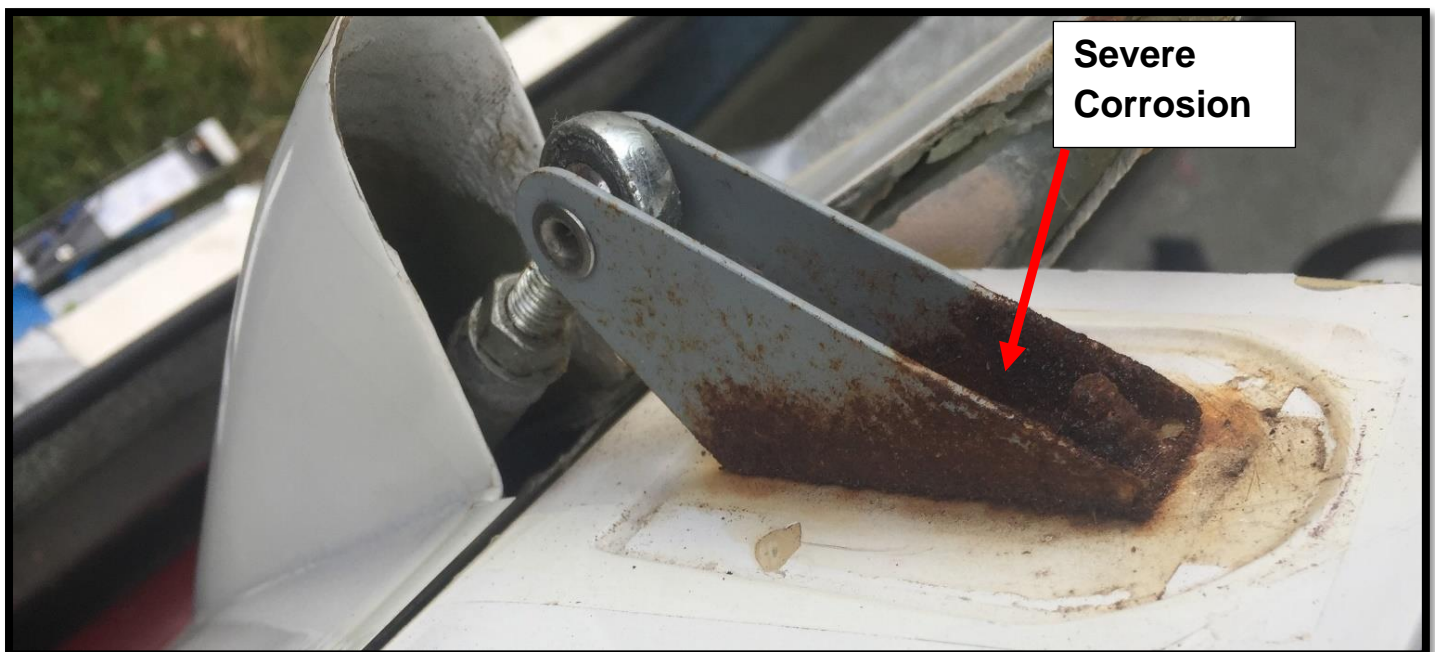
**17 Lak 17 aileron horn corrosion but has been known on other types****Advisory**

This severe corrosion is a most likely the result of moisture collecting in horn area, possible while parked outside. This shows the importance of having a careful look in horns at every annual. This has been known on other manufacturers of glider as well.

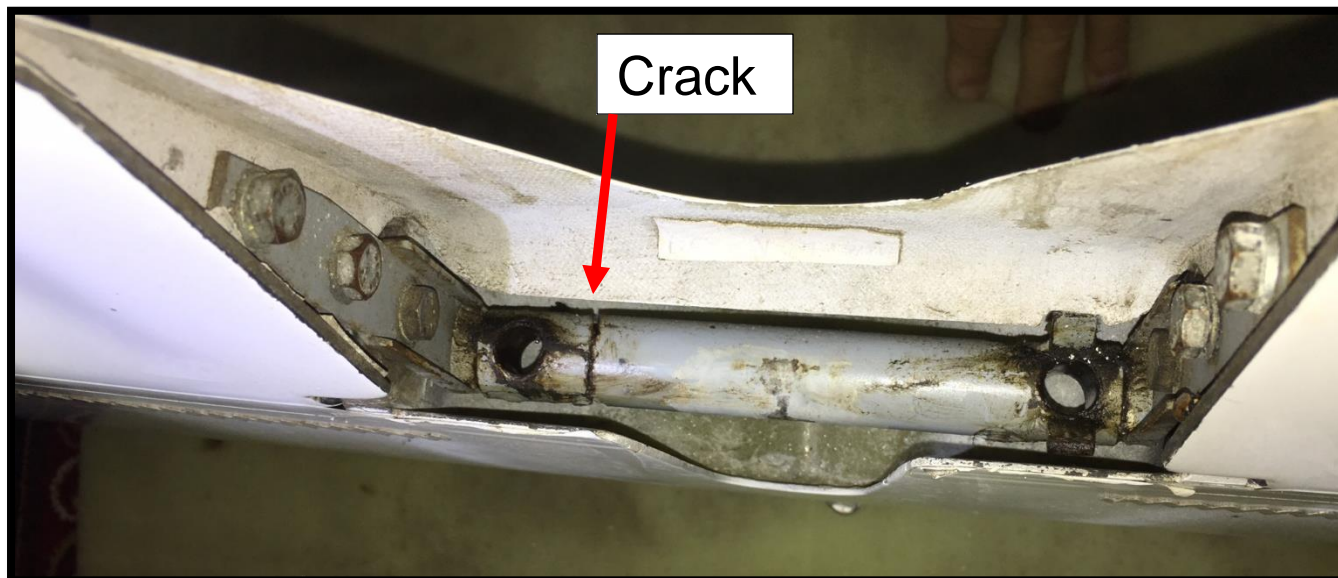
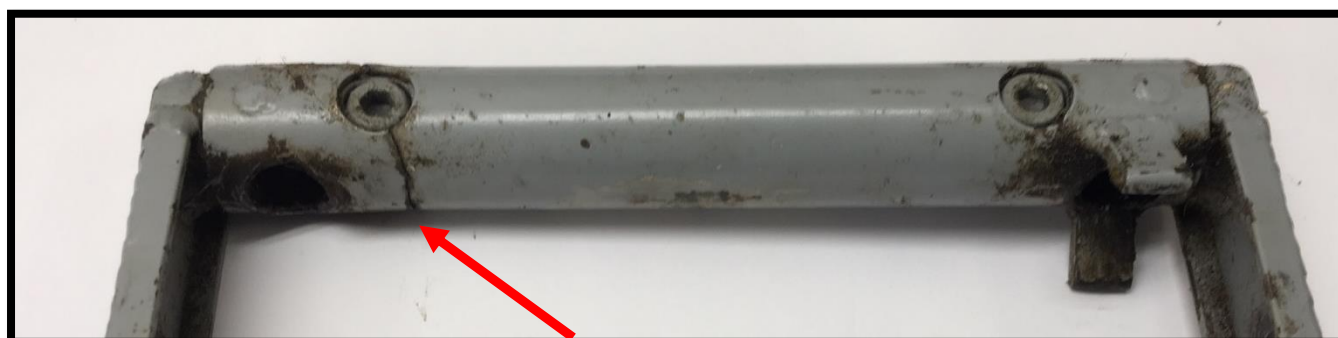
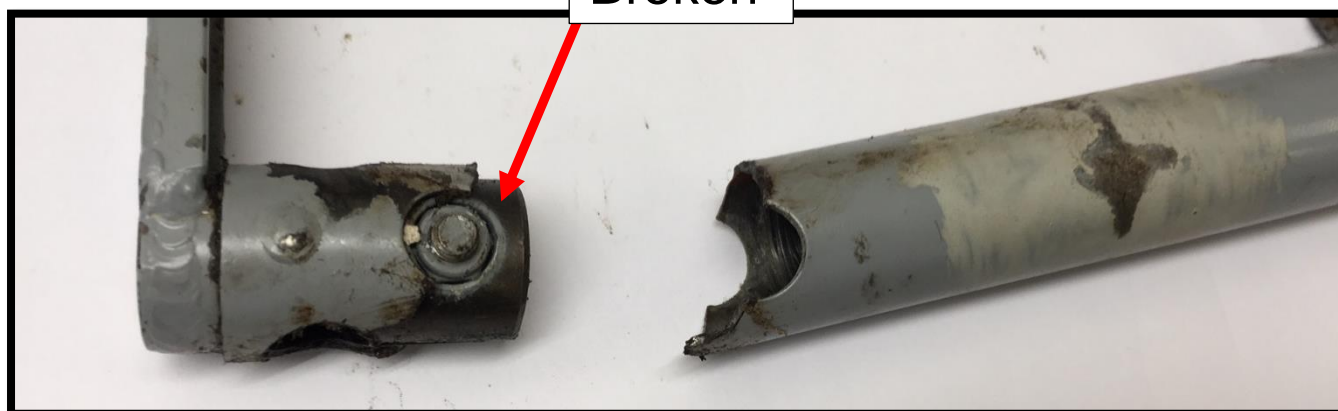
**18 Nimbus 3T Elevator U bracket. But applies to most Glasflugel and Schemp Hirth fixed tailplanes types.**

See images below. This glider was left rigged outside for a Summer and this crack was found after its derig. The damage was partially hidden by grease. It is almost certainly caused by a heavy landing/groundloop or possible tow out stress.

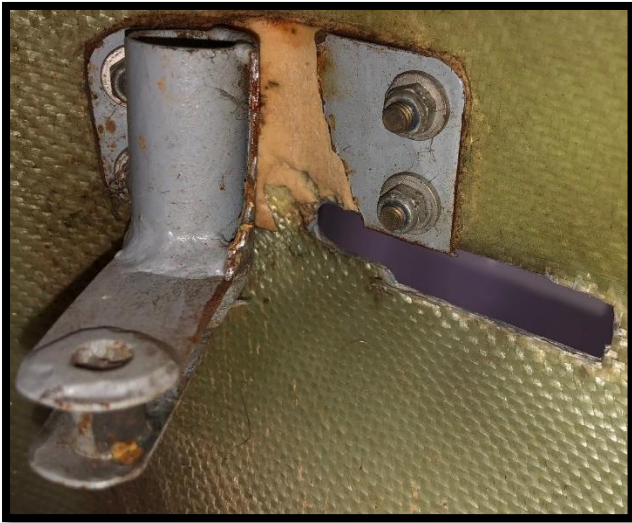
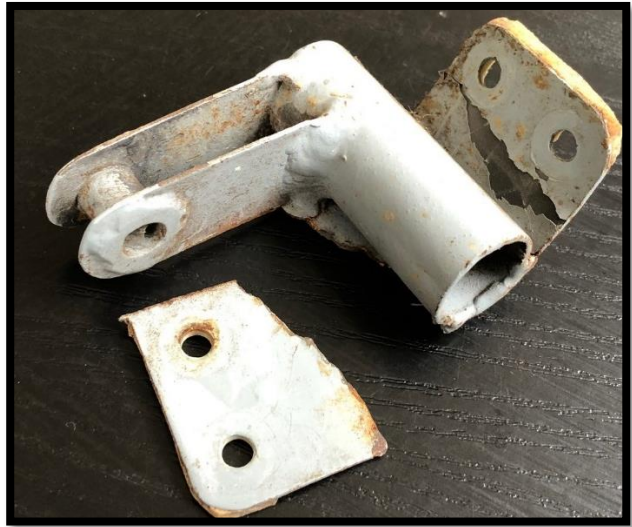
## 20 ASK21 seat back mount

Broken seat back mount. A very rare failure in this 7000 hour part. This most likely caused by having only 1 side engaged when load was applied to it.. Another part to closely look closely for cracks on annual maintenance.

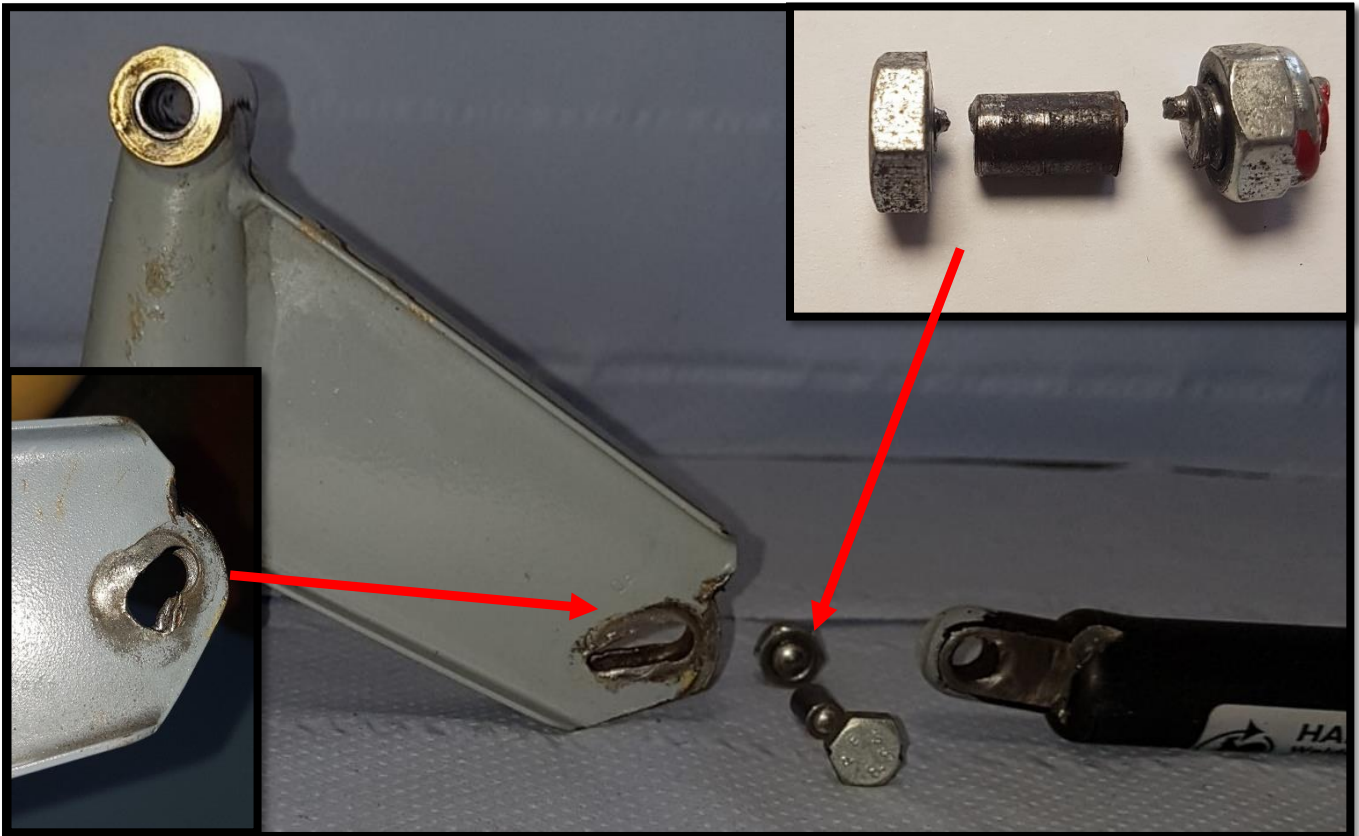
## 21 ASK21 front and rear Canopy hinges (applies to most front/rear hinge canopies)

This canopy hinge had so much wear it eventually broke. Because the gas strut puts constant pressure on the hinge, it can make play difficult to detect. In this case the hinge bracket elongated, then the bolt wore through and then due to the wear the edge of the gas shaft contacted the hinge bracket and eventually broke. The system should have no play at all when maintained correctly.

The best way to help detect the elongations and worn bolts is with the canopy open, to flex the canopy further beyond its natural upright position and see if there is any free play beyond that point.

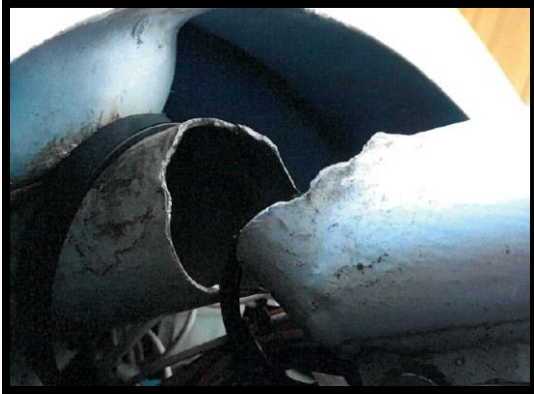
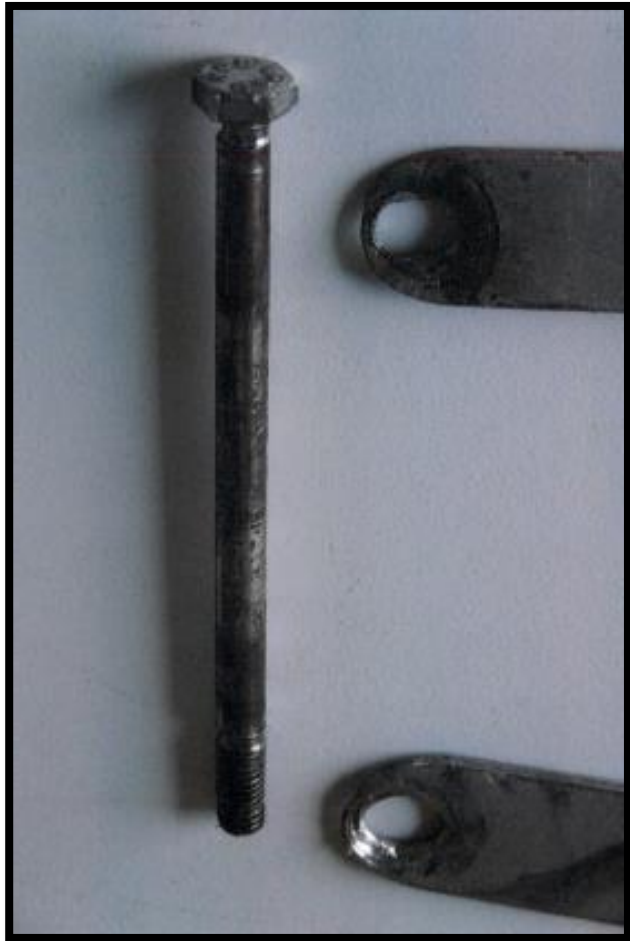
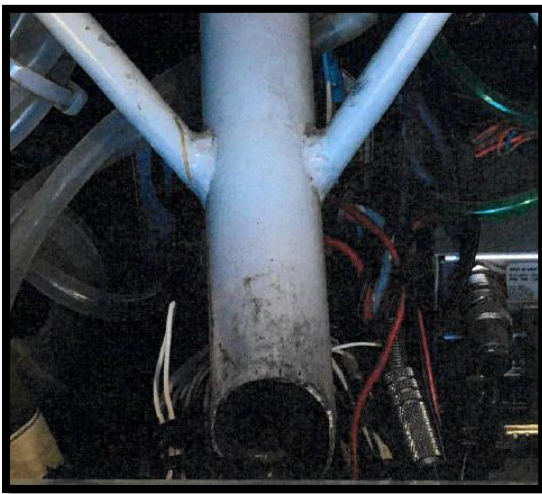
## 22 ASK21 front canopy support and tensioning bars.

The front canopy mount failed (had over 12000 hours on it) and the canopy became detached due to a fatigue failure. As in the previous item a more thorough examination of the canopy mechanism (zero play) and stops might have prevented this.

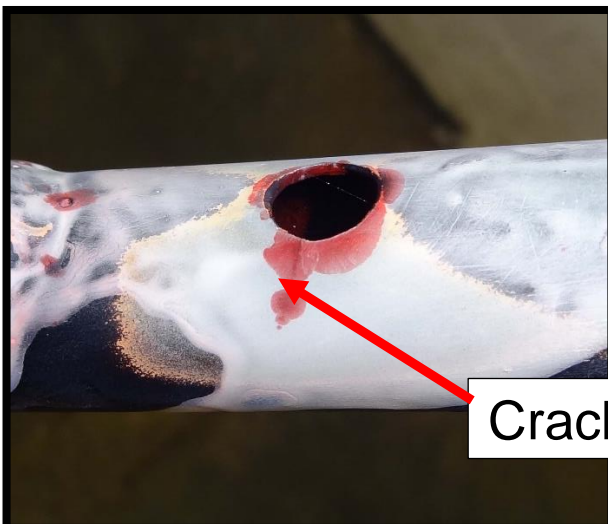
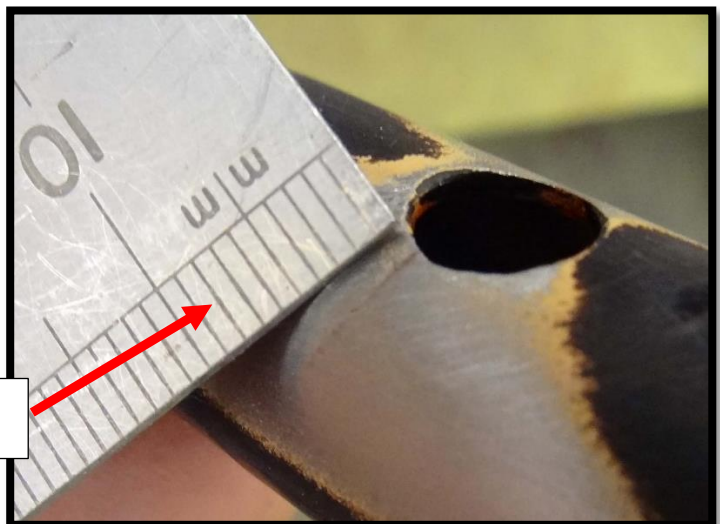
## 23 ASK21 rear Canopy hinges

This rear canopy frames requires weakening holes so that when jettisoned in an emergency, it breaks off at the weakening hole. In this case the hole has been overstressed (possible do to slamming open in high winds?). Not an easy repair as it is not acceptable to just weld the crack. The tube requires changing which in order to make the canopy a good fit is quite a lot of skillful jiggging prior to welding.

Crack

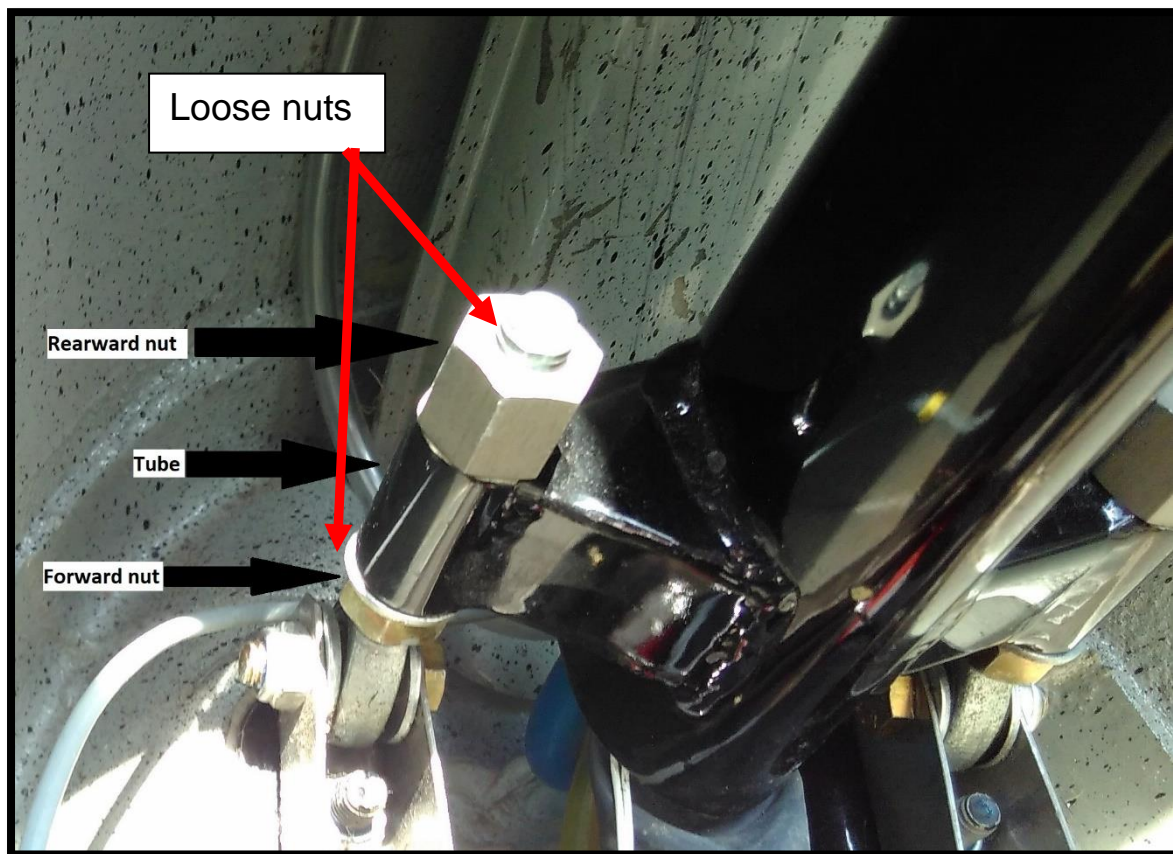
## 24 LS6/7/8/9/10 canopy adjustment

This canopy became difficult to close over a period of time. Upon examination it was discovered the forward stop had moved as the nuts were not fully locked.

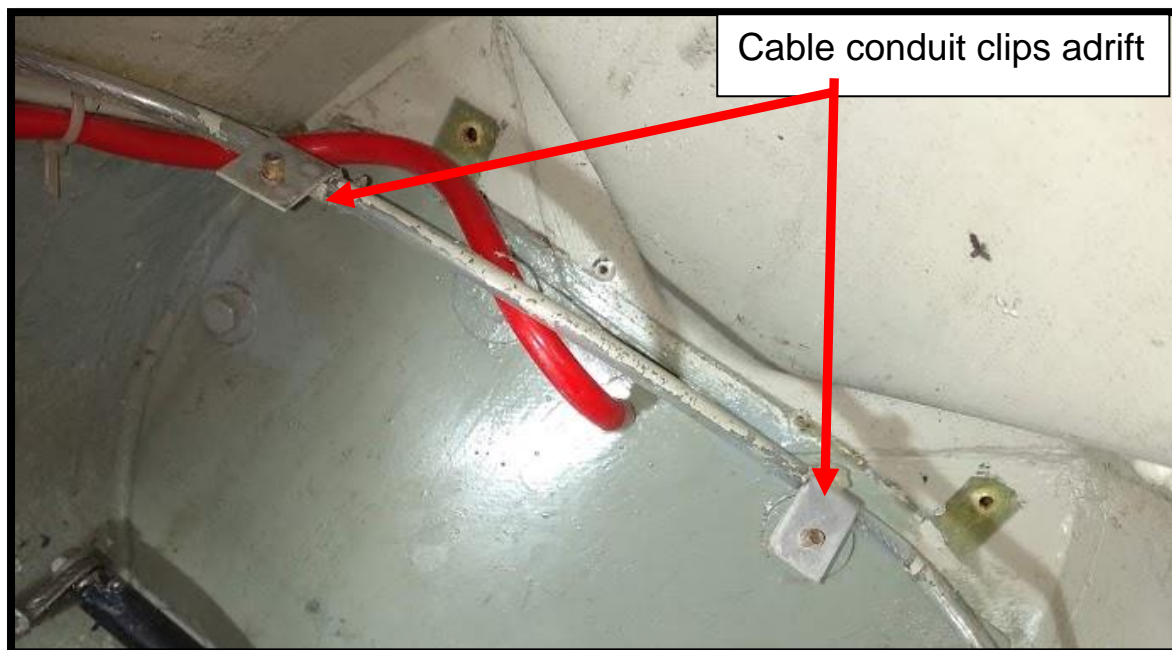
## 25 Glasflugel Mosquito canopy jettison cable conduit

The emergency jettison handle pulls a cable that pulls 2 pip pins out to jettison the canopy. In the below image the cable conduit has come adrift from the front fuselage bulkhead. It was held on with rivets. Always test this during annual maintenance while looking at these conduits for play.

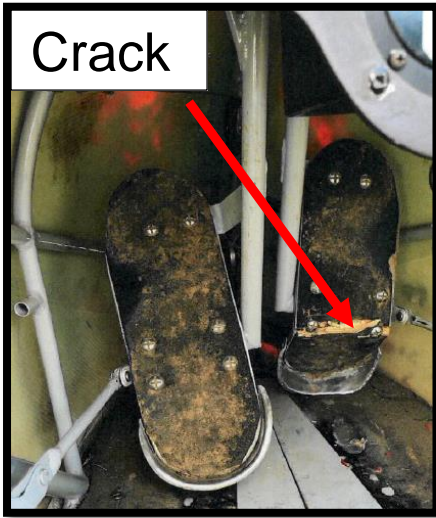
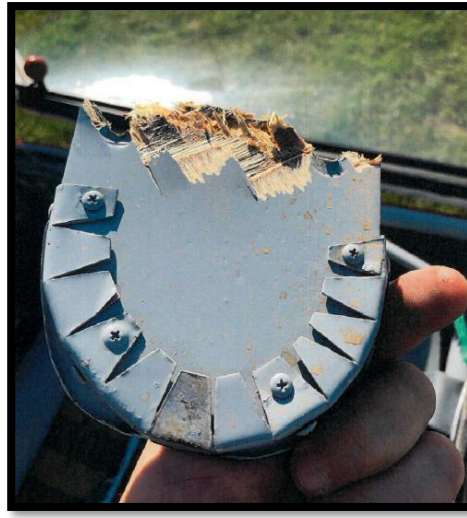
**26 ASK13 front rudder pedal heel failure.**

The front rudder pedal heel plate failed in flight. As you can see from the image the wood failed after being overstressed. It is very likely there was damage on this prior to the flight. The most likely scenario is that there was insufficient clearance between the front floor and the bottom of the pedal after the heel plate had been bent wedging it on the floor. .

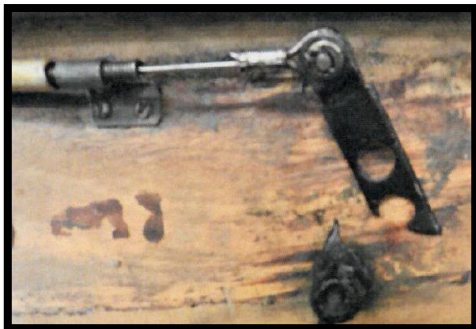
**27 Puchacz trimmer actuator failure**

The actuator was found to have failed when the trimmer stopped working. Piano cable failures are quite common, but not the arm. This can only be inspected with the tailplane off.

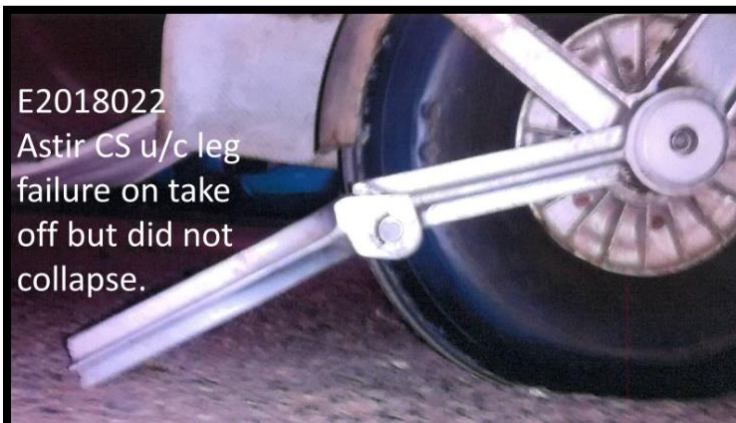
**28 Astir U/C leg failure but did not collapse**

This was caused by the U/C down locks not locking symmetrically/correctly. So one leg took most of the load, until it broke at which point the other leg was strong enough to support the glider. Every annual and after heavy landings the U/C over centre locks must be checked for symmetry and play.

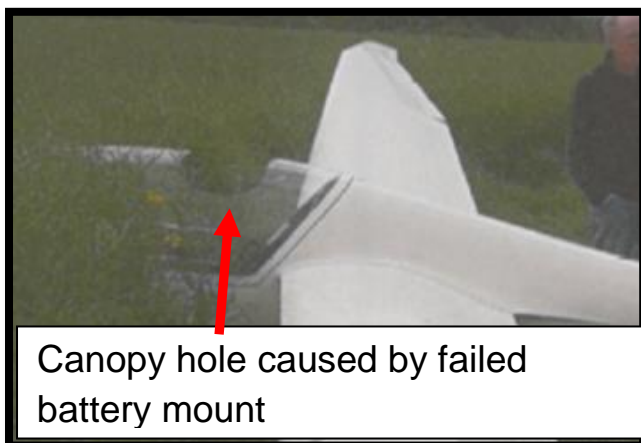
An out landing in a crop field resulted in a Vega experiencing approximately 10G deceleration. Apart from bending the main pin (requiring a hacksaw blade to saw through the pin to derig it), the only other damage was the glider battery smashed the canopy. This highlights the problems of some legacy glider battery installations not being sufficiently crashworthy enough to meet the current requirements.

Canopy hole caused by failed battery mount

We have updated the BGA AMP section of advice on battery maintenance including how to legally (using EASA CS Stan 3) mount batteries and check the retention is adequate. **All BGA inspectors are to read this and apply it at the next annual maintenance, or sooner if you think there is a deficiency.** If a battery mount does not meet the requirements, then the glider must have a defect raised and no battery fitted until the installation is exchanged for a compliant one.

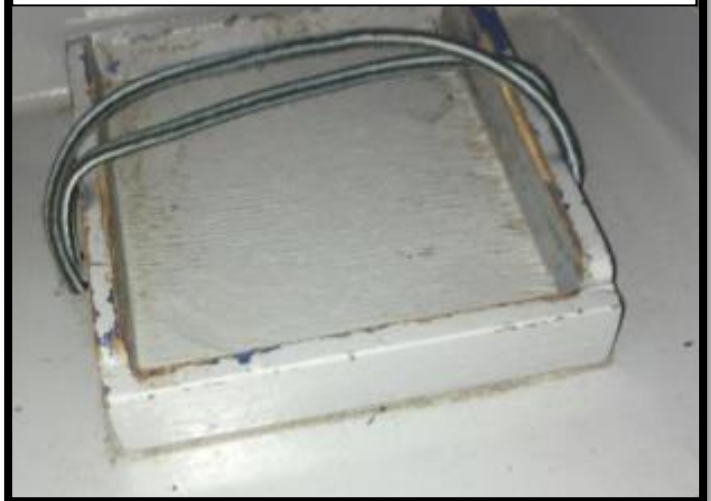
Vega Barograph holder converted into a battery holder did not meet EASA 'G' requirements
