## CAA and EASA Airworthiness Directives (ADs)

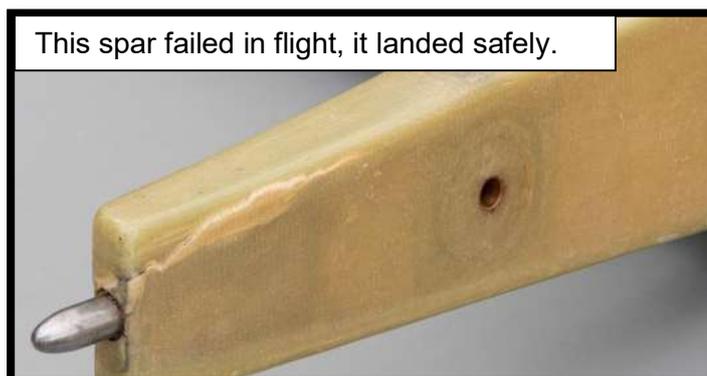
| <p><b>7 SAZ Allstar Junior spars</b><br/> <a href="https://ad.easa.europa.eu/ad/2022-0095">https://ad.easa.europa.eu/ad/2022-0095</a><br/> Every annual and incident inspection must include a thorough look at the spar. The latest revision of the SB Service Bulletin No. BE-014/51-1/2022 (26<sup>th</sup> April 2022) makes the inspection easier. (Thank you Alan Garside).</p> | <p><b>EASA AD 2022-0095</b></p> | <p><b>Mandatory</b></p> |

The latest revision of the SB Service Bulletin No. BE-014/51-1/2022 (26<sup>th</sup> April 2022) makes the inspection easier. (Thank you Alan Garside).

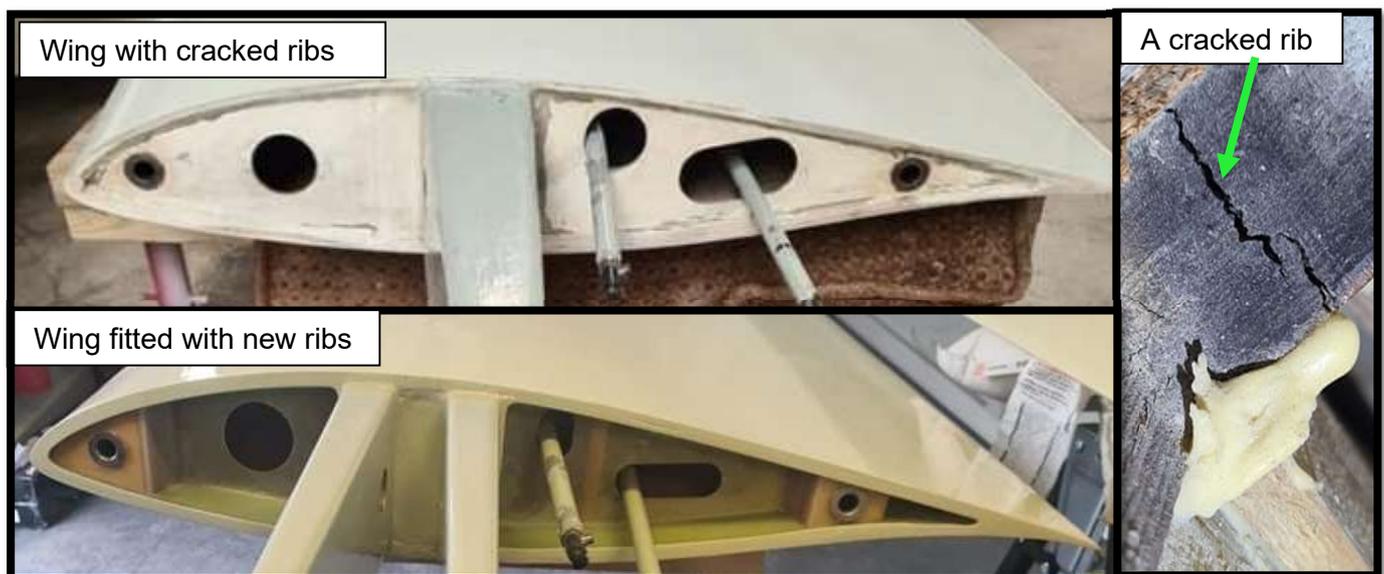
The original AD only applied to the ASW15A. We are not aware of any passing the inspection. Please let me know if they have. But wooden ribs have now also been found in the ASW15B, so the AD now applies to them (to establish if they do not have wooden ribs). The cost of the rib replacement (mostly very skilled labour with LOTS of jiggng) can exceed the value of the aircraft. So far Schleicher agent Zulu Glasstek (Pete Wells) and North Notts Sailplanes (Tim Sharpe) have carried out the rib replacements.

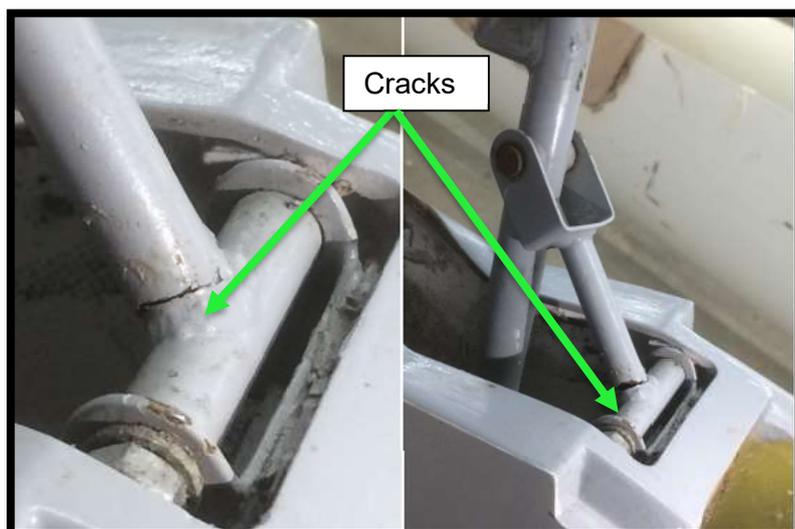
**12 ASK21 and other Schleicher Automatic elevator couplings**

This is a legacy AD from 1990, that in another country was found not to have been accomplished.

Check here for cracks every annual. Trailer fittings can cause these to crack. Applies to many Schleicher types with auto connect elevators.

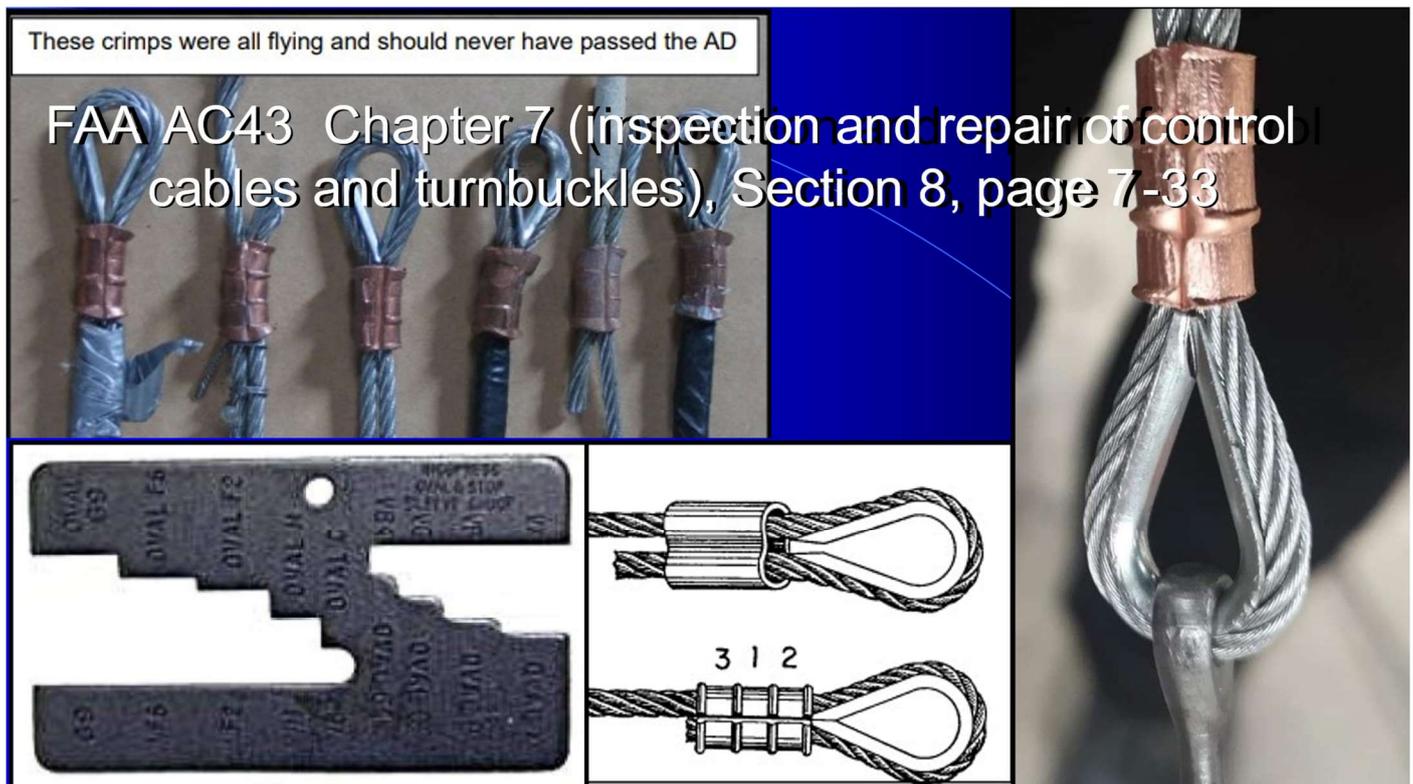
This is a legacy AD. On the face of it, it is very simple to follow, **BUT some inspectors are still not following it.** On audits we are still occasionally find incorrectly crimped cable ends, some with only 2 squeezes. These should not pass a DI, let alone an annual inspection. If found, they must be changed to compliant crimps. It is not optional.

Remember use only galvanised cables. If you see a cable with only 2 squeezes, then it must be corrected. Do not forget you also need the gauge (see photo below) to check it is correctly squeezed to the correct thickness. Light Aircraft Spares LAS) [https://www.lasaero.com/parts/?search\\_part=nicopress](https://www.lasaero.com/parts/?search_part=nicopress) or Aircraft Spruce <https://www.aircraftspruce.com/search/search.php?s=nicopress%20swaging%20tool> are good sources for these tools, cables and sleeves.

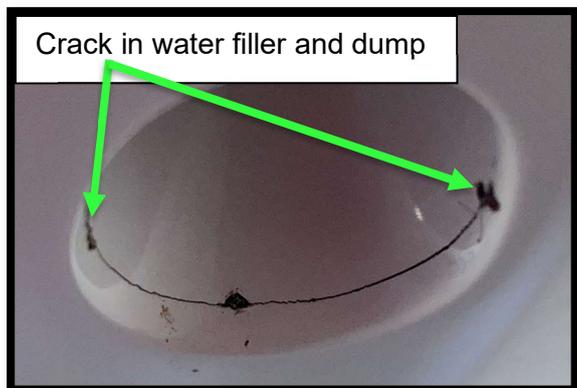
**18 LS4a water dump hole. But can include many other similar types.** reported by Eric Munk

See image left. The water filler/dump access hole is bonded into place inside the wing. If it fails, the water when dumped can go into the wing instead. The crack is most likely caused by a high side load applied to the fitting, most likely caused by using badly fitting filling equipment.

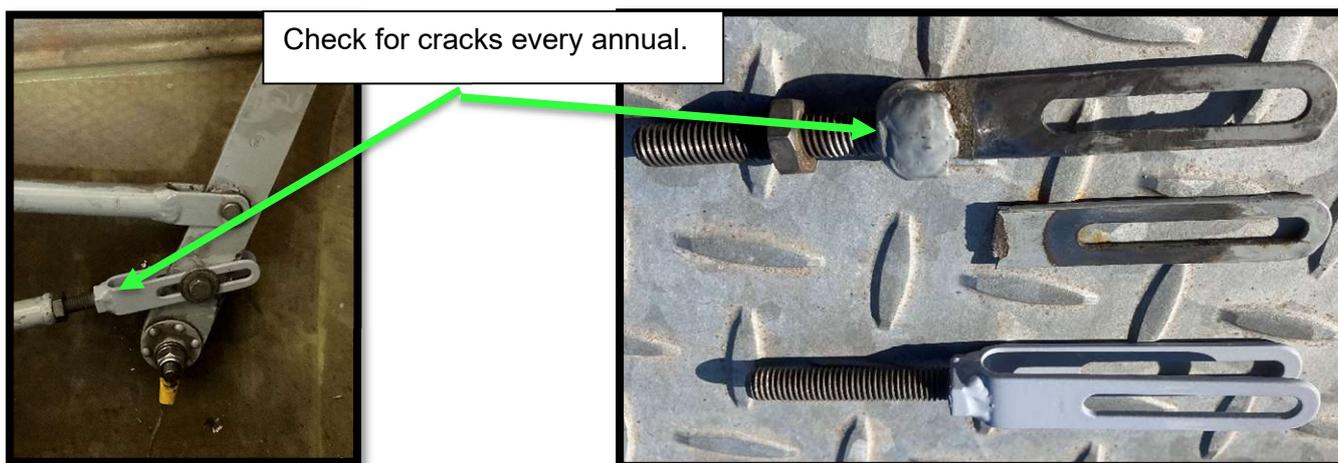
**19 ASK21 wheel brake cracks**

This can easily be missed during annual maintenance. Possibly caused by a badly adjusted wheel brake that comes on well before maximum airbrake is achieved.

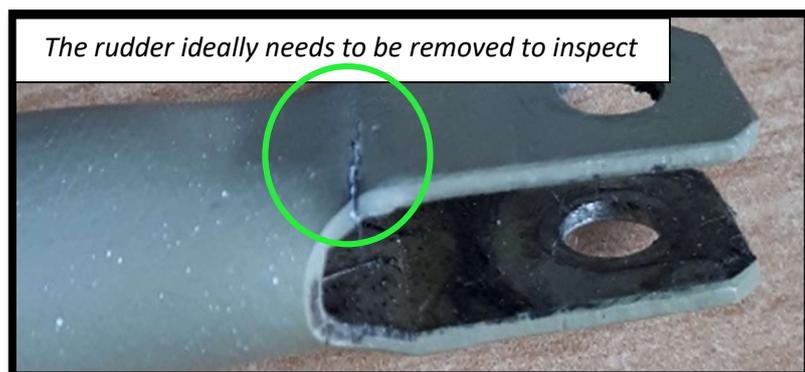
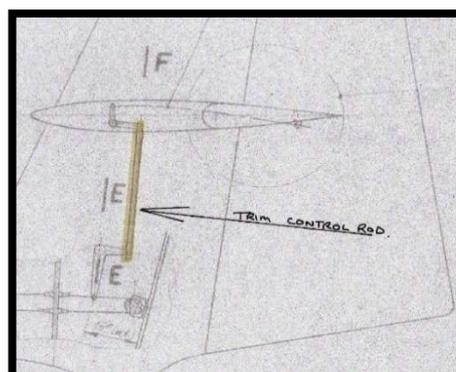
**20 Puchacz Trim Pushrod in fin**

Photos below show crack found in Puchacz vertical trimmer push rod mounted in fin. The ends of the control rod have been formed by pressing together the end of the control tube to form a fork end. This is common on other push rods on Puchacz's. So anywhere this type of rod end is fitted, check carefully.

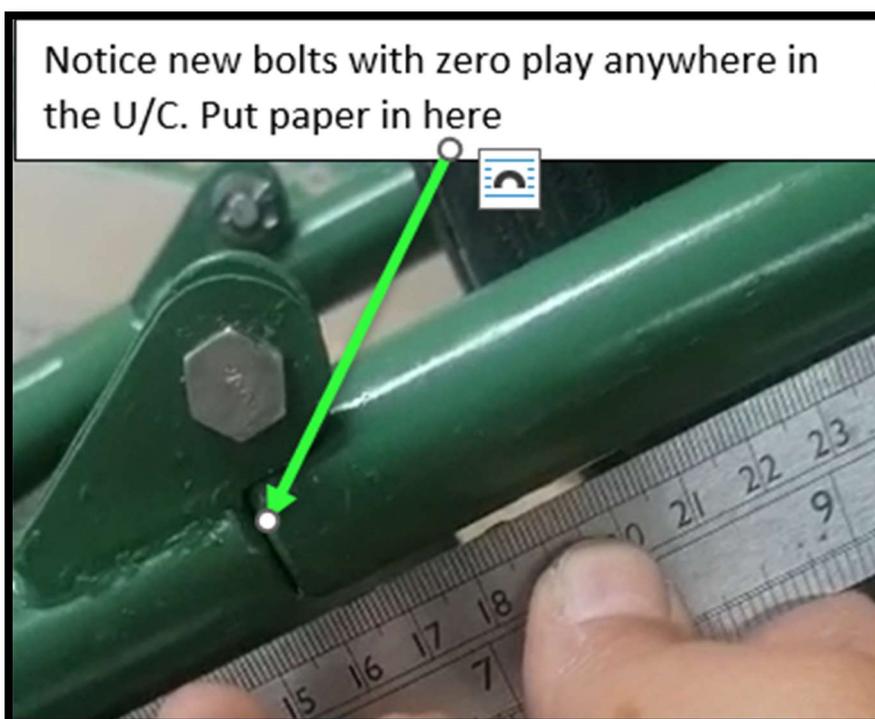
A common trend is corrosion (internal as well as external), small amounts of play in every part that gradually leads to, worn bearings, badly adjusted over centre locks and a design that is intolerant of any of these problems.

With zero weight on the wheel and the glider in its dolly, put a piece of paper in the U/C knuckle joints (both left and right).

Make sure the knuckle joints grab the paper equally both sides.

**If not, then adjustment is required!**

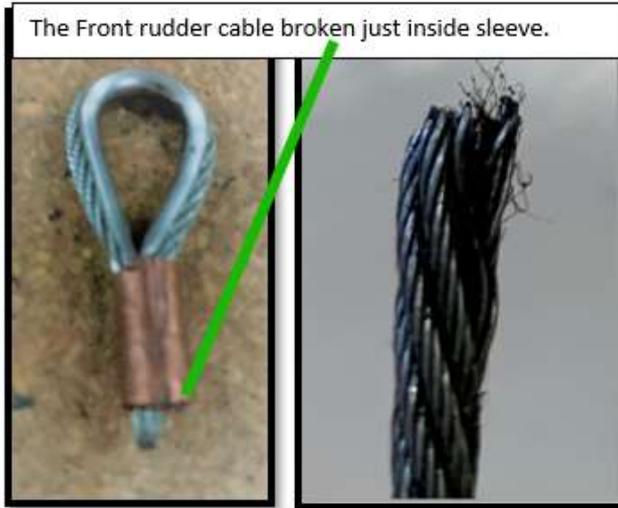
Reading the Striefly TNs on Libelle Rudder cable problems (see links above). These problems are not new. There are important, but subtle details of how to ensure the Nico press Thimble must shaped prior to making the cable join.

This cable failed at 258 hours. But its opposite cable was changed at 177 hours due to wear/fatigue. These cables should last 1000 hours plus. So why did these cables have problems after so few hours? It's a combination of multiple factors.

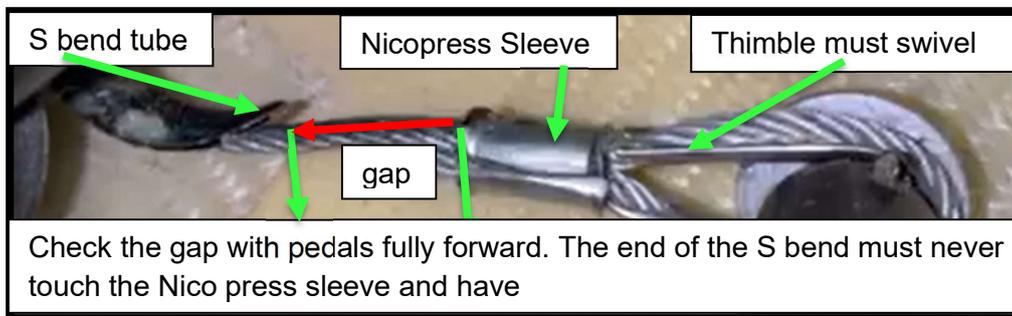
The glider had been flown with the rudder pedals in the fully forward position since the current owner had owned it.

This shortens the distance between the S bend tube and the Nico press cable

sleeve. Every time the pedal is moved, there is only 1cm or so (less perhaps) of cable to take the bending strain. The failure appears to be more of fatigue failure rather than a more conventional friction causing wear on the cable.

The cable must be free to swivel on the attachment shaft with little friction. Without low friction the rudder cables bends (and fatigues) rather than lining itself up with the direction of strain from the S bend.

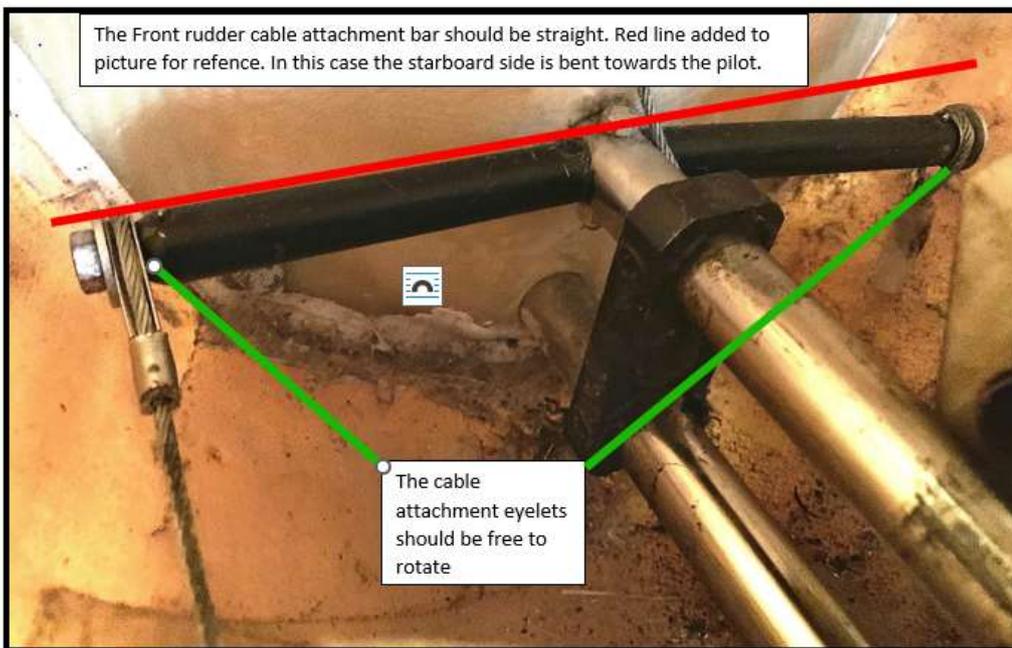
The front bar that the rudder cables attach to, **must** be straight. If it is bent, that significantly reduces the distance between the Nico press joint and the S bend. This causes more strain on the cable at

The Bar does not look out of place being bent. Streifly can sell you a new bar if required.

- 1 Read the Streifly TNs. The subtle detail is important.
- 2 Check the thimble is correctly shaped prior to fitting.
- 3 Check the end of the S bend is not too close or touching the Nicopress sleeve
- 4 Check the front attachment of the rudder cable and the thimble is free to rotate
- 5 Check the front rudder bar is straight.
- 6 If you must change a cable after a very short life, find out why.
- 7 Change cables as a pair. This is good practice.
