CAA and EASA Airworthiness Directives (ADs) all owners notified.

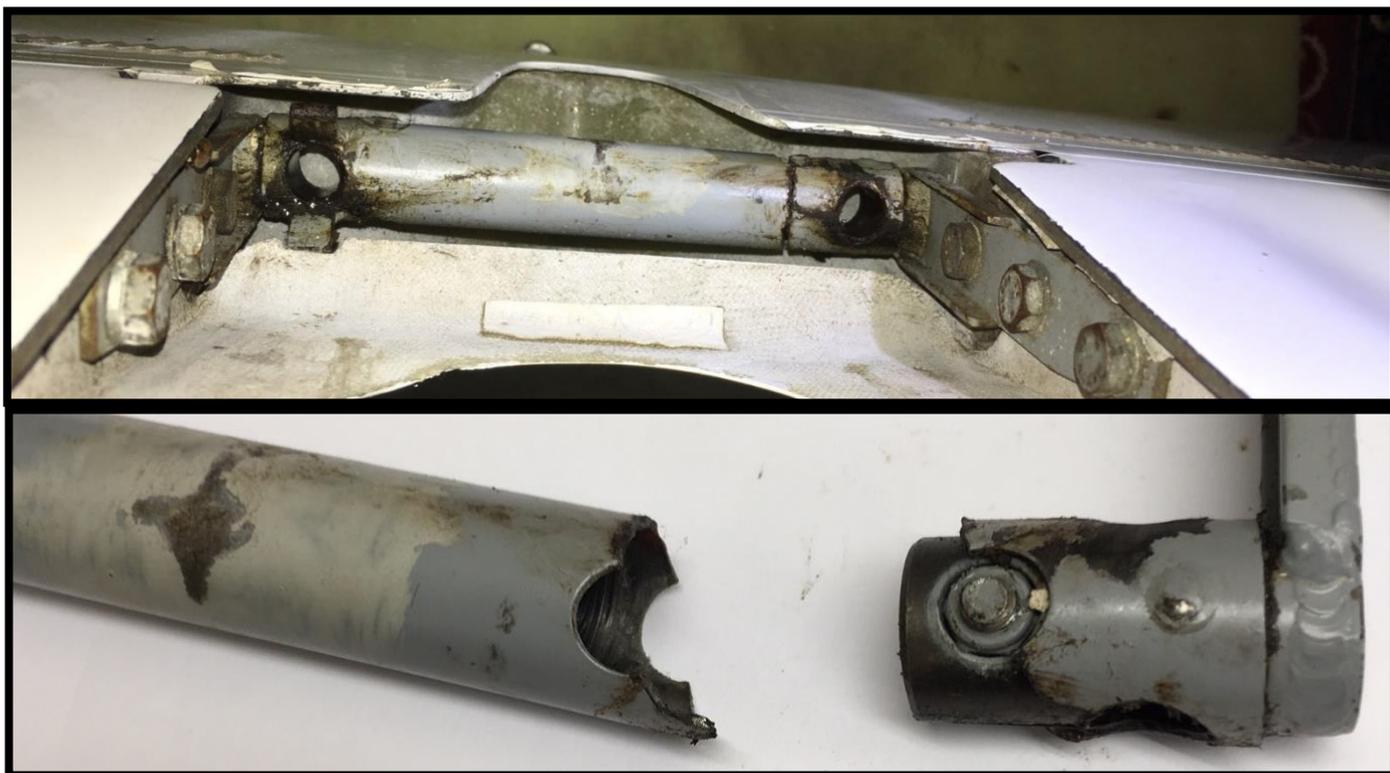
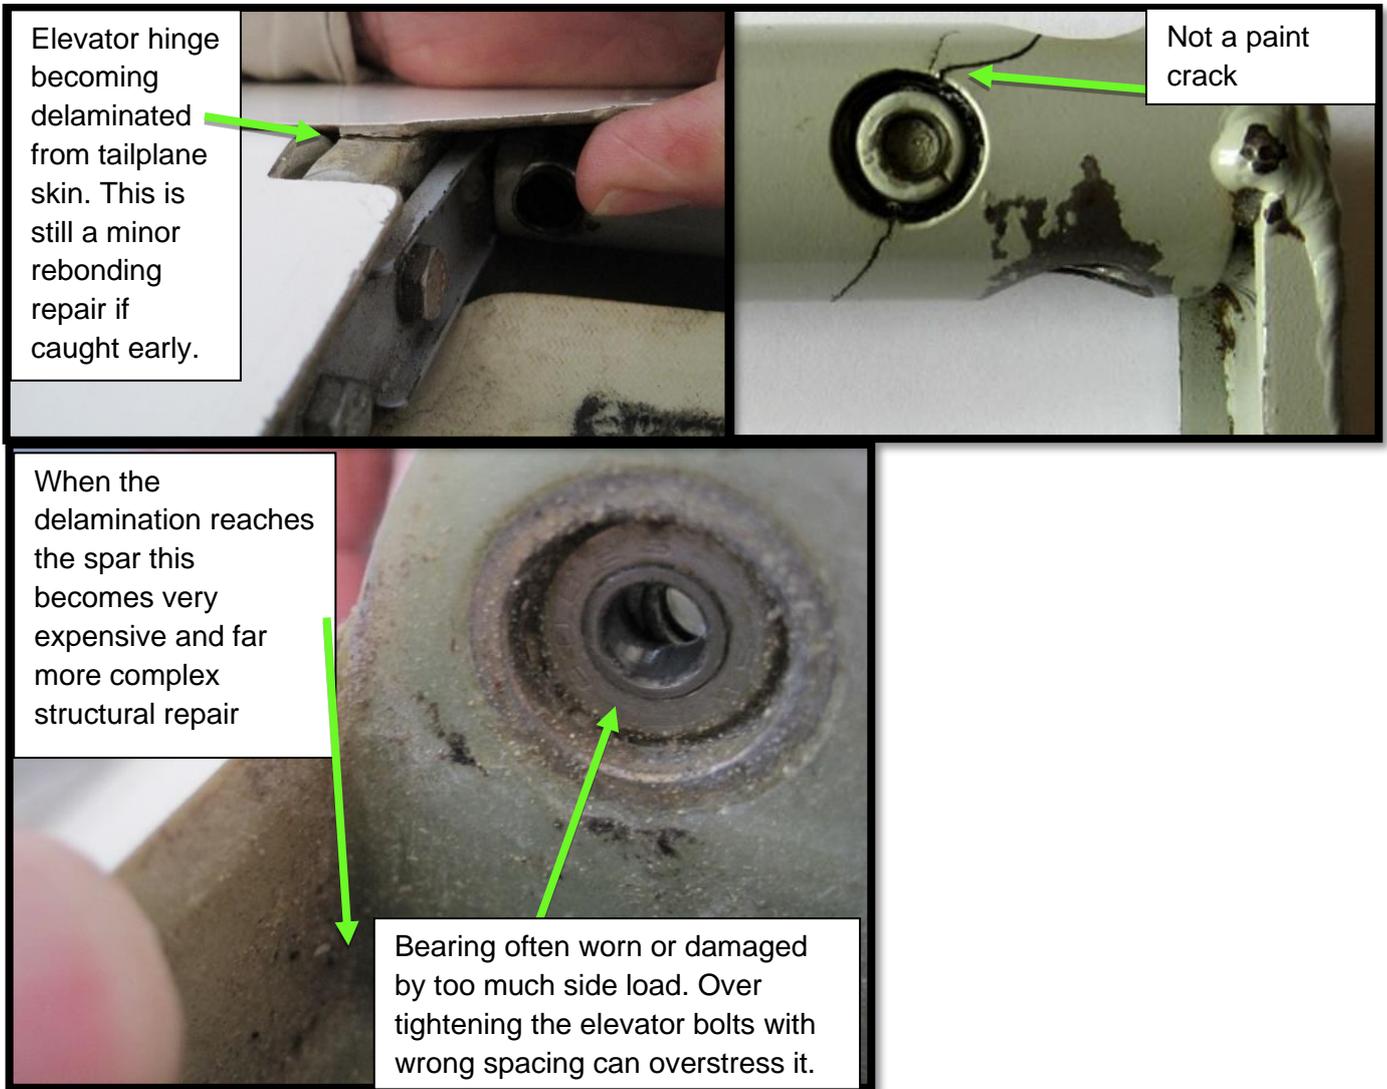
3 Horizontal Tail Elevator U-Bracket – Inspection EASA AD 2022-0242-E Mandatory

This should not require an AD to find these problems. This damage is common after a ground loop, heavy landing, and excess side loads (not using a tail dolly for instance) on all Schemp Hirth (and VTC G81) fixed T tail tailplanes. All the Glasflugel (and Slingsby Kestrel) gliders are very similar by design and prone to the same.

Every annual and after ground loops, the elevators should be removed (take very careful notes/pictures of where every washer goes so you reassemble it correctly) and U bracket be inspected. Inspect the hinges for associated damage as well (unpeeling from the tailplane skin). Also check the tailplane inner elevator bearing is not like a 50 pence piece in rotation.

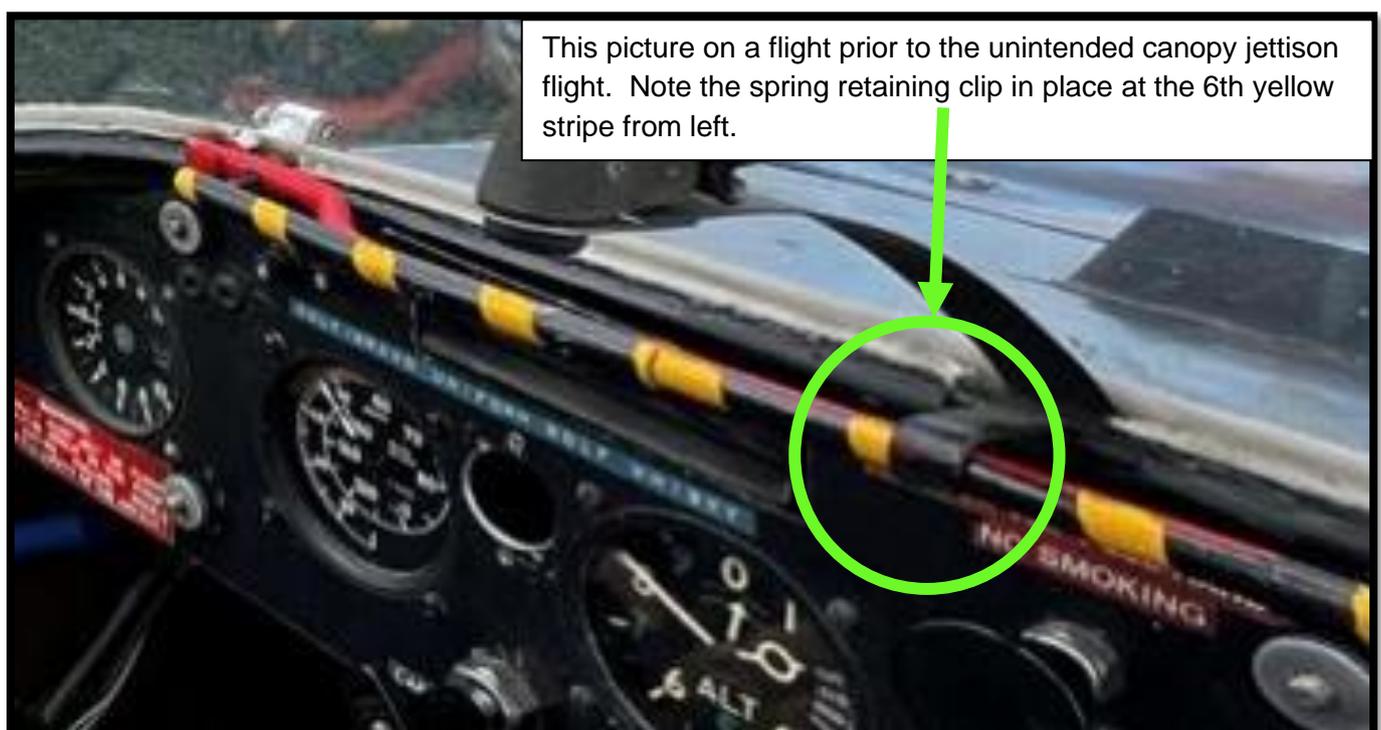
On a recent flight, the canopy detached because the spring latch that keeps the front retaining hinge pins in place had become unlatched. This was possibly accidentally unlatched with a knee or foot while getting in/out of the cockpit. This was not noticed by the pilots. The pins eventually vibrated out and canopy jettisoned - as it is designed to do.

This image was taken during the accident flight prior to the canopy falling off. The spring clip is not in place at the 6th yellow stripe from left. It is recommended that the spring clip is painted red to bring it into line with CS22 and make far easier to see if it is not latched.

It is strongly recommended that the spring Latch is painted red. That way it conforms to current CS22 standards, and it is more noticeable if it is not attached to the canopy jettison handle (which is painted with black and yellow stripes).

ALL OPERATORS AND PILOTS with this military specified jettison system need to know that the canopy spring latch spring must be checked prior to take off every flight.

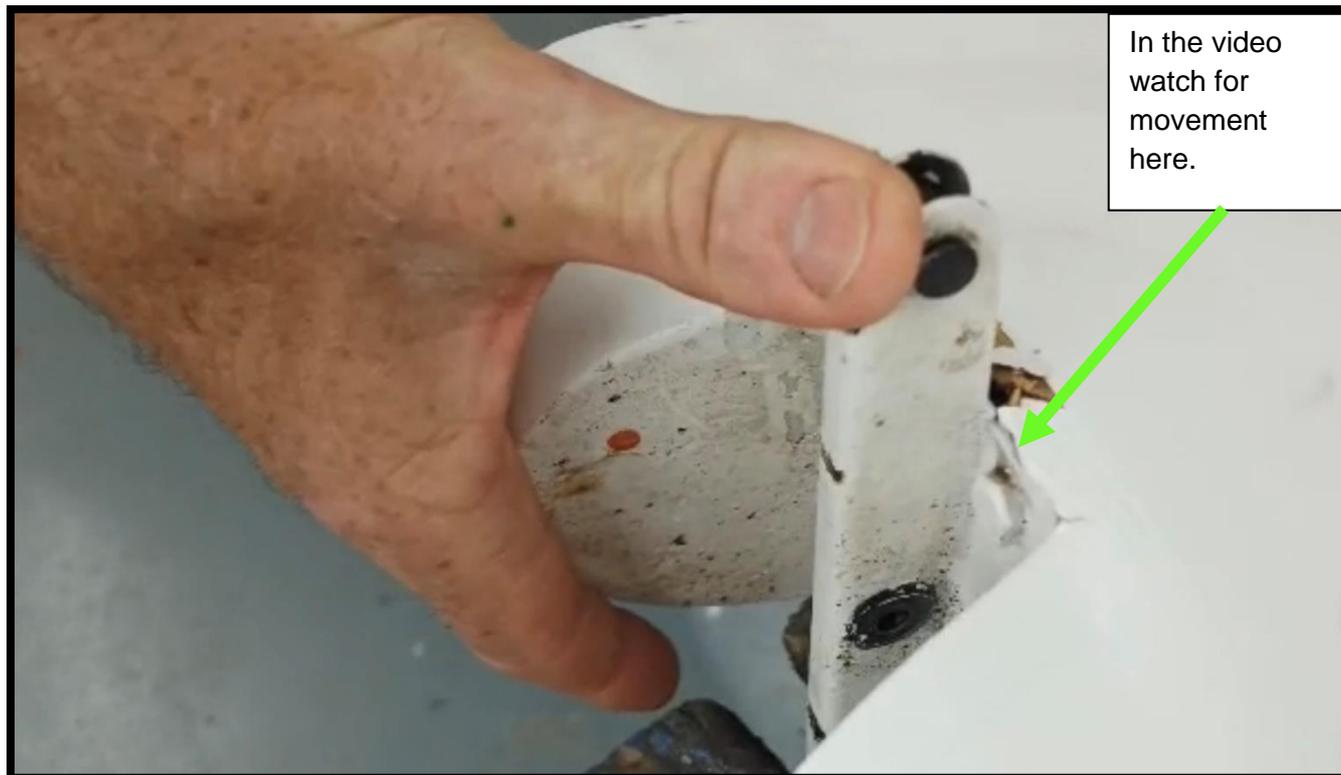
11 K2 lower rudder hinge found lose due to glue joint failure

This failure was discovered during an inspection before it became a flight safety issue. It would have been very easy to miss this failure. This applies to all the hinges and hard points (elevator, rudder, trim and ailerons)

Checking for glue failure is now part of the bread and butter of wooden sailplanes. As such, if you find any unusual failures, please report it to us. We are now working on version 7 of the glue inspection, that will take on board modern media education, show failures like the one below, include enhanced inspections inside tailplanes (and K6e elevators) and non-removable fins (like K2 and K6) as well as testing steel tubing in the fuselage for internal corrosion.

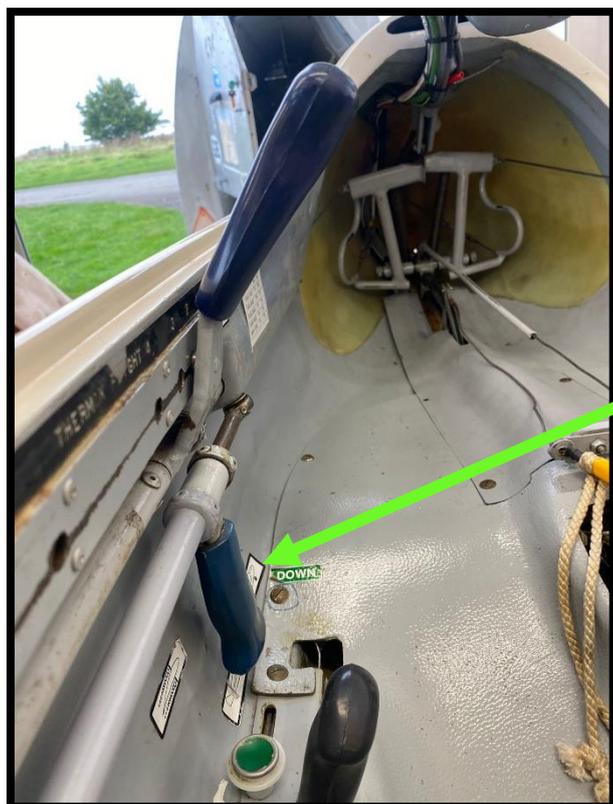
12 ASW20/19 Pagase undercarriage/airbrake lever confusion

See image of ASW 20. You have 3 similar levers Flaps, brakes and U/C. Most of these gliders have been broken at some point in their life, due to the pilot using the wrong lever on the approach.

Help prevent this by making sure that the airbrake lever is blue and the Flap and U/C levers are not also Blue.

Only the brake handle should be blue, not the flap or U/C lever as well.

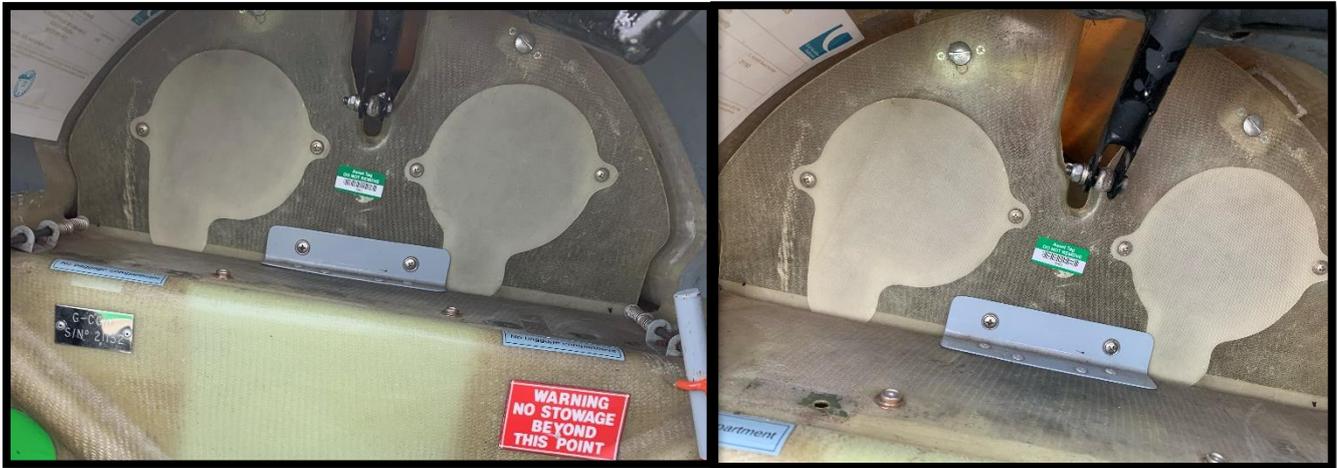
13 ASK21 cover to prevent FOD in the controls

The K21 has been used in the the UK for 42 years now, it has become apparent that FOD was sometimes accidentally being put into the K21 controls, when people try and use the space behind the instructors head to store coats etc. Not noticing the big red label that says not to put anything there. The sure fix is to buy (from Schleicher) and fit the panel to prevent anything falling into the controls. This appears to be standard on new k21. See image below.

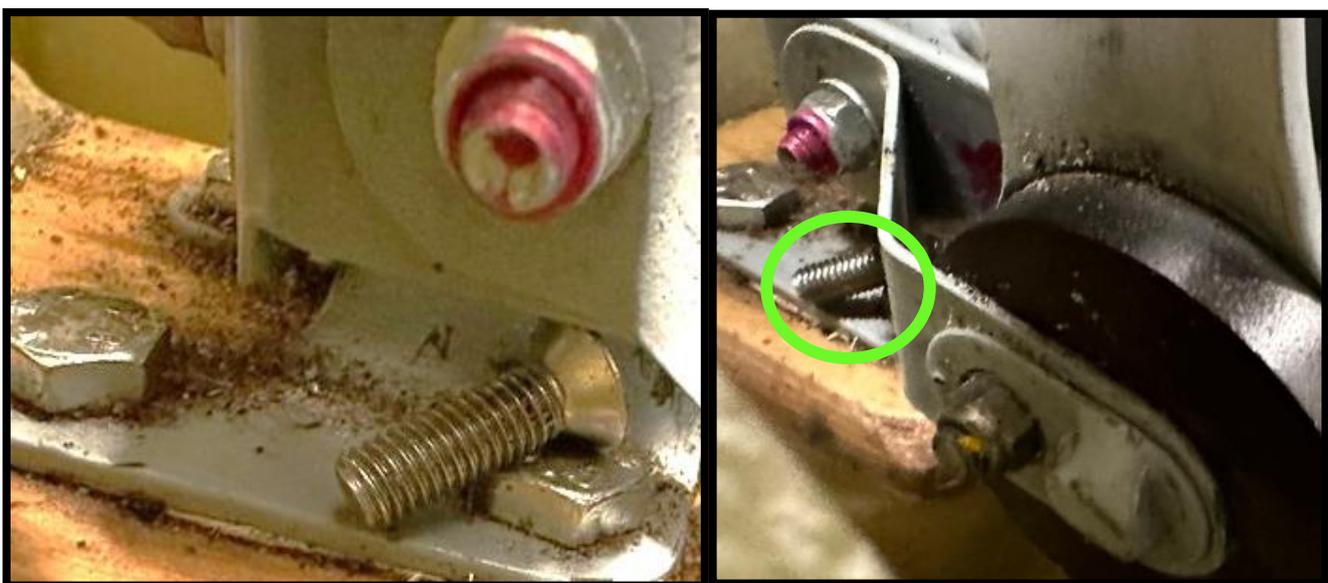
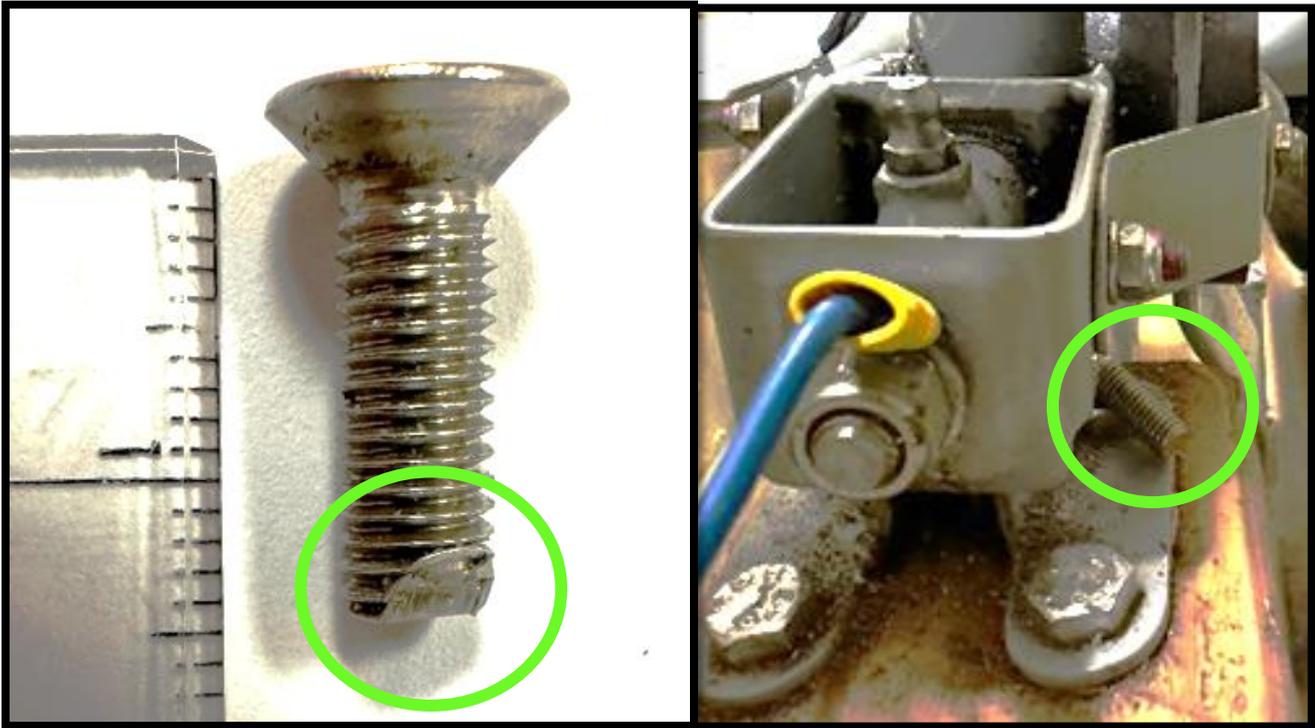
14 ASK21 control restriction caused by lose seat screw (can apply to many other types)

The pilot experienced a control restriction after a loop that restricted aileron movement. Eventually the restriction cleared, and a normal landing was made. Upon examination a seat screw that had come out of the lower rear seat pan (not easy to see on a DI), was found under the front the front stick mechanism. The screw had witness marks caused by the front stick mechanism control restriction.

A lot of 2 seat gliders have large open areas, where FOD can travel into the controls from the back cockpit. K13, K21 and Duo Discus for instance. They all have large openings in the back cockpit, under the front seat, where the instructors must put their legs to use the rudder pedals. This is by design and cannot be fixed without a huge design change. If FOD gets in that area, over time it is free to travel around the entire front seat area causing problems.

But why was the screw lose? This was possibly caused by how the seat must be installed.

With most glider seats, they are flexible and not perfectly jugged. You must install the seat and loosely put in all the screws before you tighten them all up. It becomes a 2 part process, fit all the screws first and only then tighten them all up. It would be very easy to not torque a previously lose screw up, as could still look flush and tight.

The fact that the average Rivnut relies entire on the screw clamping down on the seat to increase the friction does nothing to help retain a lose screw if not fully tight. And overtightening them can break the Rivnut lose. Moral of the story is make sure they are tight enough and it's a good idea to have second person check.
