TECHNICAL INSTRUCTION NO. 27.T49B. CAPSTAN MOD. NO. 5.REINFORCING OF THE CANOPY FRONT LAMINATION.

This modification has been prepared at the request of the British Gliding Association.

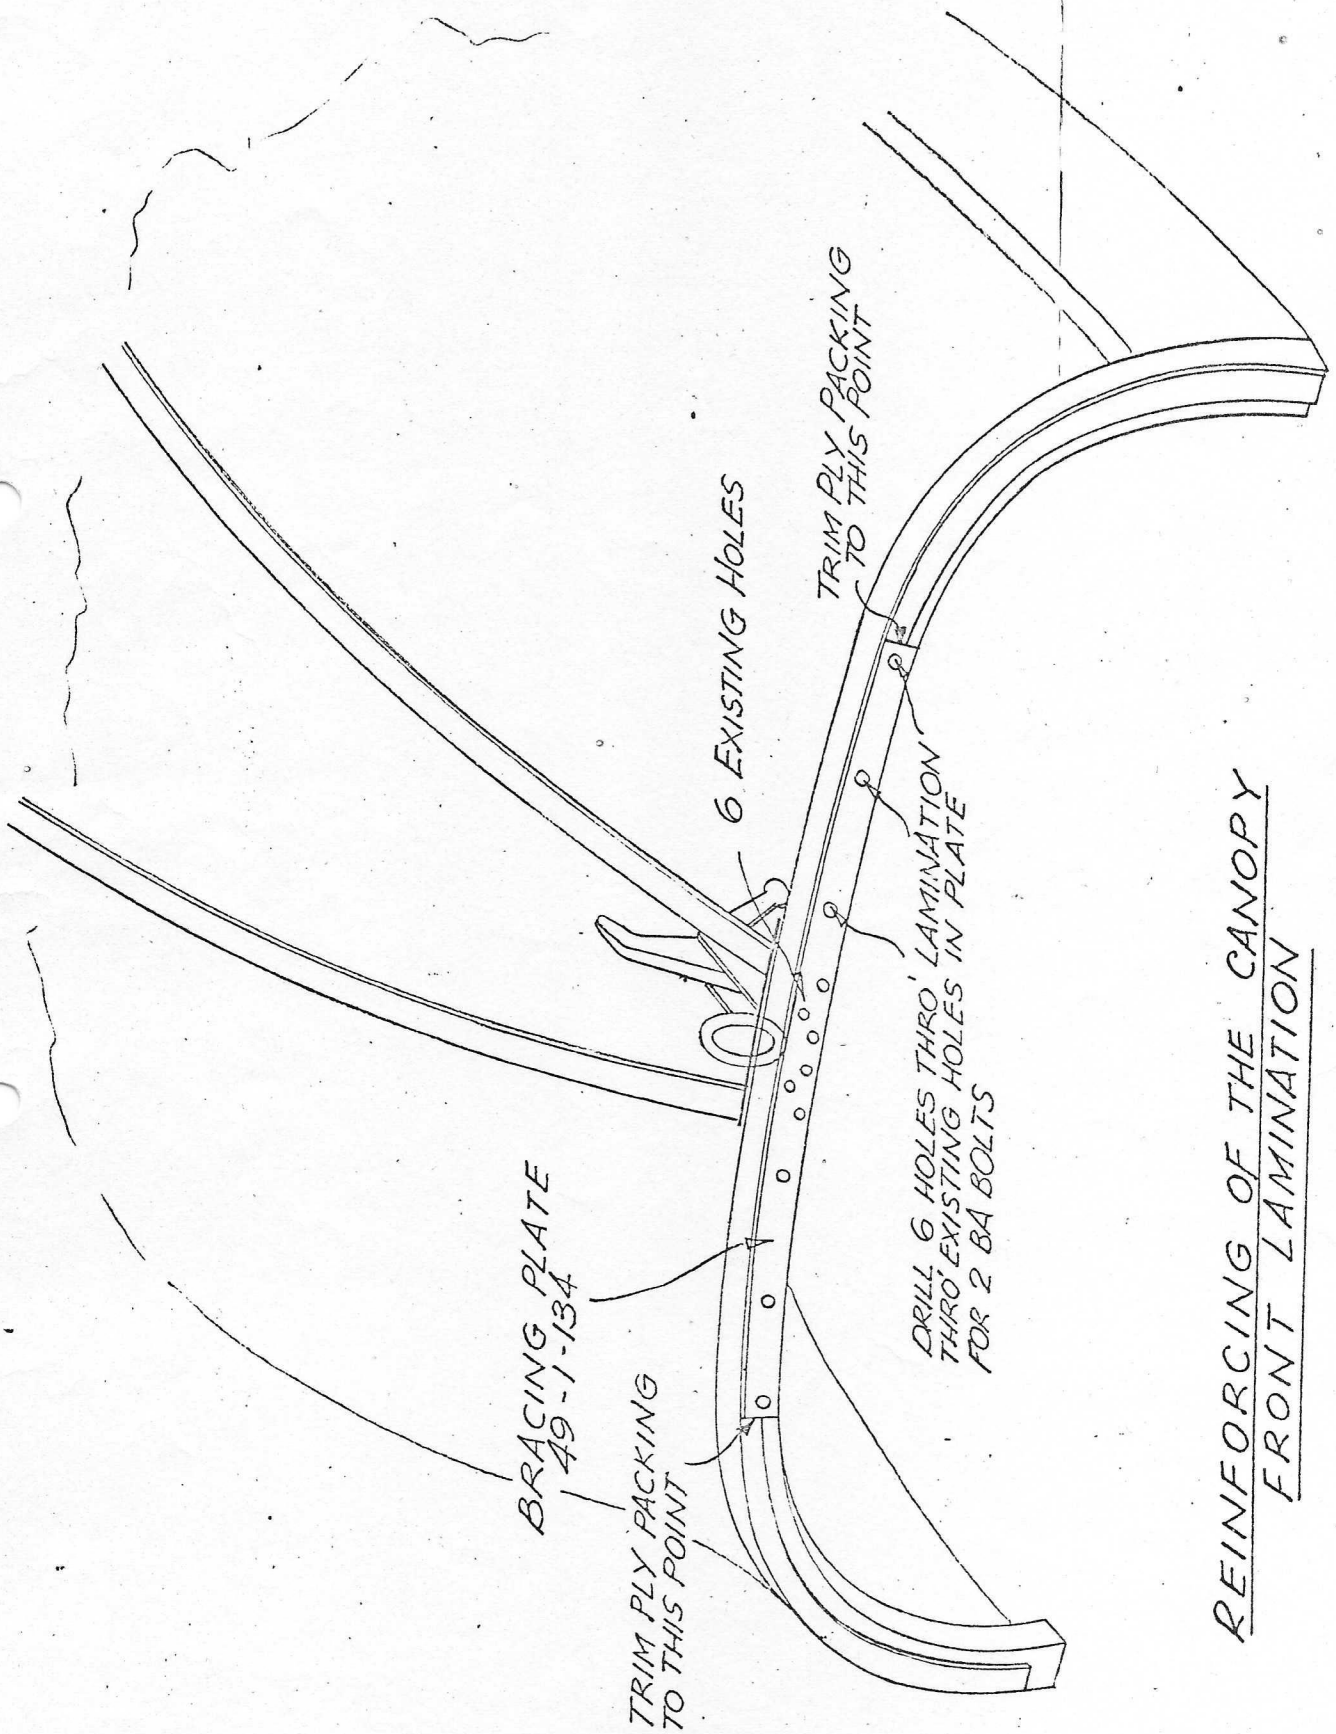
TECHNICAL INSTRUCTION N° 27  
T 49 B. CAPSTAN MOD No 5

Cases have occurred where the front corner of the canopy has lifted under extreme yawed flight.

The existing plate on the canopy front lamination is replaced by a longer plate.

1. Remove the front plate on the front lamination.
2. Position the new plate by inserting bolts through the centre holes in the plate and the existing bolt holes in the front lamination.
3. Mark the position of the extreme ends of the plate on to the front lamination.
4. Remove the plate.
5. Remove the ply packing on the front of the lamination from the centre to the plate end marks.
6. Fix the new plate by replacing the centre bolts (holding the canopy catch).
7. Drill through the lamination at the hole positions in the new plate.
8. Insert bolts and assemble washers and nuts.
9. Touch up paint as required.

NOTE. Care must be taken, when removing the ply packing from the front lamination, to avoid damage to the perspex canopy.
