TECHNICAL INSTRUCTION NO. 29

T.51 DART 17R

Mandatory Modification No.66

STRENGTHENING OF MANUAL RETRACTABLE UNDERCARRIAGE

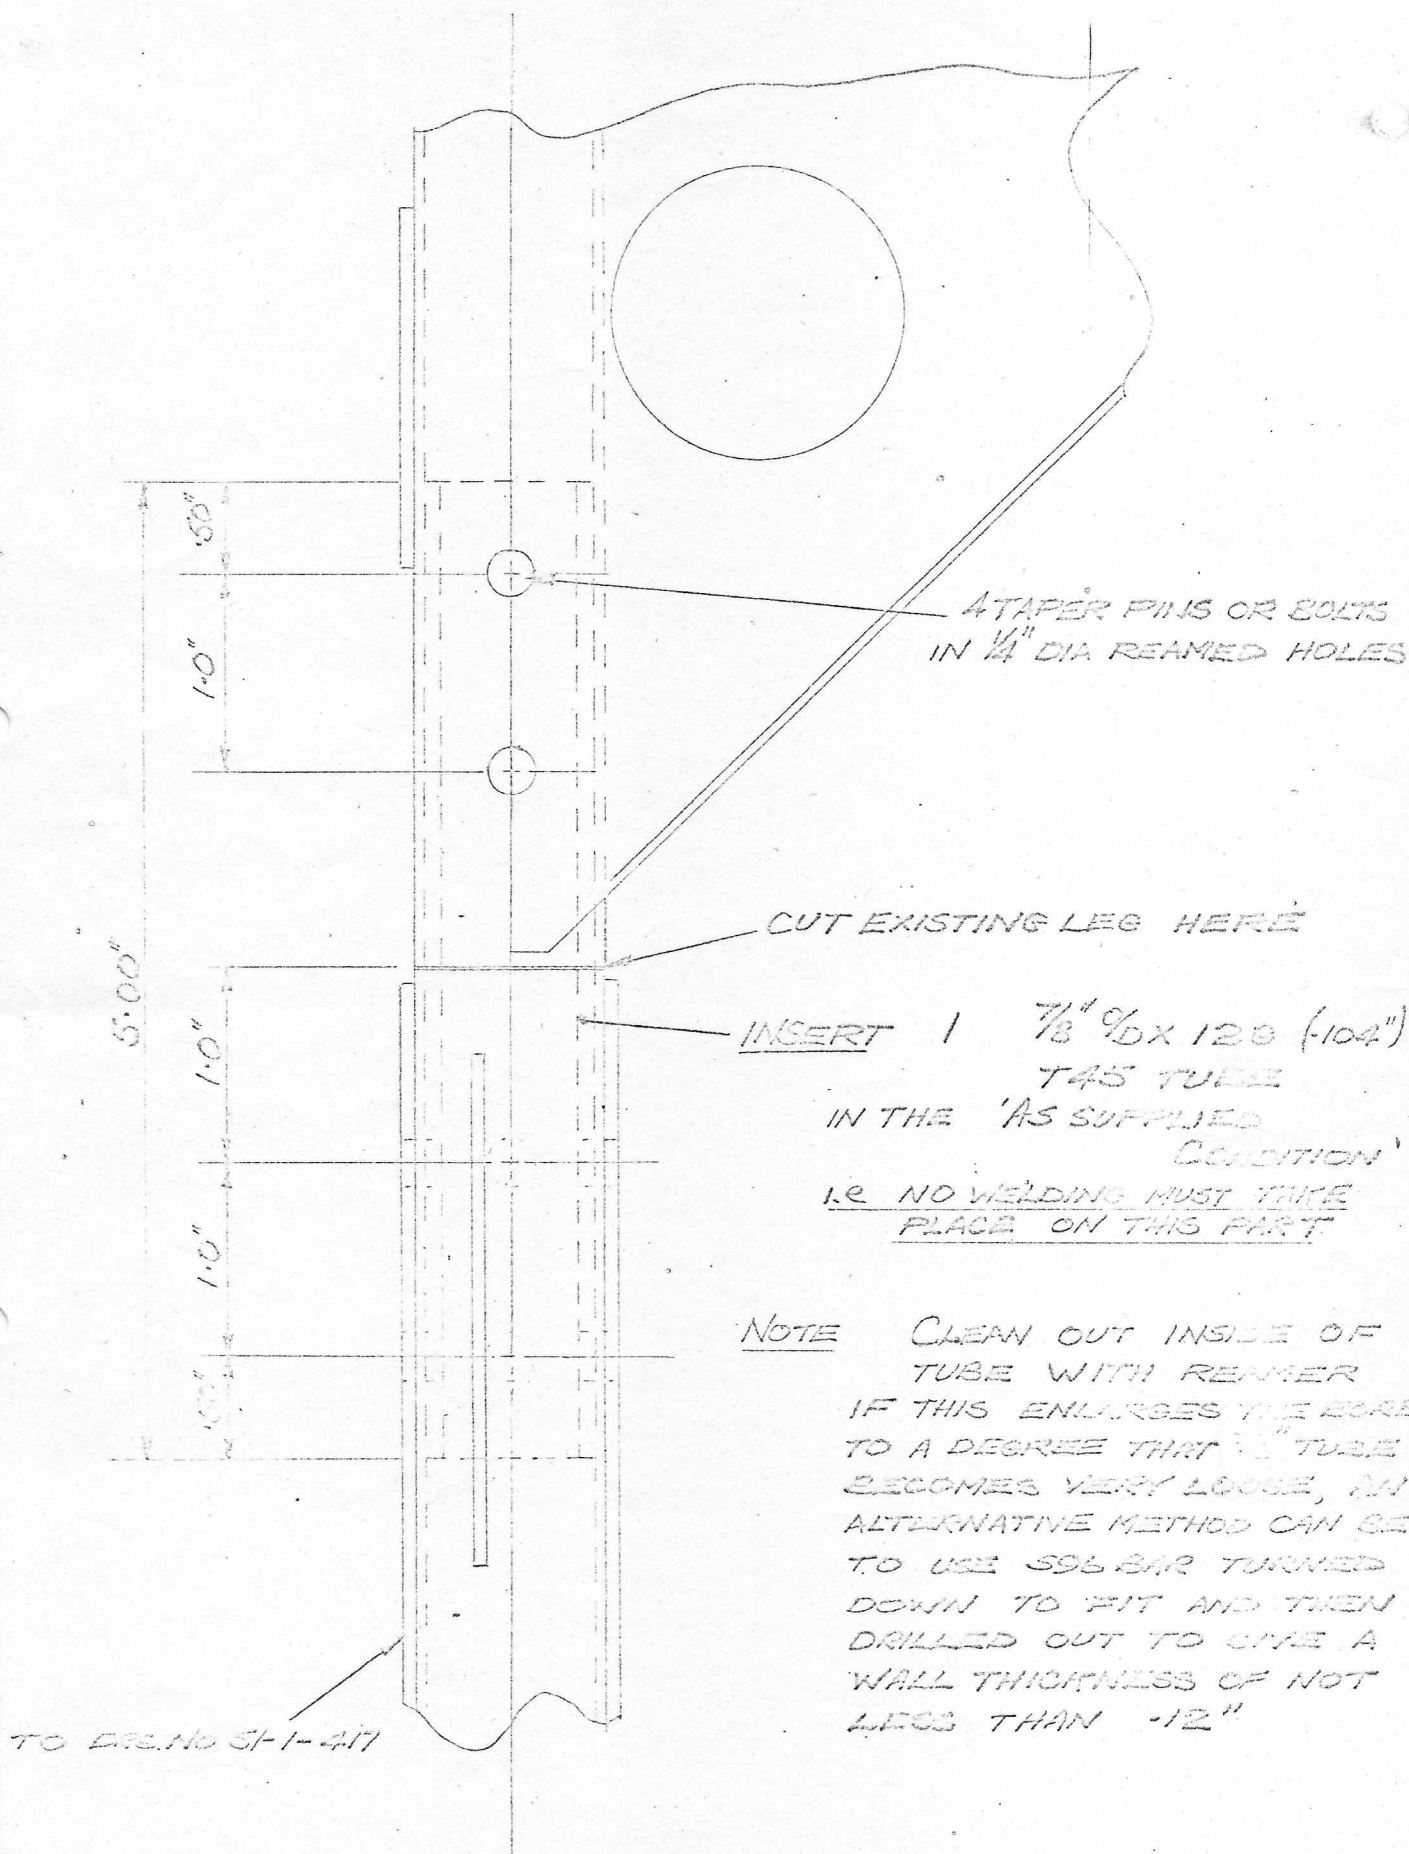
SK51/443

Due to a small number of main undercarriage fork failures a design change has been made, introducing strengthening of the Fork.

This modification is in the form of an internal tube inserted into the existing 1.0"  $\phi$ /D Tubes.

CUT EXISTING LEG HERE

INSERT 1  $\frac{7}{8}$ "  $\phi$  X 120 (-104")  
T45 TUBE  
IN THE 'AS SUPPLIED  
CONDITION'  
I.E. NO WELDING MUST TAKE  
PLACE ON THIS PART

NOTE CLEAN OUT INSIDE OF  
TUBE WITH REAMER  
IF THIS ENLARGES THE BORE  
TO A DEGREE THAT THE TUBE  
BECOMES VERY LOOSE, AN  
ALTERNATIVE METHOD CAN BE  
TO USE S96 BAR TURNED  
DOWN TO FIT AND THEN  
DRILLED OUT TO GIVE A  
WALL THICKNESS OF NOT  
LESS THAN .12"
