SLINGSBY SAILPLANES LIMITED, KIRBYMOORSIDE, YORKSHIRE  
E N G L A N D.

TECHNICAL INSTRUCTION NO. 30

T.51 DART ALL VARIANTS

INCREASE IN TAILPLANE MASS BALANCE WEIGHT

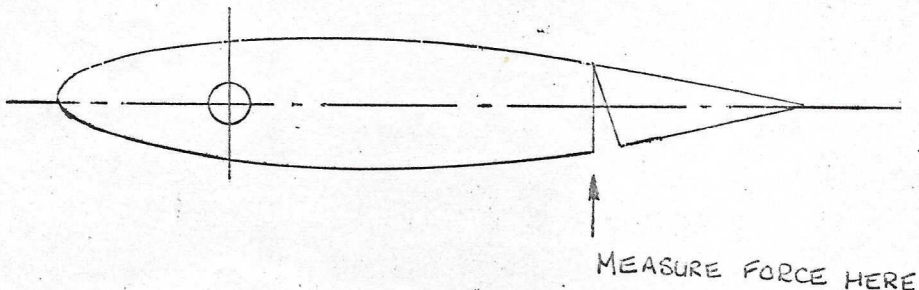
Object of the Modification: It seems likely that, in two or three incidents, Darts have suffered from fairly high-frequency pitching oscillations when flying fast. A detailed analysis of the dynamic stability confirms this possibility and indicates that a larger mass-balance weight for the all-moving tail is required.

1. Remove the two inspection panels forward of the tailplane in the rear fuselage.
2. Remove the existing elevator mass balance weights via the inspection panels.
3. Disconnect the rear end of the elevator push rod from the lever in the rear fuselage.
4. Since there are several different types of "Dart" tailplane, the new balance weights are somewhat too large as supplied, and must be trimmed to suit each aircraft.
5. Fit the new balance weights to the balance weight arm but do not tighten the attachment bolt fully.
6. Fit the tailplanes.
7. Measure the force which has to be applied to the root rib of the tailplane, immediately forward of the leading edge of the tab, to bring the tail to its neutral position.

8. Trim the balance weights, taking roughly equal amounts off each, until the upwards force, measured in the manner described above, is between 1 and 1.25 lb (0.45 to 0.56 kg).

Be careful to allow for the effect of friction by taking the mean of the forces which (a) just allow the trailing edge to rise and (b) just push it down.
