SLINGSBY AIRCRAFT COMPANY LTD., KIRKBYMOORSIDE,
YORKSHIRE ENGLAND.

Technical Instruction No. 32

T.51 Darts which are outside the scope of
Mandatory Modification No. 67

MANDATORY MODIFICATION No. 67A

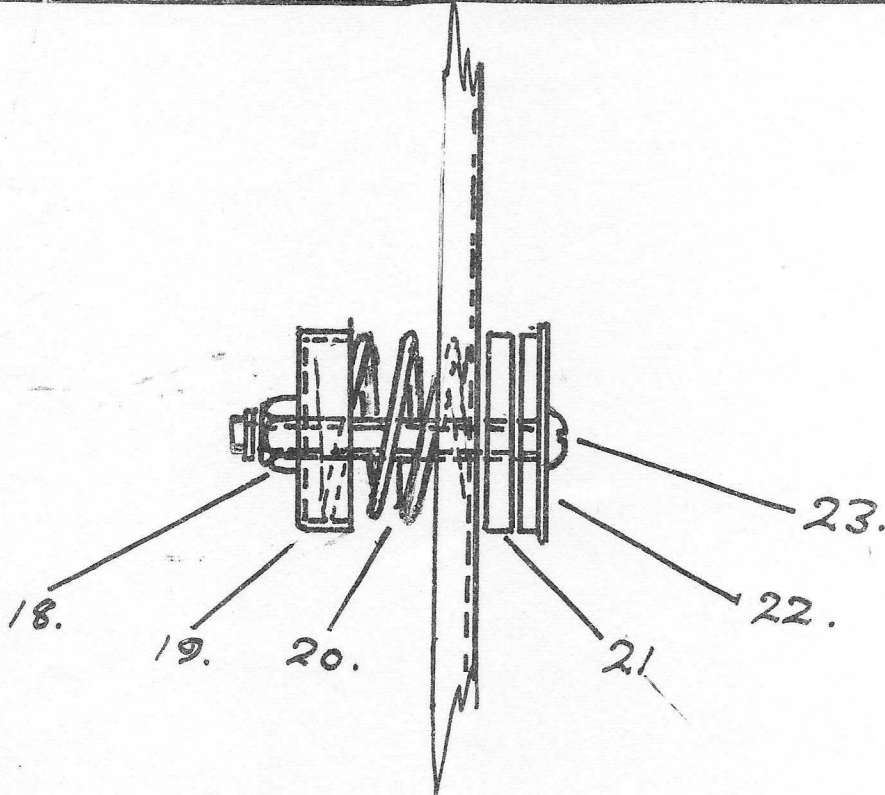
ASSEMBLY OF FRICTION DEVICE. DART MOD 67A.

It has been found that whilst there is no difficulty in fitting Dart Modification No. 67 to the later Dart variants with wooden tailplanes it is not practicable to apply it to those with metal tailplanes, nor to some earlier machines with a small range of cockpit load.

4. Fit items 18, 19, 20, 21, & 23 as supplied in Modification kit in accordance with sketch attached. Use existing large dia. $\frac{3}{16}$ " washer removed from old assembly.

Tension in accordance with rigging drawing 51-1-1 Iss. 6 or 7 or 51-1-201 Iss. 8 or 9 whichever is applicable. No grease whatsoever should be present on the friction device.
