TECHNICAL INSTRUCTION NO. 36.

Slingsby T.53.B. - Mod. No. 11

REPLACEMENT OF MOUNTING BRACKET FOR ELEVATOR LEVER (REAR CONTROL BOX).

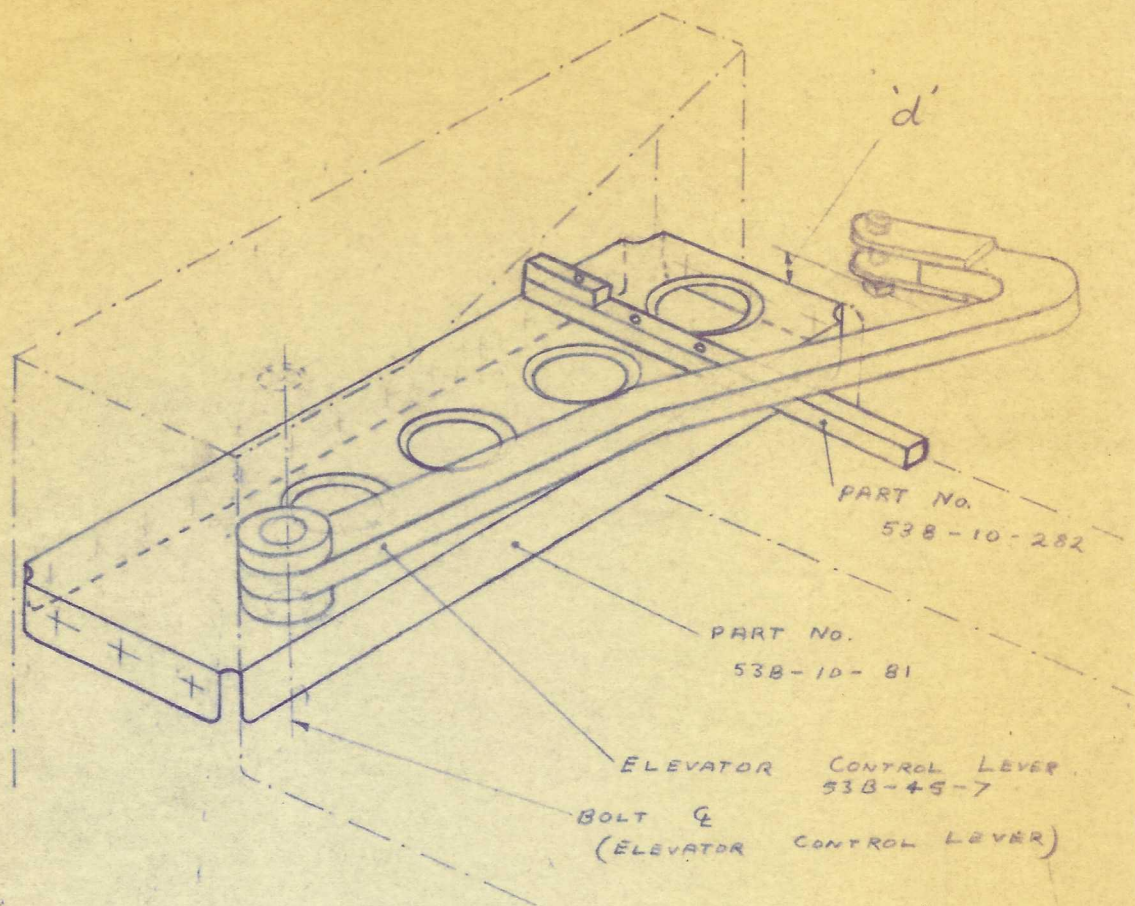
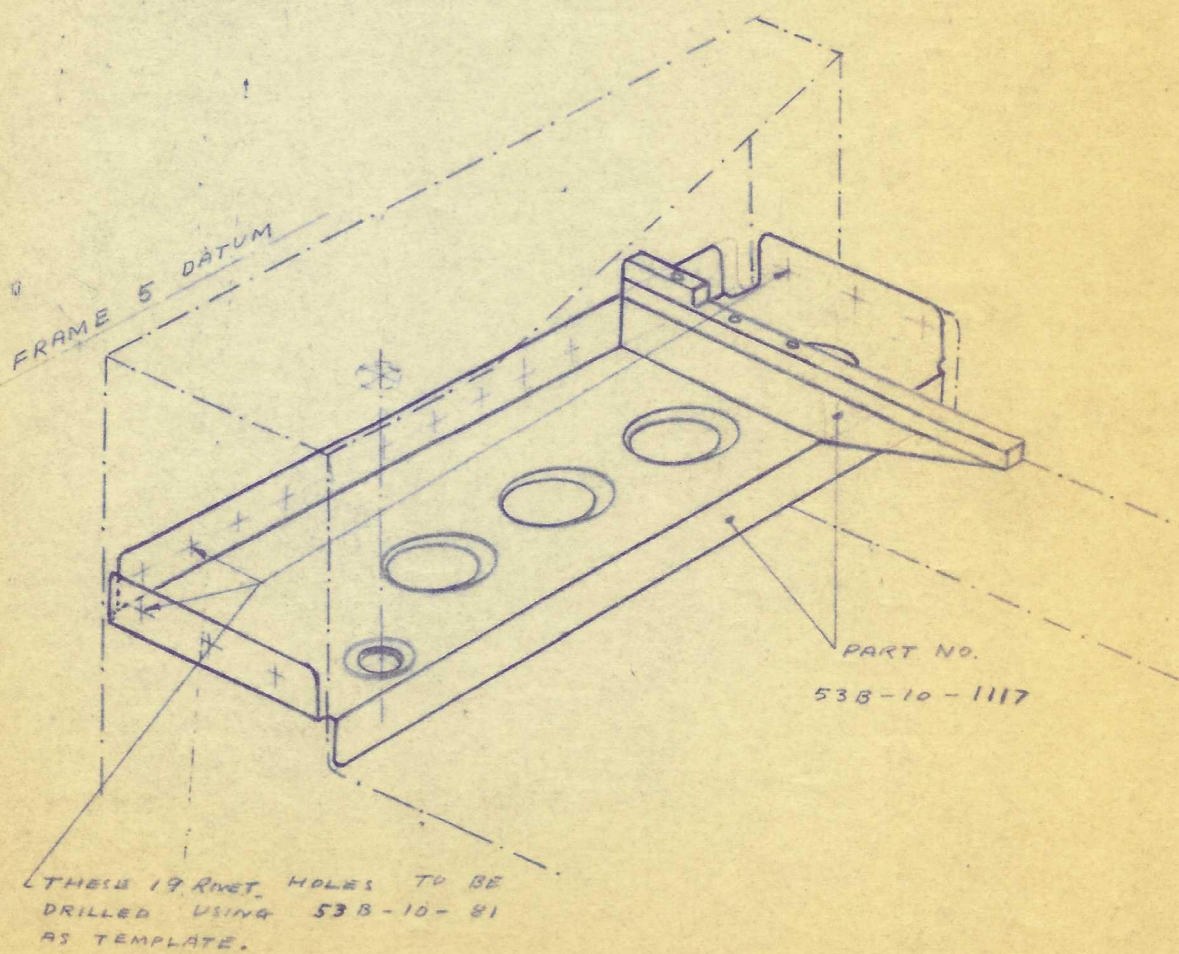
Mounting Bracket part No. 53B-10-81 and lever part No. 53B-10-282 are to be replaced by part No. 53B-10-1117 to give increased clearance between part No. 53B-10-81 and the elevator lever push rod attachment bolt. (see enclosed sketch).

If dimension "d" shown on the attached sketch is less than 3/16" no further flying is to take place until this modification is incorporated.

1. Remove elevator control lever pivot bolt.
2. Remove part No. 53B-10-81 by drilling out the 19 pop rivets attaching it to the surrounding structure.
3. Fit part No. 53B-10-1117 by picking up on existing holes in the structure. Part No. 53B-10-81 can be used as a template for drilling item 53B-10-1117.
