TECHNICAL INSTRUCTION

TITLE		T.I. No. 100/T53 Issue 1
Inspection of attachment of wing centre section to Frame 6.		
COMPLIANCE		
CAA MANDATORY Inspection to be completed before next flight and annually thereafter		
JUSTIFICATION		
This is a re-issue of the information of TI 90 which this instruction hereby cancels and replaces. A failure in fatigue of the brackets which holds the rear spar member of the centre section to Fuselage Frame 6 has been reported.		
APPLICABILITY		
All T53B gliders and to later variants of YS 53 by Yorkshire Sailplanes.		
RESTRICTIONS		
The glider must not be flown until this Technical Instruction is carried out.		
OBJECTIVE		
To inspect for fatigue cracks in the affected parts listed below : T53B-10-168 issue 1-4 welded fittings T53B-10-168 issue 5 rivetted " T53B-10-118 issue 1 T53B-10-115		
PARTS REQUIRED		
In the event of cracks in any of the fittings then they must be discarded and new parts fitted.

T53 WING CENTRE SECTION JOINTS
TO FRAME 6

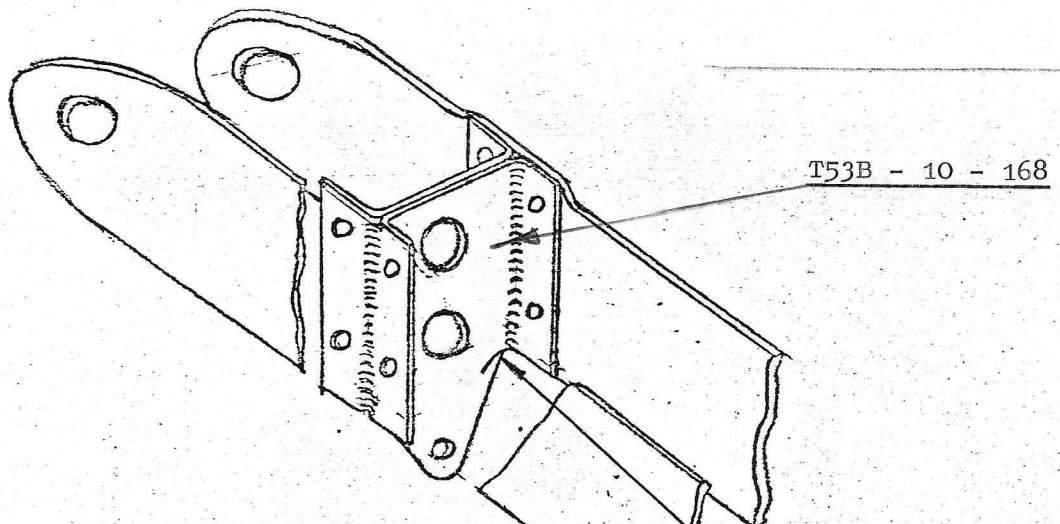
Figure 1

PROCEDURE		
Remove glass fibre fairing No.T53B-10-1093 and wings if fitted. Using a Dye penetrant crack detection system, inspect for cracks at the corner of the fittings where the attachment flanges begin (a) the welded brackets Pt No.T53B-10-168 issue 1-4 see figure 1 page 2 which holds the rear spar member of the c/s to the fuselage frame 6 and (b) the alternative riveted bracket Pt No.T53B-10-168 issue 5. Also in a similar manner inspect the metal lugs T53B-10-115 and channel section T53-10-118 on frame 6. See Figure 2. Checking for cracks in way of rivets. If any cracks are found the aircraft is to be grounded. All findings to be reported to SEL marked for the attention of the undersigned. New components can be obtained from SEL if required as listed above. If there are no cracks the aircraft is cleared for flight. Once the inspection has been complete the TI 100/T53 action should be recorded in the aircraft log book.
