SLINGSBY SAILPLANES

TECHNICAL INSTRUCTION No.69

SLINGSBY T53B and LATER VARIANT YS.53

IMMEDIATE INSPECTION OF ATTACHMENT
OF WING CENTRE SECTION TO FRAME 6

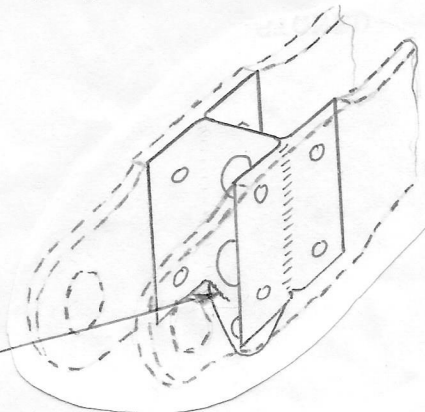
Part No.: T53B-10-168

Inspect the welded bracket which holds the rear spar member of the centre section to the fuselage Frame 6. Cracks have occurred at the corner of the fitting where the attachment flanges begin, see drawing.

Possible Fatigue
Cracks

If any cracks are found the Aircraft is NOT to be flown and the results of the Inspection should be communicated to Slingsby Sailplanes.
