TITLE		T.I. No. 101/T59 Issue 1	
Kestrel Rudder Actuator Inspection			
CLASSIFICATION		CAA MANDATORY	
COMPLIANCE		A single inspection to be completed by 1st March 1982	
OBJECTIVE		To ensure structural integrity of the rudder actuator, part number T59A-45-427	
JUSTIFICATION		Cracks on the fitting have occurred, in Area 'A' shown on diagram, the cause of which cannot be established.	
APPLICABILITY			
All Slingsby T59A, B, C, D, E, F, G, H & J gliders including spares held in stores and all rudder assemblies pre and post Mod 25.			
CONSEQUENTIAL LIMITATIONS			
If cracking is found the part must be discarded immediately and scrapped.			
ACTION			
<p>Remove the rudder in accordance with Addendum A.2.2 of the Pilots Notes. Visually examine (using a x5 magnification) the actuator for cracks especially in the area of the central weld 'A' see diagram. Should any sign of cracking be found then the existing part must be discarded and scrapped.</p> <p>Replace Rudder.</p> <p>Anotate aircraft log book showing compliance of this T.I.</p> <p>All findings to be reported to the undersigned.</p>		<p>Inspect these areas closely</p>

T.I. No. 101/T59 Iss 2

T59 'Kestrel' Rudder Actuator Inspection

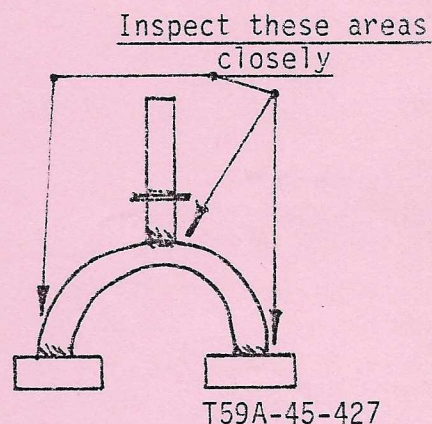
JUSTIFICATION Further examples of cracking in Area A have been found on German built gliders.

ACTION Remove the rudder in accordance with Addendum A.2.2. of the Pilots Notes. Visually examine (using a x5 magnification) the actuator for cracks especially in the area of the central weld 'A' see diagram. Should any sign of cracking be found then the existing part must be discarded and scrapped. Replace Rudder. Annotate aircraft log book showing compliance of this T.I.

If cracking is found the part must be discarded immediately and scrapped.

If inspection reveals a defective actuator, a replacement T59A-45-427 Issue 5 (one off) actuator may be obtained from SA PLC.
