TECHNICAL INSTRUCTION

T.I. No. 106/T59

T59 'Kestrel' Elevator Push Rod in Fin

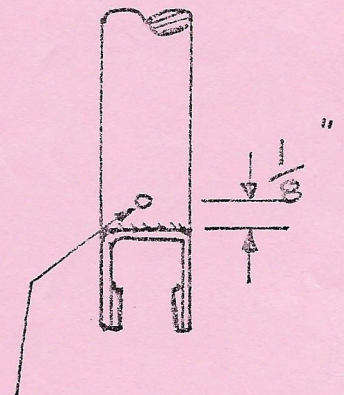
JUSTIFICATION An inspection on a Kestrel revealed internal corrosion on the push rod of the elevator, sufficiently advanced to corrode through the rod wall, due to water ingress from the top inspection hole.

1/16" dia inspection hole can be drilled and left open on refit if no corrosion found.

The Push Rod must be removed for examination. Bottom access can only be gained through the removal of the wheel well fairing. If possible inspect to check wall thickness at the bottom. See Fig. If facilities exist for ultrasonic inspection or x-ray to ensure no internal corrosion then the rod can be refitted. If structural integrity cannot be confirmed then the rod must be replaced.
