TECHNICAL INSTRUCTION No. 44

Repositioning of Bolts on
Undercarriage Operating Shaft of Kestrel Glider

Modification T.59 - Mod. No. 5

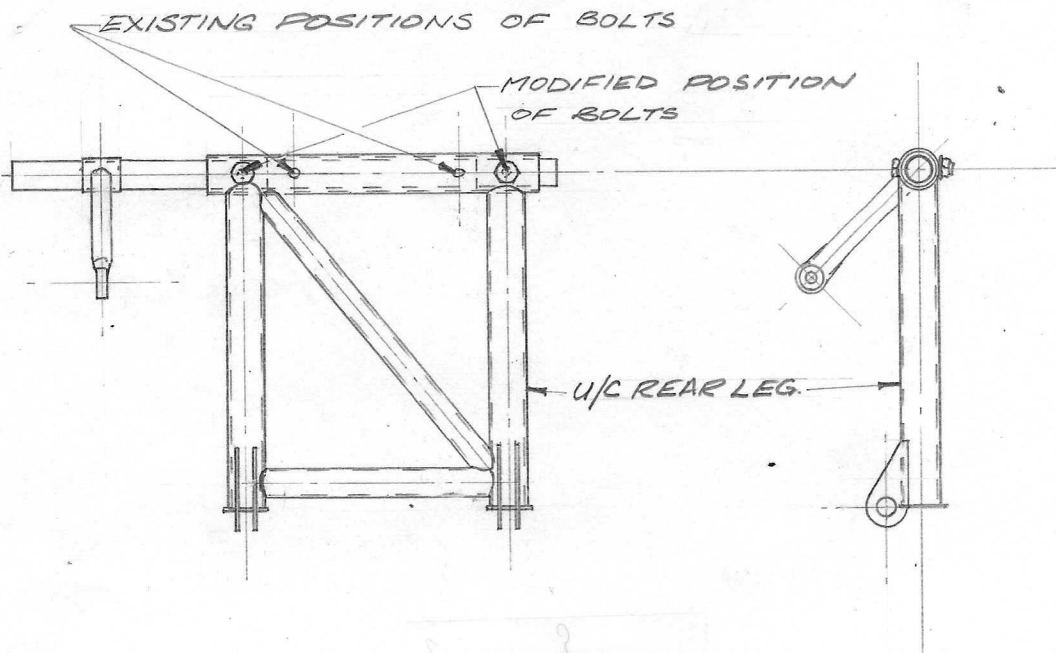
The bolts shown below have been wrongly positioned on a number of 17 metre Kestrel gliders causing excessive wear. This instruction shows the correct positioning of these bolts. It is strongly advised that this modification is carried out as soon as possible, but in any case within 20 flying hours.

1. Remove the seat back and the fibre glass panel forming the front of the wheel box.
2. Remove the wheel.
3. Remove the bolt connecting the undercarriage operating shaft to its operating lever.
4. Remove the bolts connecting the front and rear undercarriage forks.
5. Allow the rear fork to hang down.
6. Mark, drill and ream the rear fork for a $\frac{1}{4}$ " bolt as shown in the diagram.
7. Fit the new bolts and remove the old ones.
8. Reinstate the parts removed.
