Inspection of Kestrel Landing Flap Cable

Following the failure of a landing flap cable on a 19 metre Kestrel glider the following inspection is called for to ensure that no bending loads are being applied to the cable ends.

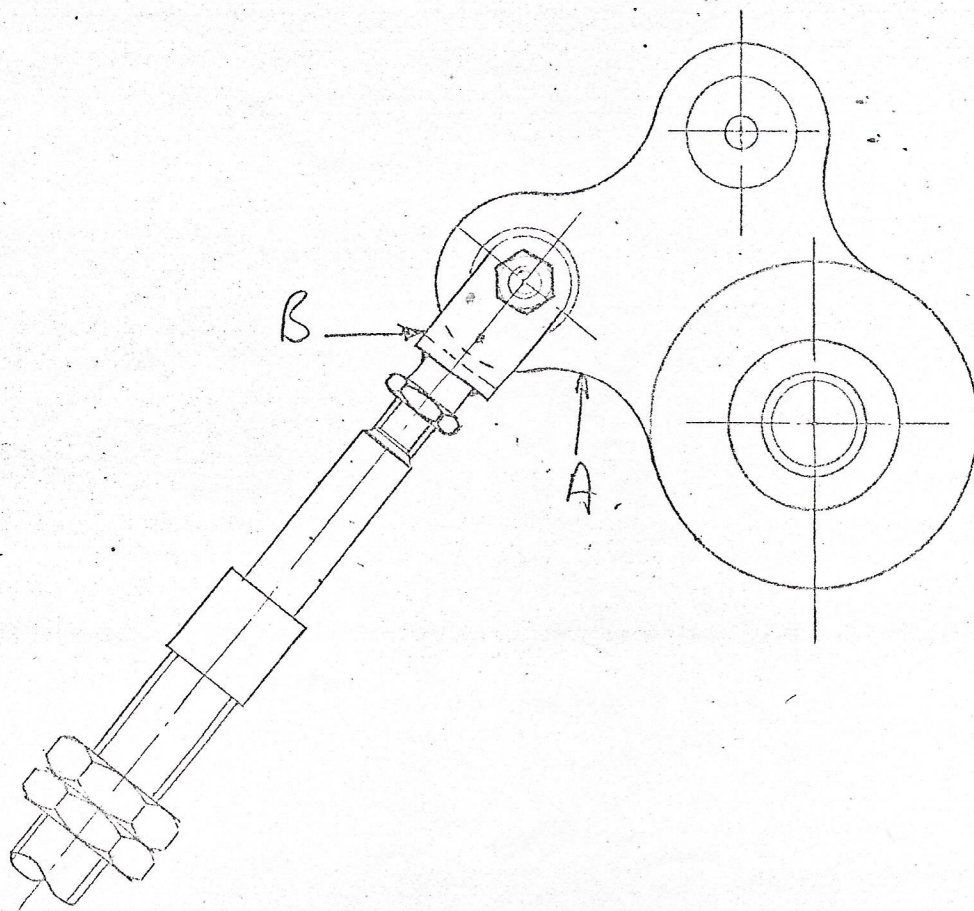
FIGURE 1.

The arrangement at the ends of the flexible drive cable are as shown in Figure 1.

1. Check that at the aft end of the cable the bracket "B" does not foul on the lever "A", thus trying to bend the threaded portion of the cable.
2. Disconnect both ends of the cable from the levers and ensure that movement of the uniball is free and not liable to cause extraneous loading of the cable ends during normal movement of the levers.

If any of the above checks has lead to doubts about the state of the cable, the cable should be replaced or at least crack tested by an approved method. Any signs of bending or deformation of the threaded portion at the end of the cable will necessitate renewal of the cable.

When replacing the cable, if this is necessary, do not over tighten the nuts holding the bracket "B" to the cable.
