TECHNICAL INSTRUCTION

TITLE T65 'VEGA' Central Elevator Hinge on Tailplane, Elevator Tongue & Pivot Bearings for Elevator Rocker Arm.		T.I. No. 104/T65 Iss.1
CLASSIFICATION C.A.A. Mandatory		
COMPLIANCE Inspection to be carried out before the next flight unless LTO 'Elevator & Canopy Jettison Mechanism', 20th August has been carried out.		
OBJECTIVE To ensure structural integrity of the central elevator hinge on tailplane elevator drive tongue and to inspect the pivot bearings for the elevator rocker arm assy. Also to reinforce central elevator hinge on tailplane.		
JUSTIFICATION Cracking and a lack of stiffness has occurred in the area 'A' (Fig 1), the cause of which is attributable to heavy landings and/or excessive bearing loads during elevator assembly.		
APPLICABILITY All Slingsby T65A, C, D gliders, including spare tailplane/elevators expanding on CAA Airworthiness Directive No.008-08-82. (LTO 'Elevator & Canopy Jettison Mechanism', 20th August).

TITLE	T65 'VEGA' Central Elevator Hinge & Pivot Bearings For Elevator Rocker Arm.	T.I. No. 104/T65 Issue 1
- (2) -		
2.1	Rectification of lack of stiffness of the elevator tongue will be as follows :-

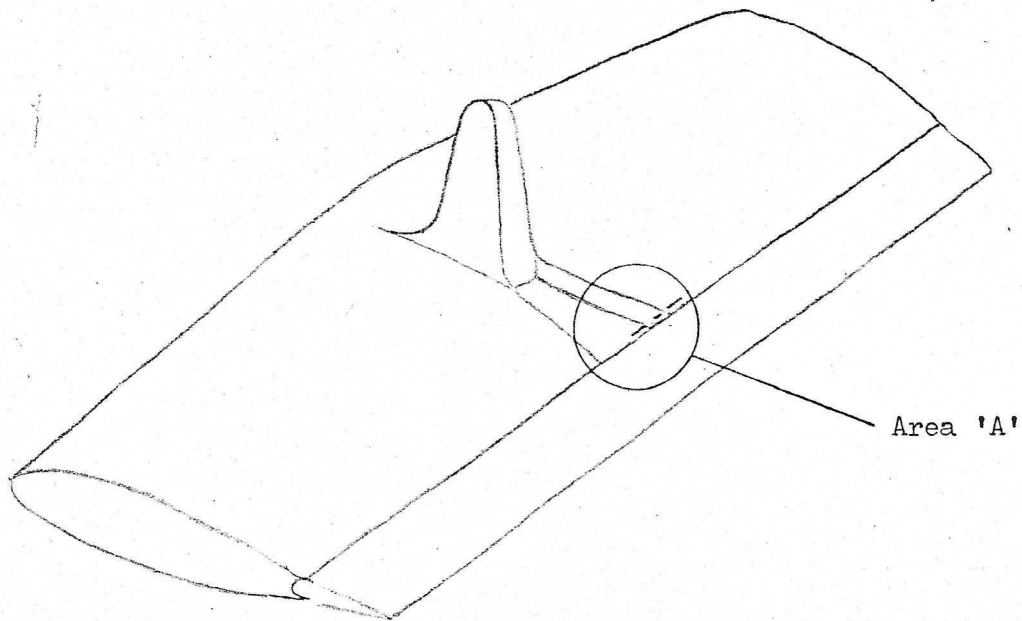
FIG 1 Area of Cracking on Vega T-Plane

CONSEQUENTIAL LIMITATIONS If cracking is found on the tailplane central hinge the repair will require a new central tailplane rib (T65A-30-15) which must be fitted by S.A.L. or an approved repair shop before next flight.		
ACTION - Inspection to be carried out as follows : 1.1 With the tailplane/elevator assembly removed from the aircraft examine the glass reinforced plastic operating tongue of the elevator which projects forwards into the tailplane. The lips of this channel shaped tongue must be unbroken and continuous to the point where it merges with the elevator proper. Check the tongue for lack of stiffness in the vertical sense by attempting to bend the tongue with the fingers. If any degree of cracking, damage or abnormal flexibility is found it must be rectified before further flight in accordance with a repair detailed in Section 2. The preceding action must be carried out following a heavy landing or ground loop in addition to any other required inspections. 1.2 Inspect the pivot bearings (04 DU 04) for the elevator rocker arm assembly, on the top of the fin for wear. Any wear found in excess of 0.01" in the fwd & aft direction must be rectified before further flight. Fitting of the bearing is detailed in Section 3. 1.3 Inspect the tailplane centre hinge pin mounting rib at the section just forward of the hinge pin as detailed in Fig 6. If cracks or damage are found a repair entailing the fitting of a new 'reinforced' rib will be required. The repair scheme is detailed in Section 4 and should be undertaken by S.A.L. or an approved repair shop. If the section does not show signs of cracking a reinforcement cloth will be required as detailed in Section 5. Alternative means of repair for minor cracking may be carried out with the agreement of SAL. <u>Note</u> - Use Epikote 162/Epikure 113 resin system throughout.

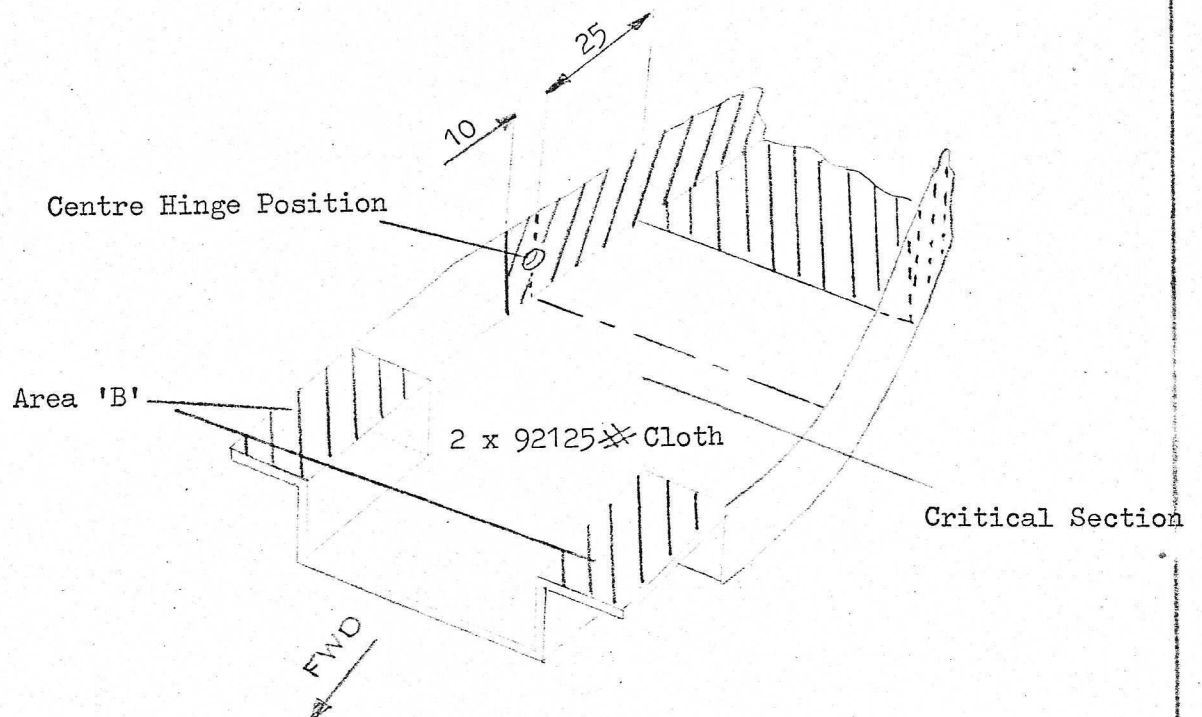
FIG 2 Reinforcement of Elevator-Tongue

Only layup cloth on the inside of the tongue on the area NOT shaded.

(a) Remove the tailplane/elevator assembly from the aircraft.	
	(b) With the elevator removed from the tailplane, abrade the tongue of the elevator over the area detailed in Fig 2.

(c) Layup 2 layers of woven roving cloth (2 x 92125 5) over the area detailed in Fig 2.	
3.1	If the pivot bearing 04 DU 04 is worn it may be replaced as follows (refer Fig 3).

- (j) When fitting the tailplane elevator assembly ensure the elevator tongue seats correctly on the actuator. If there is a clearance between the tongue and actuator the tongue must be built up in the Area 'B' detailed in Fig 2. If there is a foul between the tongue and actuator, the tongue must be trimmed (refer Area 'B' Fig 2) to seat properly on the actuator. Build up the cloth under the flanges and around the web to compensate for any cloth removed.

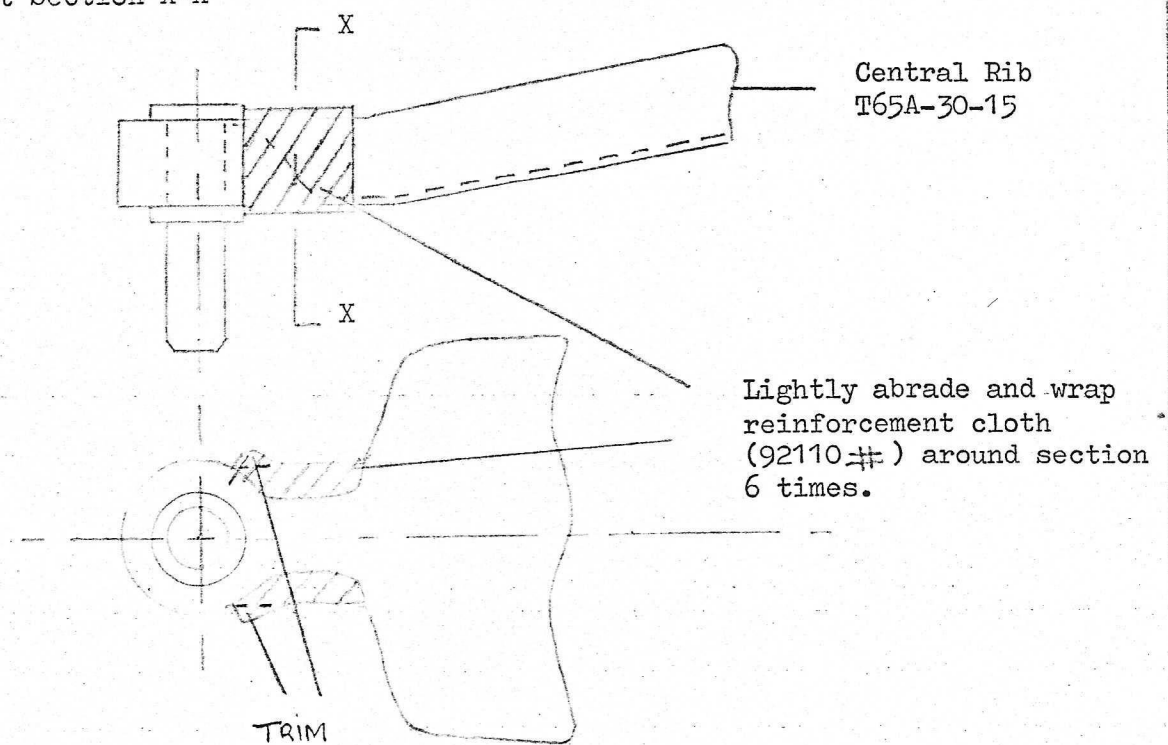
FIG 6 Reinforcement Cloth on the Centre Tailplane Hinge

Inspect Section X-X

- (k) Cure for 8 hours at 56°C.
- 5.1 If the central elevator hinge on the tailplane is not cracked, reinforcement will be added as follows :-
- (a) Remove the tailplane/elevator assembly from the aircraft.

- (b) When the elevator is removed from the tailplane, lightly abrade the area shown in Fig 6.
- (c) Wrap a 10mm strip of 92110 # woven roving cloth 6 times around the area detailed.

- (d) When cured trim any rough edges.
- (e) Trim the elevator cutout to enable maximum deflection of the elevator
+24°
-16.5° ± 1° 30'
- (Note - the cutout may now be visible when full deflection of the elevator is applied.)
