TECHNICAL INSTRUCTION

TITLE T65 'VEGA' Central Elevator Hinge on Tailplane, Elevator Tongue & Pivot Bearings for Elevator Rocker Arm.		T.I. No. 104/T65 Iss.2
CLASSIFICATION C.A.A. Mandatory		
COMPLIANCE Inspection to be carried out before the next flight unless LTO 'Elevator & Canopy Jettison Mechanism', 20th August has been carried out.		
OBJECTIVE To ensure structural integrity of the central elevator hinge on tailplane elevator drive tongue and to inspect the pivot bearings for the elevator rocker arm assy. Also to reinforce central elevator hinge on tailplane.		
JUSTIFICATION Cracking and a lack of stiffness has occurred in the area 'A' (Fig 1), the cause of which is attributable to heavy landings and/or excessive bearing loads during elevator assembly.		
APPLICABILITY All Slingsby T65A, C, D gliders, including spare tailplane/elevators expanding on CAA Airworthiness Directive No.008-08-82. (LTO 'Elevator & Canopy Jettison Mechanism', 20th August).

T.I. No. 104/T65 Issue 2

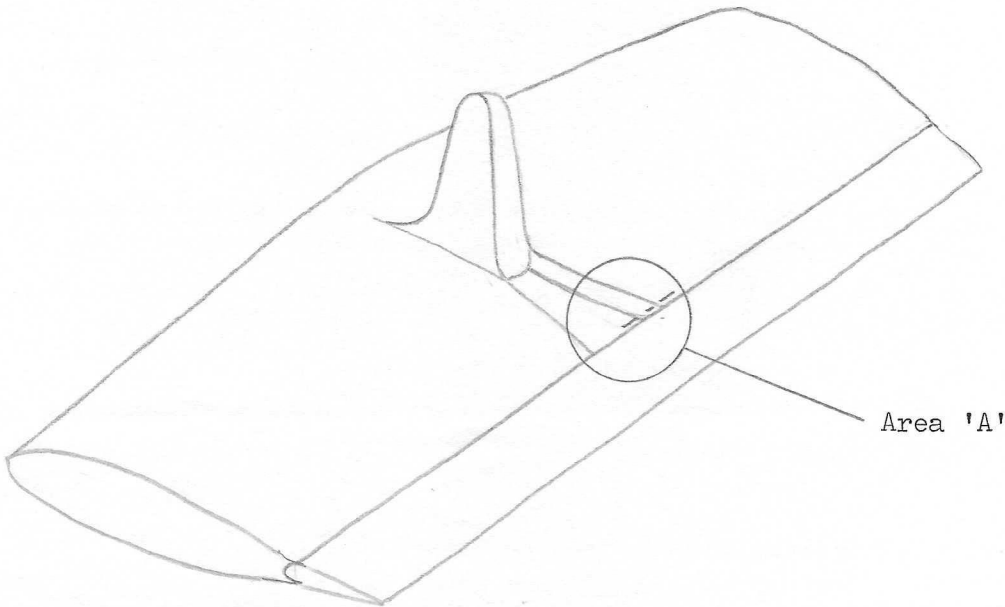
FIG 1 Area of Cracking on Vega T-Plane

CONSEQUENTIAL LIMITATIONS If cracking is found on the tailplane central hinge the repair will require a new central tailplane rib (T65A-30-15) which must be fitted by S.A.L. or an approved repair shop before next flight.		
ACTION - Inspection to be carried out as follows : 1.1 With the tailplane/elevator assembly removed from the aircraft examine the glass reinforced plastic operating tongue of the elevator which projects forwards into the tailplane. The lips of this channel shaped tongue must be unbroken and continuous to the point where it merges with the elevator proper. Check the tongue for lack of stiffness in the vertical sense by attempting to bend the tongue with the fingers. If any degree of cracking, damage or abnormal flexibility is found it must be rectified before further flight in accordance with a repair detailed in Section 2. The preceding action must be carried out following a heavy landing or ground loop in addition to any other required inspections. 1.2 Inspect the pivot bearings (04 DU 04) for the elevator rocker arm assembly, on the top of the fin for wear. Any wear found in excess of 0.01" in the fwd & aft direction must be rectified before further flight. Fitting of the bearing is detailed in Section 3. 1.3 Inspect the tailplane centre hinge pin mounting rib at the section just forward of the hinge pin as detailed in Fig 6. If cracks or damage are found a repair entailing the fitting of a new 'reinforced' rib will be required. The repair scheme is detailed in Section 4 and should be undertaken by S.A.L. or an approved repair shop. If the section does not show signs of cracking a reinforcement cloth will be required as detailed in Section 5. Alternative means of repair for minor cracking may be carried out with the agreement of SAL. <u>Note</u> - Use Epikote 162/Epikure 113 resin system throughout.

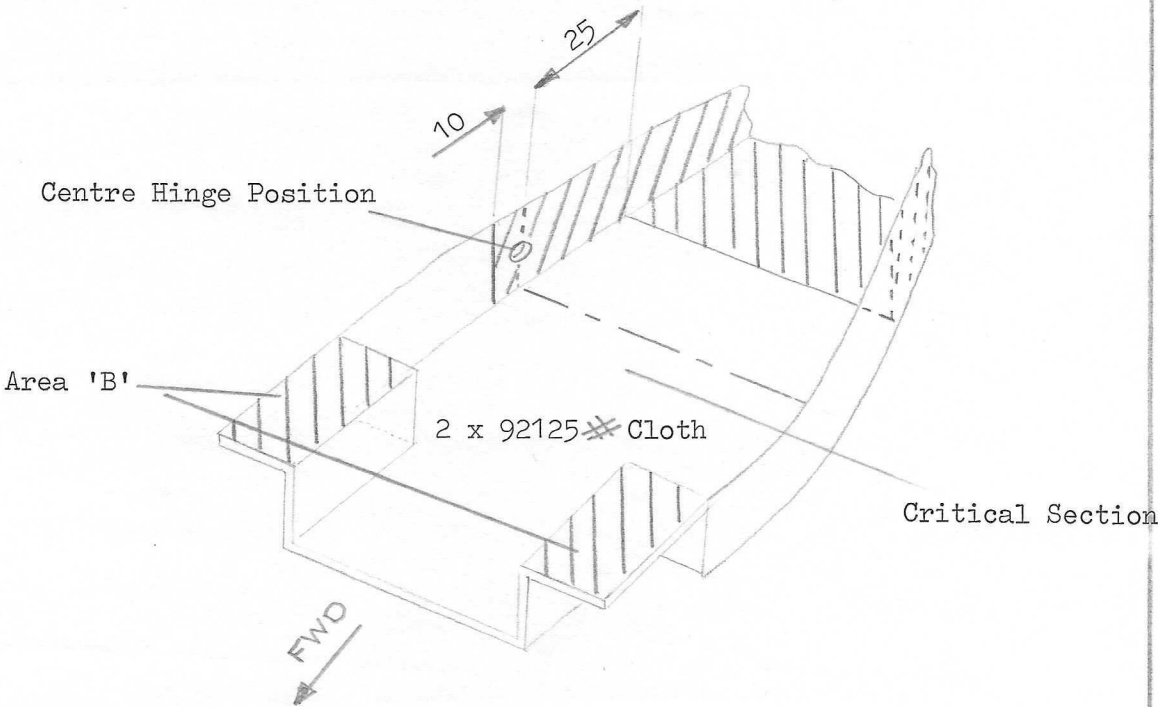
FIG 2 Reinforcement of Elevator-Tongue

Only layup cloth on the inside of the tongue on the area NOT shaded.

- 2.1 Rectification of lack of stiffness of the elevator tongue will be as follows :-
- (a) Remove the tailplane/elevator assembly from the aircraft.
 - (b) With the elevator removed from the tailplane, abrade the tongue of the elevator over the area detailed in Fig 2.

- (c) Layup 2 layers of woven roving cloth (2 x 92125~~XX~~) over the area detailed in Fig 2.
- 3.1 If the pivot bearing 04 DU 04 is worn it may be replaced as follows (refer Fig 3).

- (j) When fitting the tailplane elevator assembly ensure the elevator tongue seats correctly on the actuator. If there is a clearance between the tongue and actuator the tongue must be built up in the Area 'B' detailed in Fig 2. If there is a foul between the tongue and actuator, the tongue must be trimmed (refer Area 'B' Fig 2) to seat properly on the actuator. Build up the cloth under the flanges and around the web, to compensate for any cloth removed.

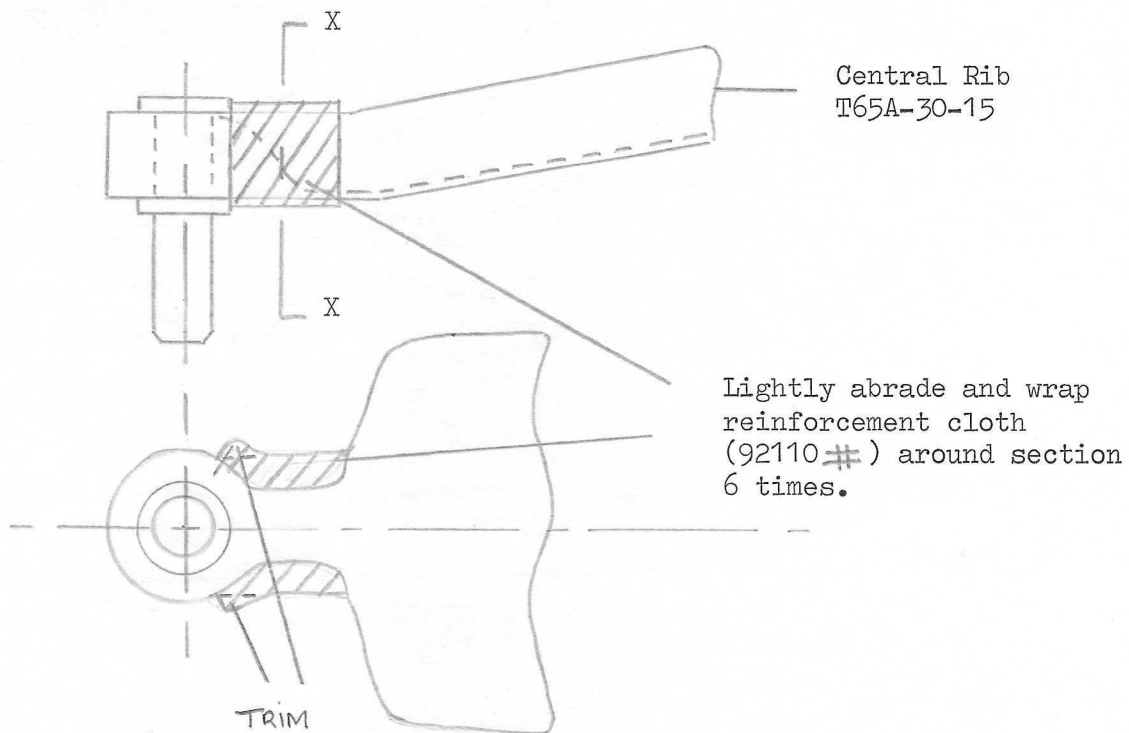
FIG 6 Reinforcement Cloth on the Centre Tailplane Hinge

Inspect Section X-X

- (k) Cure for 8 hours at 56°C.
- 5.1 If the central elevator hinge on the tailplane is not cracked, reinforcement will be added as follows :-
- (a) Remove the tailplane/elevator assembly from the aircraft.

- (b) When the elevator is removed from the tailplane, lightly abrade the area shown in Fig 6.
- (c) Wrap a 10mm strip of 92110 # woven roving cloth 6 times around the area detailed.

- (d) When cured trim any rough edges.
- (e) Trim the elevator cutout to enable maximum deflection of the elevator
+24° ± 1° 30'
-16.5°
- (Note - the cutout may now be visible when full deflection of the elevator is applied.)

- (f) Cure for 8 hours at 56°C.
