TECHNICAL INSTRUCTION

T.I. No: 110/T65

Title: : INSPECTION OF VEGA/SPORTS VEGA FIN MOUNTED TAILPLANE ATTACHMENT BUSH ROPES

APPLICABILITY: All T65A, T65D Vega and T65C Sports Vega

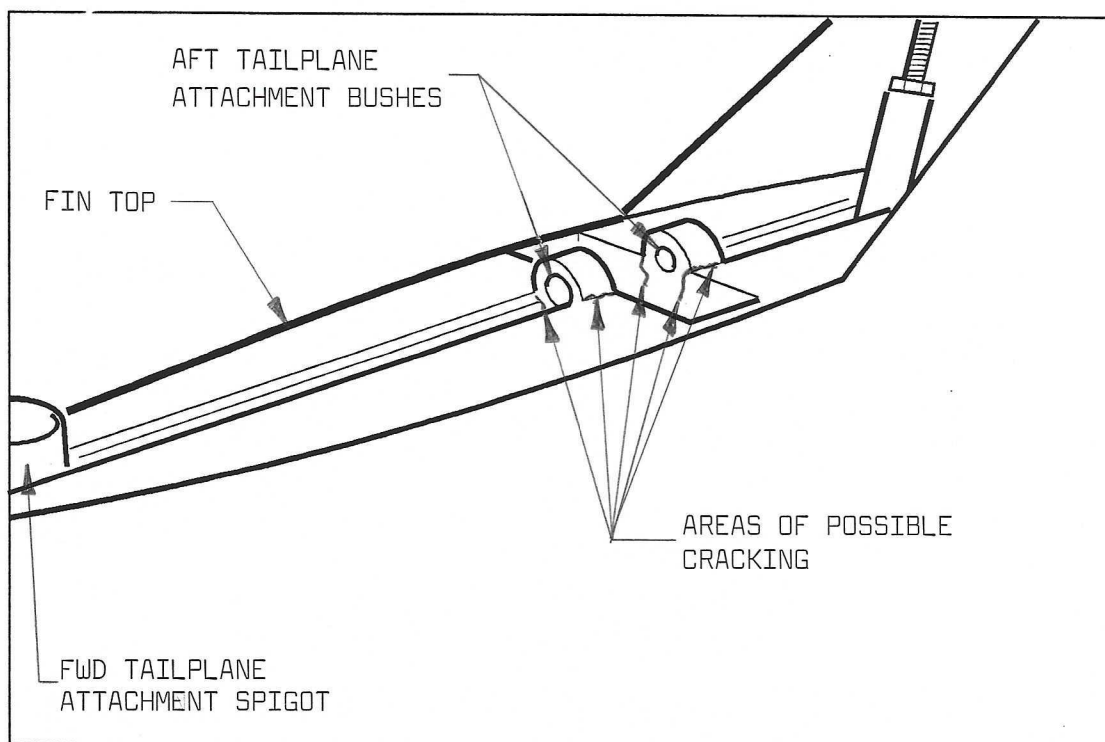
FIG 1

There have been cases reported of cracks having been found in the glass ropes which retain the fin mounted tailplane attachment bushes.

These cracks were found during repairs to a glider following a ground loop and could be an indication of further damage to tailplane mounting structure.

1. If applicable, de-rig tailplane from fin.
2. Clean area of inspection using acetone or equivalent.
3. Using a torch and a magnifying glass, check the structural integrity of the ropes securing rigging bushes to fin, ie there are no cracks in the areas shown on Fig 1. Additionally check the tailplane tang support structure within the fin for delamination etc. Should there be any doubt as to the existence of any cracks then place a bar (bush diameter is 7mm) in each bush in turn and carefully apply a twisting action on the bush, sufficient to disturb any crack that may be there. Ensure force used is not such to damage structure or bush bores.

4. Should the bush ropes be found to be satisfactory and the remaining structure is deemed to be sound, continue as paragraph 6.
5. Should cracks be found in the ropes around the bushes and/or structure is found to be unsound, then please supply to SAL, details of cracking/or other damage, stating whether glider was subject to any recorded ground loop incident, together with glider works number etc.

7. Repair any damage prior to next flight, either from information received from manufacturer, ie SAL, or if applicable i.a.w. Vega/GRP Repair Manual.
8. Upon completion of this inspection, and if applicable-repair, annotate logbook "TI 110/T65 complied with" and date.
9. Upon any subsequent ground loop incident, structural integrity of the tailplane mounting structure should be inspected and if in doubt, inspection applied, as stated in paragraph 3 with compliance to the subsequent relevant paragraphs.
