TECHNICAL INSTRUCTION NO. 95

SLINGSBY T65A, T65D VEGA GLIDER

AILERON/WING VIBRATION OF T65A and T65D VEGA GLIDERS

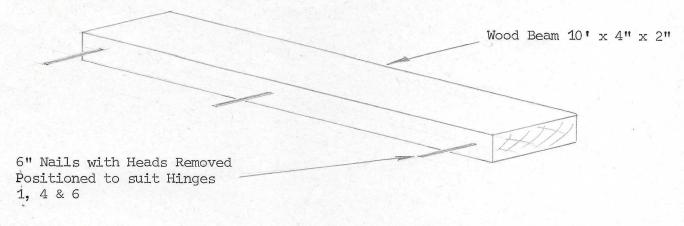
Fig. 1 TYPICAL BALANCE JIG

- 2. Determine the out of balance moment of each aileron as follows:
 - a) Support the aileron at hinge positions 1, 4 & 6 (numbered from aileron inboard hinge) on locally produced jig Ref Fig. 1.
 - b) Calculate out of balance as detailed below:

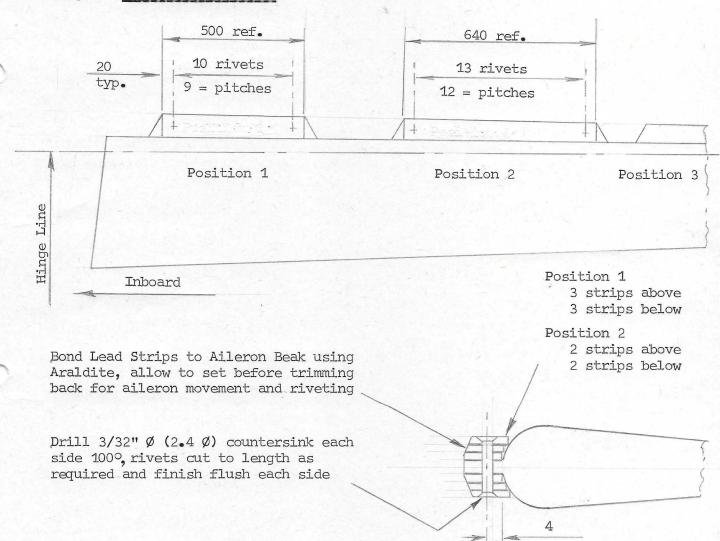
Note: At Position 3 '1' lead strip above and below may be added. Minimise length and attach as detailed above to inboard portion of Aileron Beak.

- 3. Record the actual weight and out of balance moment for each aileron (Ref. Para 7.)
- 4. From the out of balance moment for each aileron calculate the required amount of lead needed to reduce the out of balance to 3.0 lbs ins and add lead to the aileron beaks as detailed on Fig. 2.
- 5. Check out of balance moment as in Para. 2.
- 6. Temporarily fit ailerons and check maximum movements.
