2nd DECEMBER, 1957.

TECHNICAL INSTRUCTION NO. 2. SKYLARK 2 and 3.

Part A. Special inspection and adjustment to trimmer control system.

Part B. Introduction of modified attachment for turn and slip batteries.

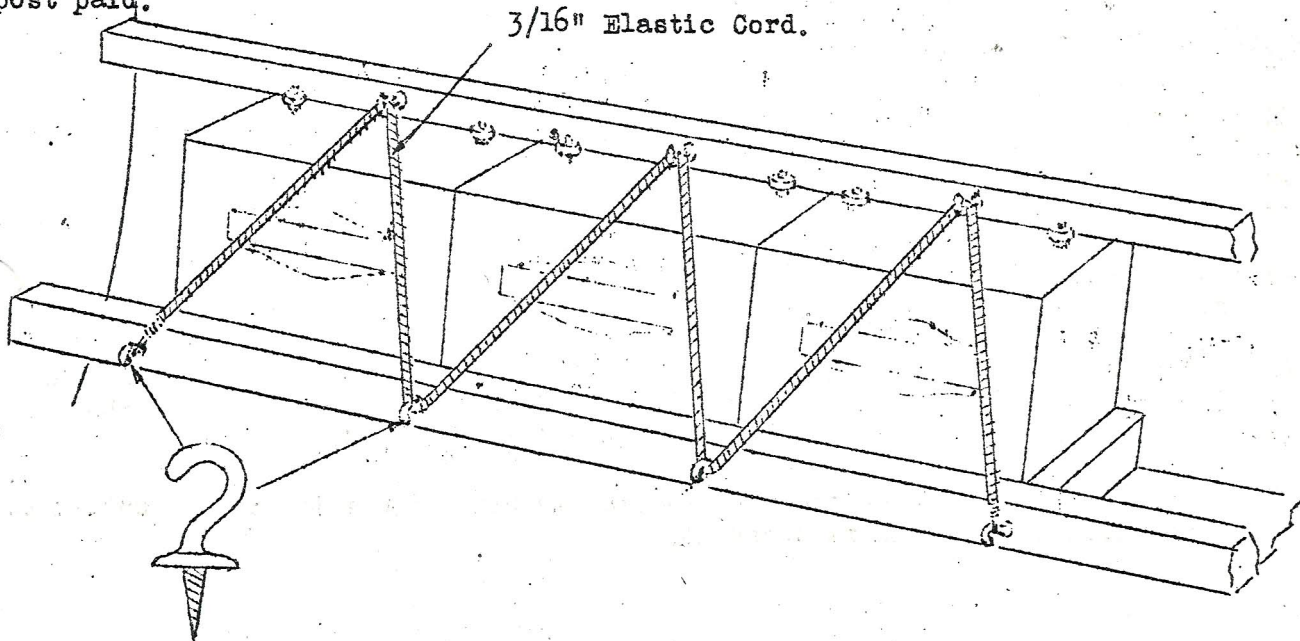
An instance has been reported where turn and slip batteries have come adrift from the mounting at the side of the fuselage during aerobatics. This matter is considered dangerous, as it could interfere with the movement of the aileron control.

The modification for retrospective action consists of fixing commercial screw hooks and fitting additional elastic cord as shown below.

3/16" Elastic Cord.
