Technical Instructions No 7

Skylark 2-Skylark 3-Prefect - Swallow

Elevator control connection Part No. 30B - 2 - 6

Tightening down of Wing Nut

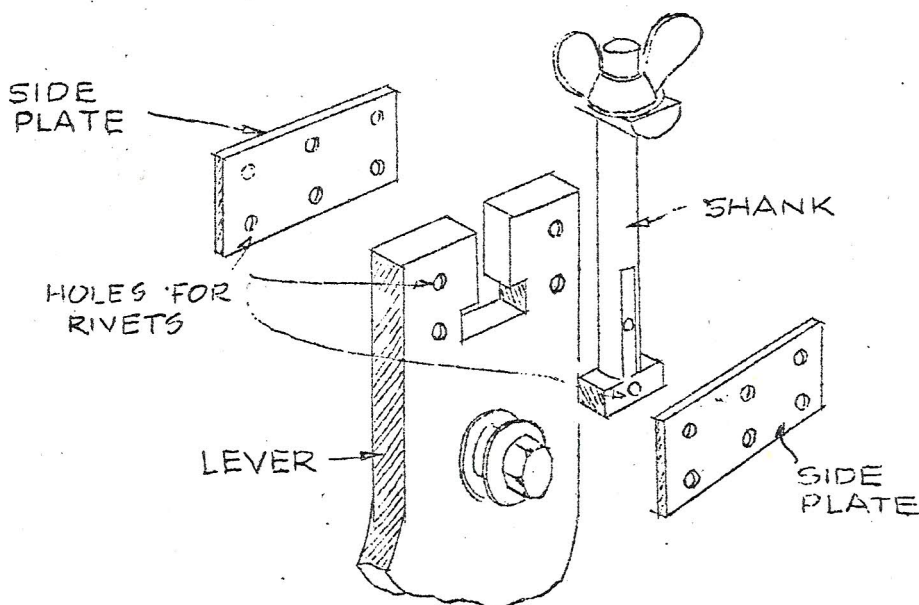
During the overhaul of a Skylark 2 for renewal of C. of A an inspector discovered that the threaded shank of the Elevator Control Connection Part No. 30B - 2 - 6 was loose and on closer examination found that the rivets holding the threaded shank in the dural lever by steel plates, were slack and in danger of being sheared off.

This can only be brought about by imposing a very high load on the wing nut such as using pliers, pincers or similar tools to turn the nut home.

The wing nut should only be turned down hand tight to provide a safe and satisfactory connection. It should then be locked by a small piece of locking wire through the holes provided. The thread in the nut of the shank should be kept free of grit or rust and well greased.

Will all owners of Skylarks and Prefects<sup>and Swallows</sup> make an early, and henceforth frequent, inspection of this connection. A sketch of the fitting showing the assembly of the shank to the lever is given herewith.
