SLINGSBY SAILPLANES LTD. Kirbymoorside, York, England. 24.11.61.

Technical Instruction No. 9

Skylark 2. Damage to Elevator Cables

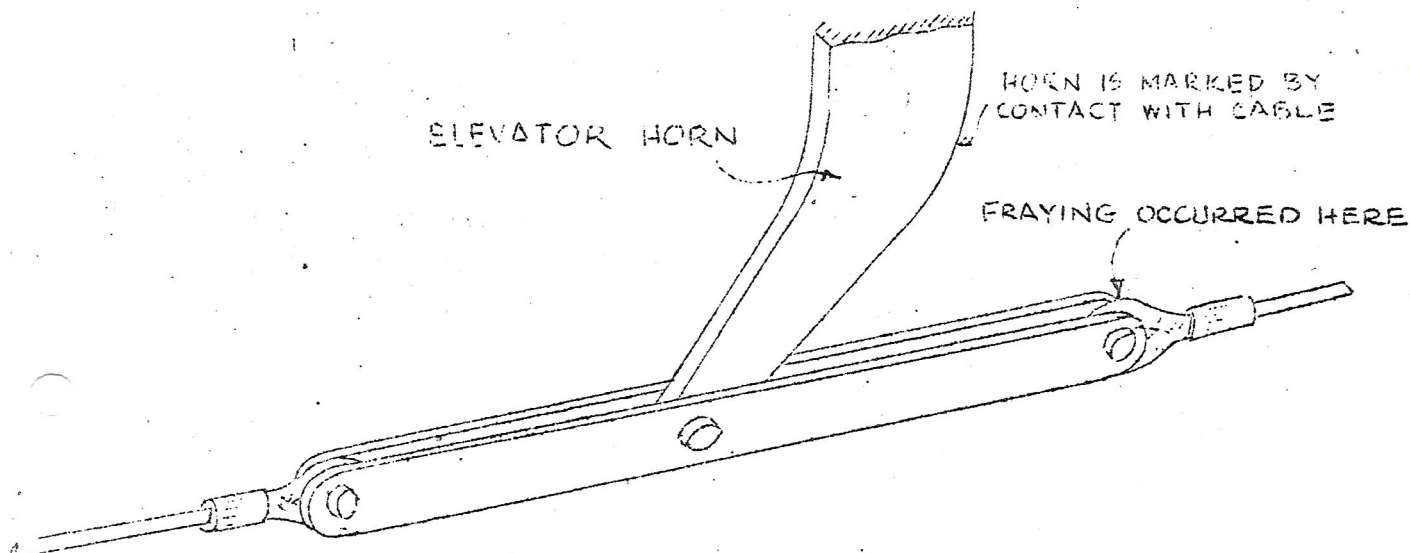
During the recent examination of a Skylark 2 elevator cable by an inspector fraying of the cable was discovered at the junction of the cable to the links attaching the elevator horn.

It was discovered that with the elevator in its fully down position, the elevator horn was in contact with the fraying part of the cable, thus inducing wear.

By adjusting the elevator stop on the control column to give the minimum down movement (i.e. 175mm) no abrasive contact between the elevator horn and the cable occurred.

(1) After rigging the tailplane examine the rear edge of the horn and the cable end through the hole in the rear fuselage decking.

With the elevator fully down check that the horn does not touch the cable end.

(2) If contact does occur, restrict the down movement of the elevator to 175mm

(3) Replace the cable if it is at all damaged. If it is not damaged no further action need be taken.
