TECHNICAL INSTRUCTION

| INSPECTION OF SKYLARK GLIDER AFT FIN SPARS AT LONGERON CUTOUTS | | 107/T50 |
| for and on behalf of SLINGSBY AVIATION LTD. Kirkbymoorside, York YO6 6EZ, England. Tel 0751 32474 Telex 57597 | | 23.6.87 |

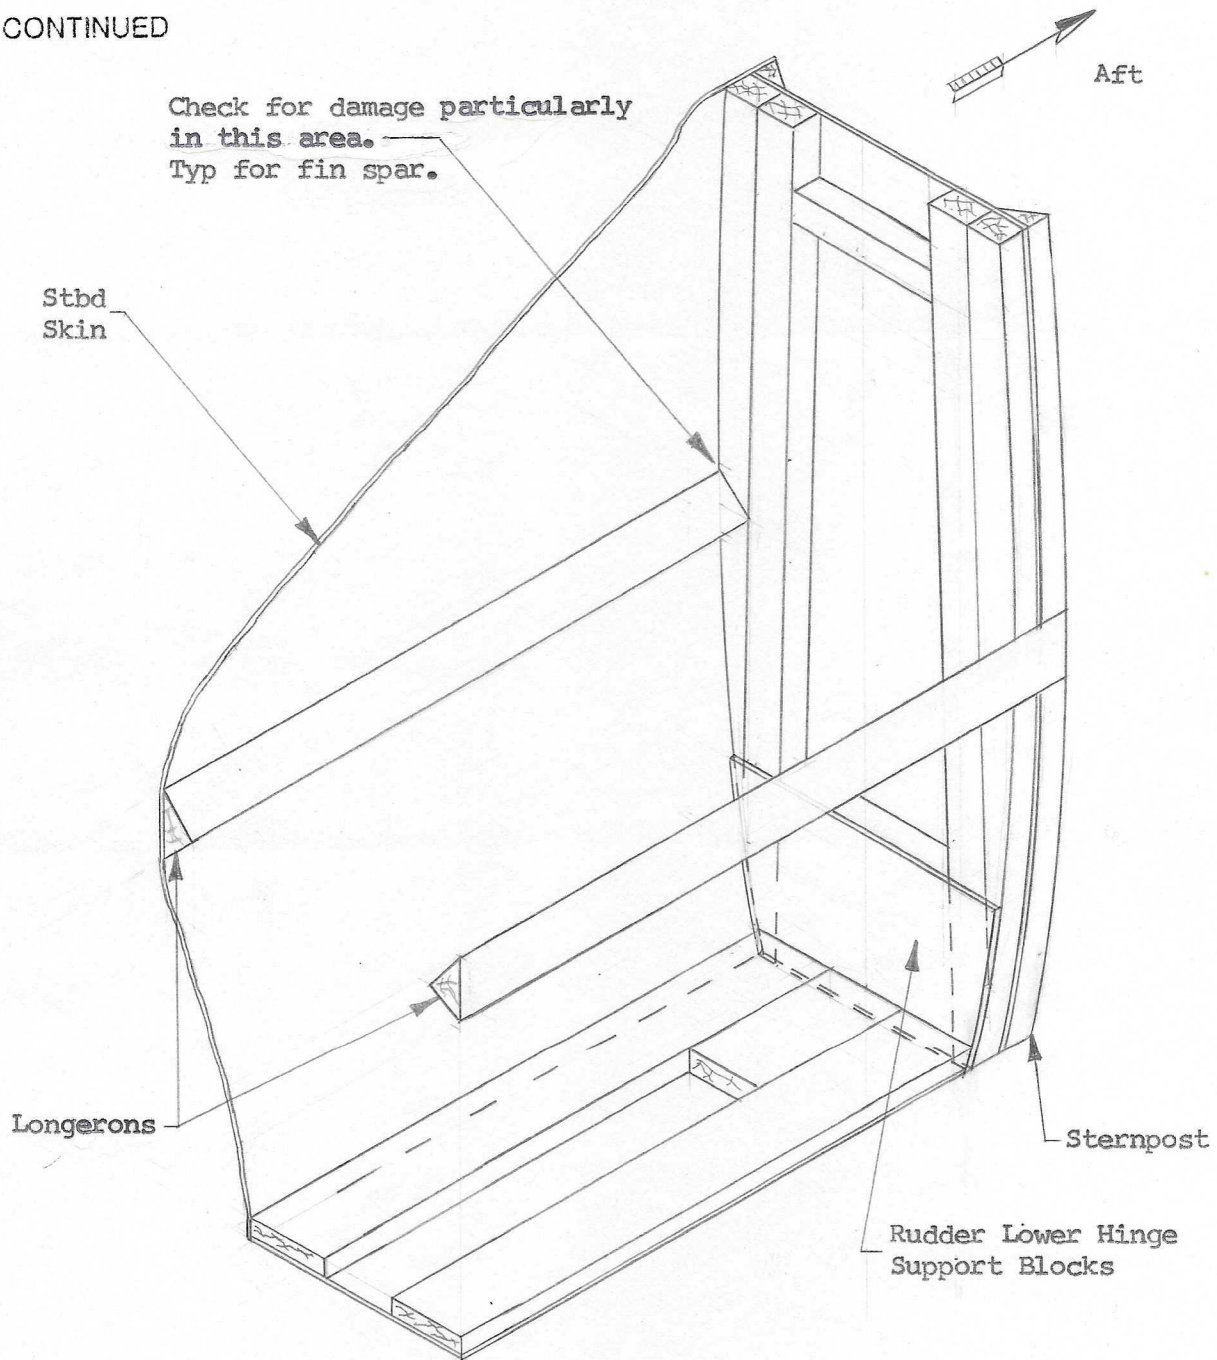
FIG. 1

| JUSTIFICATION | Following an accident to Skylark 4 Works No.1403 (BGA No. 1137) (BGA New Sheet TNS/5/6/87 (Item 1.6) refers) where during a winch launch the fin separated from the fuselage. On subsequent investigation it appeared that the sternpost had failed where the longerons are reset into the sternpost members. | |
| ACTION | <ol style="list-style-type: none">a) Gain access, see Fig. 1, Sheet 3, to the forward face of the base of the sternpost, to inspect for damage generally and specifically where the longerons pass through the fin spars. See Note 1. | |

- Note 1) If there are any indications of structural damage or excessive fin movements the aircraft must be grounded until repair is carried out.
- 2) If rudder is contacting fin and or rudder stops suspect aircraft must be grounded until rectification action is carried out.

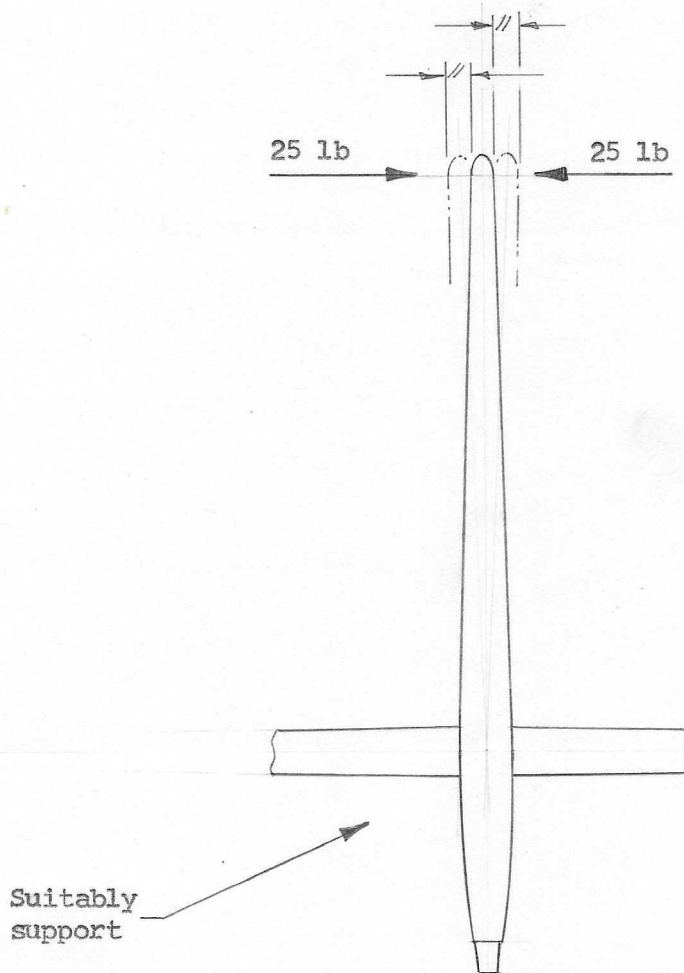
FIG. 2

- b) Apply an equal transverse load (approx. 25 lbs) ref. Fig.2 Sheet 4, alternatively in both directions to the top of the fin and check for equal movement each side. Also check for movement or noises in the affected areas, particularly on fin spar longeron connection. See Note 1.
- c) Inspect the sternpost in the area of the lower rudder hinge, for signs of plywood separation, compression shakes, de-bonding or damage inflicted by overtravel of the rudder. See Note 1.
- d) Check that the rudder cable stops limit the travel of the rudder at full deflection, port and stbd see relevant manuals for correct movement, and not the rudder contacting the fin post thus transferring loads into the fuselage. In particular inspect for signs of contact between lower rudder hinge mounting block on fin post and rudder leading edge.
