Slingsby Sailplanes Ltd., Kirbymoorside, York, England.

Technical Instruction No. 12 - Introduction of Mod 96

Introduction of Modified Shoulder Harness Attachment

Skylark 2B, 3B, F and G. aircraft fitted with the following modifications

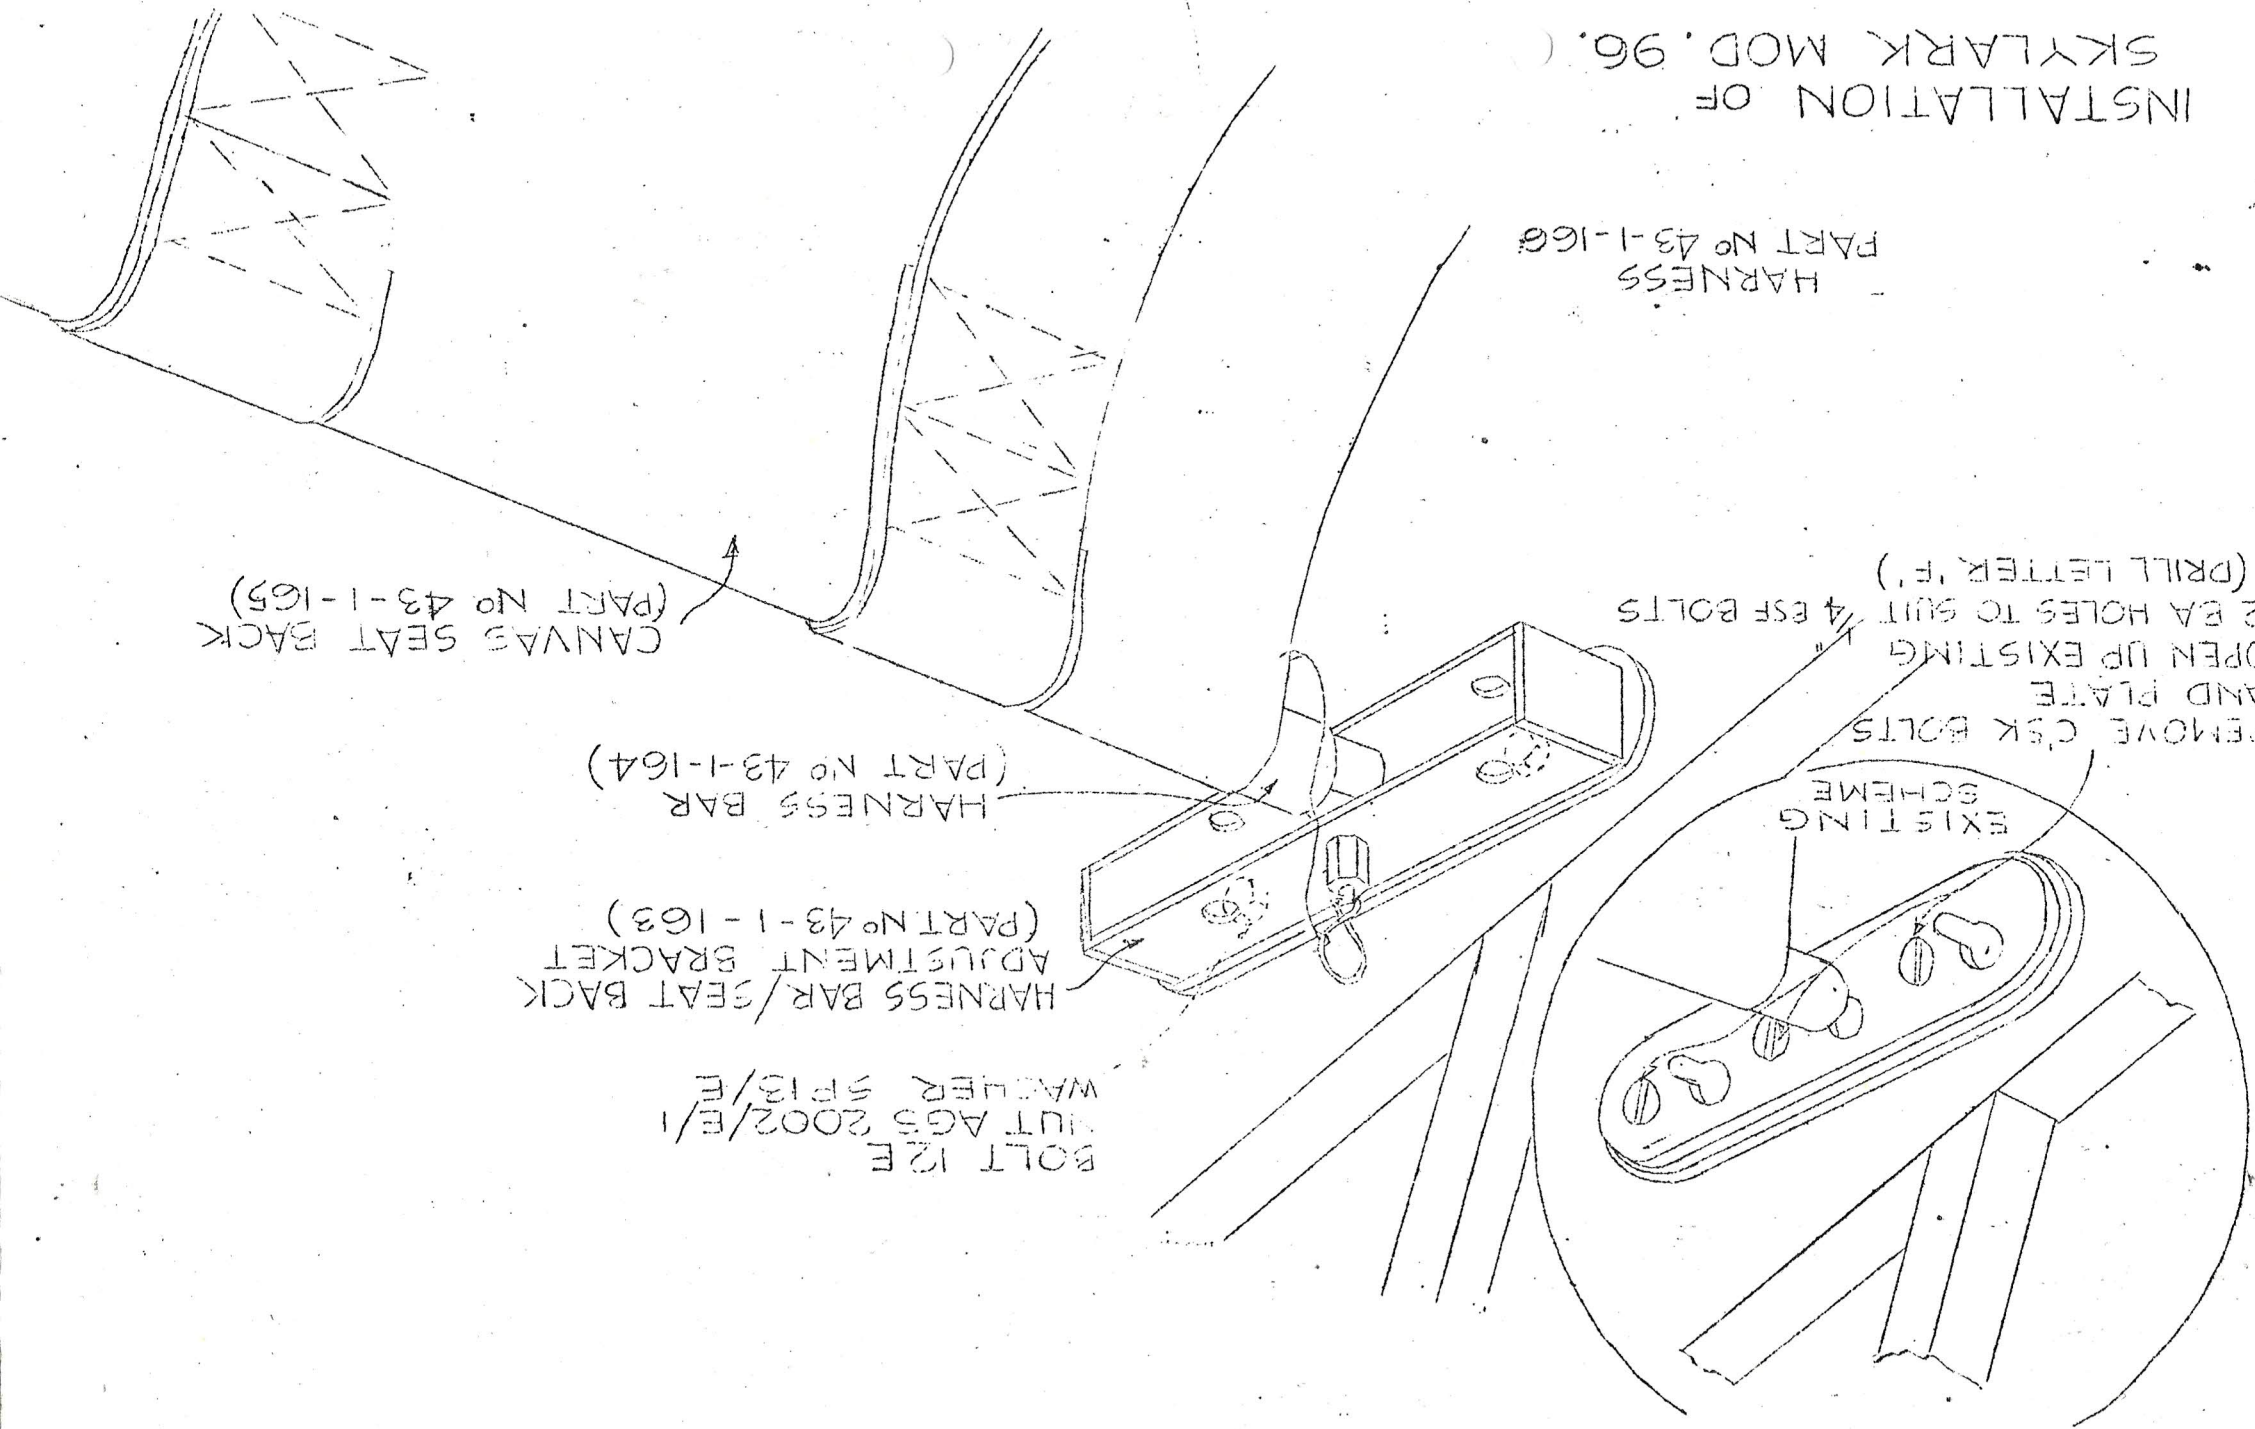
# INSTALLATION OF SKYLARK MOD. 96.

This modification is introduced to improve the attachment of the shoulder harness so as to provide extra support for the pilot against vertical movement.

REMOVE CSK BOLTS  
AND PLATE  
OPEN UP EXISTING  
2 BA HOLES TO SUIT  
4 CSF BOLTS  
(DRILL LETTER 'F')

1. Remove the existing shoulder harness, and return to Slingsby Sailplanes Ltd., for modification.
2. Remove existing canvas seat back from the seat and the shoulder support tube.

3. Remove the shoulder bar position adjustment plates from the side of the fuselage. The screws attaching these are counter-sunk into the plates and the heads are accessible. It will be necessary to scrape off the external finish of the aircraft to gain access to the nuts.

4. Drill out the existing 2 B.A. holes to suit a 1/4" B.S.F. bolts (use a letter 'F' drill) and bolt in position the new combined harness and shoulder bar attachment bracket ref: 43-1-163 using 12E bolts and AGS 2002/E/1 nuts.

5. Check the distance between the harness bar attachment holes, this should be 474 mm the harness bar should be easily positioned between the two brackets using the 'Pip' pins attached to the canvas seat back. The distance between the pin centres should be adjusted by the addition or removal of packings to give the correct dimensions.

6. Attach the new seat back ref: 43-1-165 to the seat using the attachment plate and screws removed from the obsolete seat back.
7. Slide the harness bar ref: 43-1-164 into the slot at the top of the canvas seat back and position the modified shoulder harness as shown in the sketch. This completes the embodiment of the modification.
