Technical Instruction No. 8

Skylark III

Wear on 2 B.A. bolts attaching aileron cables at wing joint

Mod. 95 - Rudder Cable Fairing on Rear Fuselage

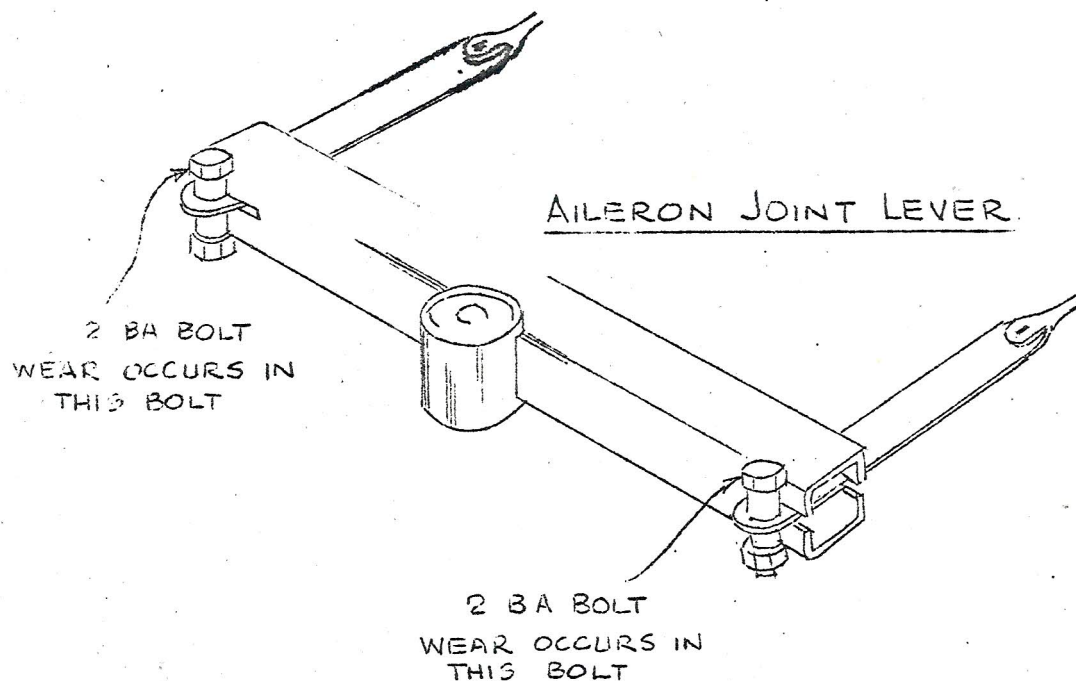
It has been discovered during C. of A. overall inspection that the 2 B.A. bolts connecting the aileron cable to the aileron joint lever are liable to rapid wear.

Inspectors should therefore be particular to check this point and to renew if wear has taken place.

The rate of wear can be considerably reduced if the connection is lubricated regularly.

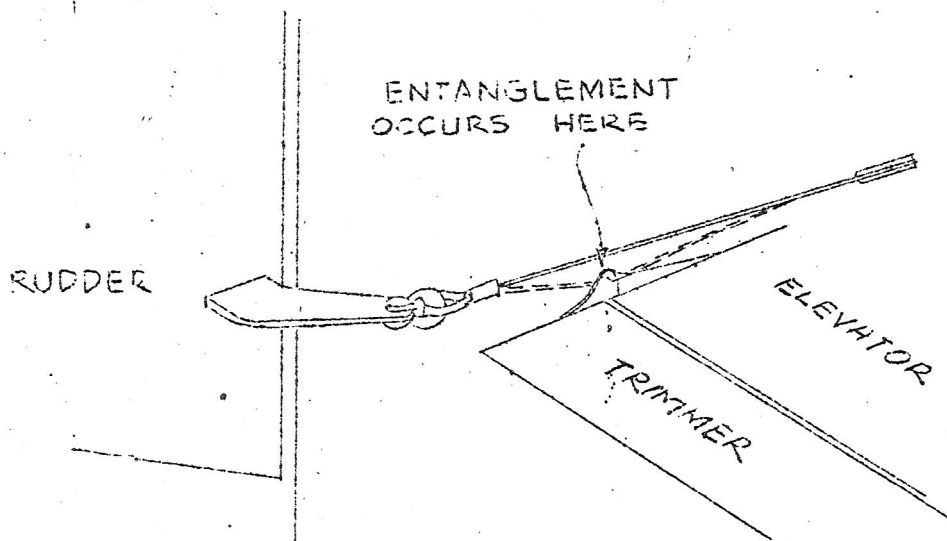
With the rudder pedals adjusted fully forward a certain amount of slack becomes apparent in the rudder cables.

In the case of Skylark 3B aircraft this may be sufficient to allow entanglement of the St'b'd. cable with the trimmer horn on the elevator.

If this occurred a highly dangerous state would result.

(1) Take the fairing Ref: 43-1-162 and place over the st'b'd rudder cable at the rear end of the fuselage, with the rudder central.

The wide end of the fairing should be to the rear and flush with the rear edge of the fin.

(2) Adjust the height of the fairing so that it is positioned equally about the line taken by the rudder cable.

(3) Check that the cable clears the fairing in all positions of the rudder by moving the rudder fully port and stbd.

(4) With the above instructions satisfied now drill 8 - 4 B.A. attachment holes through the fuselage side to suit the holes in the fairing Ref: 43-1-162.

(5) Attach the fairing with the bolts, nuts and washers supplied.
(Access to inside of fuselage skin is found by removing the perspex inspection window just above position of fairing)
