Slingsby Sailplanes Ltd., Kirbymoorside York.

Technical Instruction No. 15.

Swallow Inspection - To avert the Possibility of the Port Rudder Pedal Fouling the Quick Release pulley bracket.

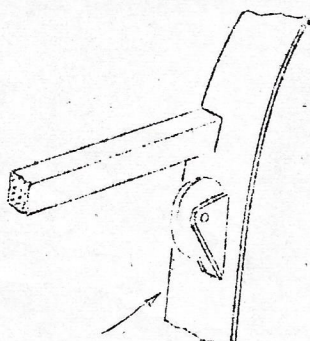
- (1) Examine the pulley on the rear face of frame 1 (mod 4) situated just below the longeron. Ascertain that it is mounted the right way up from the drawing below.

CORRECTLY ASSEMBLED

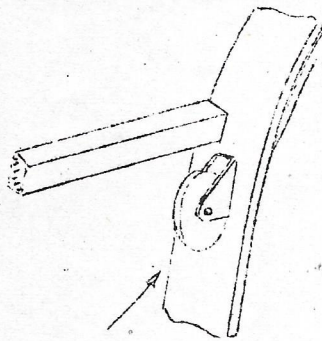
An incident recently occurred involving the jamming of the rudder control due to the pedal links fouling the bolt on the quick release pulley bracket.

This inspection is introduced because it is thought that the trouble was caused by incorrect assembly of either the pulley bracket or the rear face of frame 1, or the rudder pedals.

INCORRECTLY ASSEMBLED

- (3) If either of the above are incorrectly assembled then reassemble correctly.

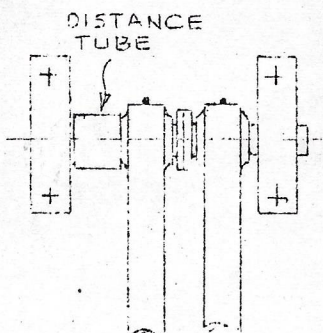
Examine the pedals and ensure that they are assembled on the pedal shaft as shown below.

CORRECTLY ASSEMBLED

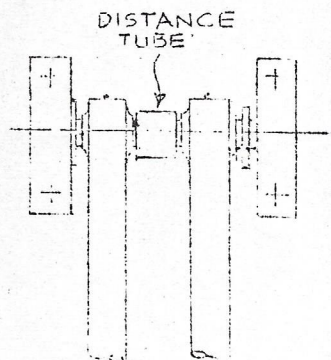
INCORRECTLY ASSEMBLED
