SLINGSBY AIRCRAFT COMPANY LTD., KIRKBYMOORSIDE, YORKSHIRE,  
ENGLAND.

Technical Instruction No. 33

T. 45 SWALLOW

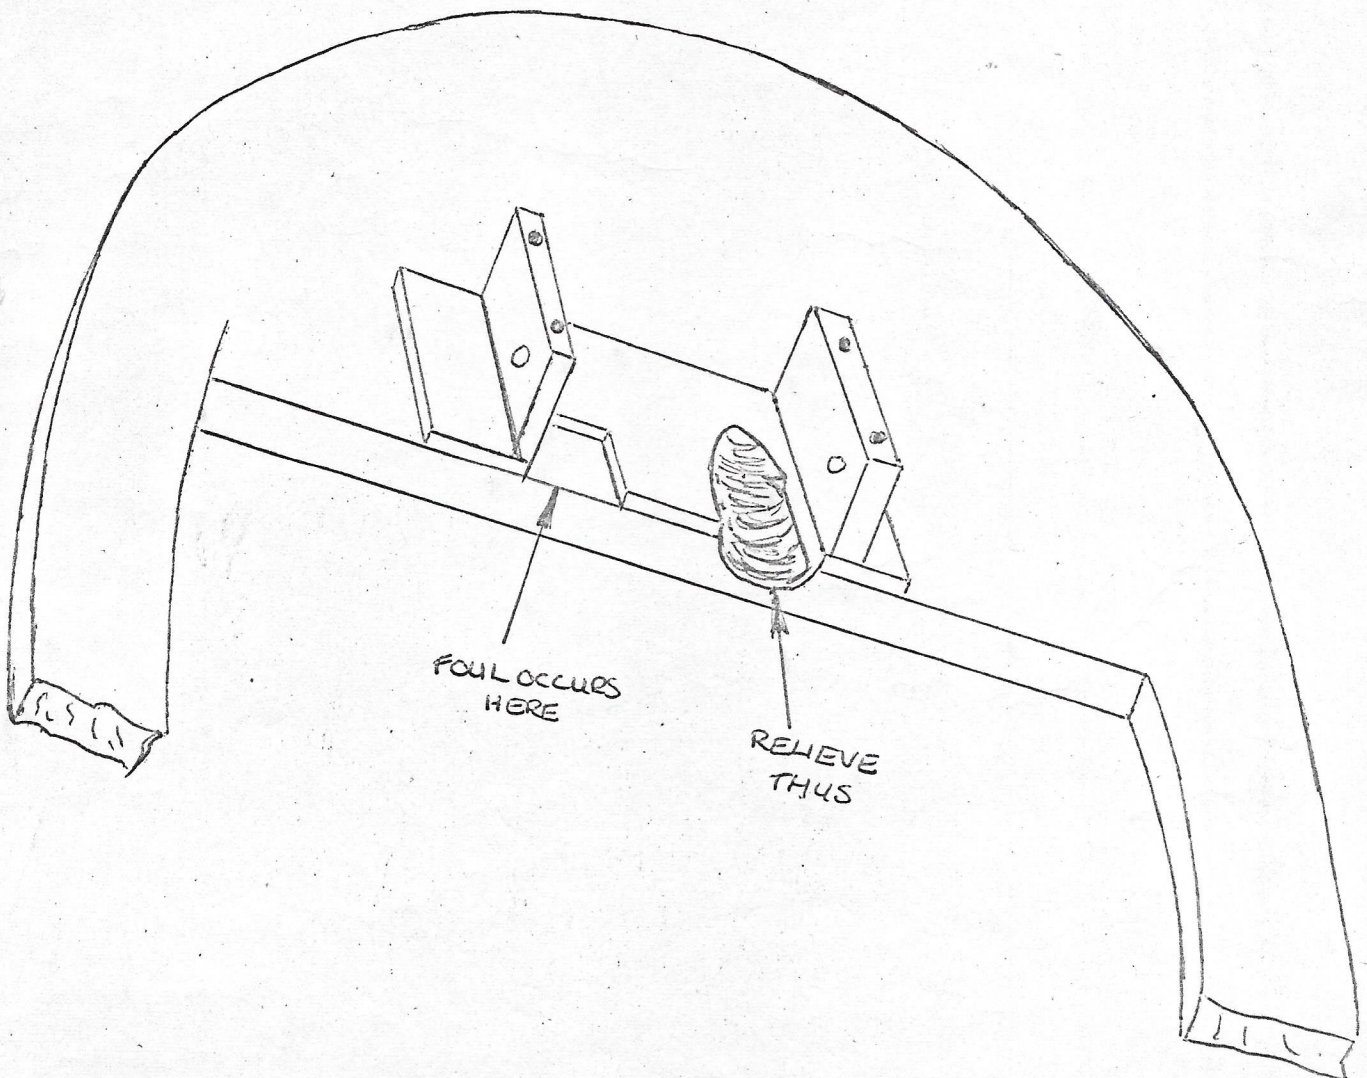
It has been found that with the rudder pedals in the fully forward position that it is not possible to achieve full rudder deflection because the vertical members of the pedals foul the rear face of Frame 1 as indicated on the sketch below.

- (1) Remove one splitpin from end of pedal spindle and withdraw spindle.
- (2) Relieve Frame as shown until full rudder deflection can be obtained.
- (3) Apply protective treatment to bare wood.
- (4) Refit rudder pedals etc. using a new splitpin.
