## CAA and EASA Airworthiness Directives (ADs) all owners notified.

## Safety Information

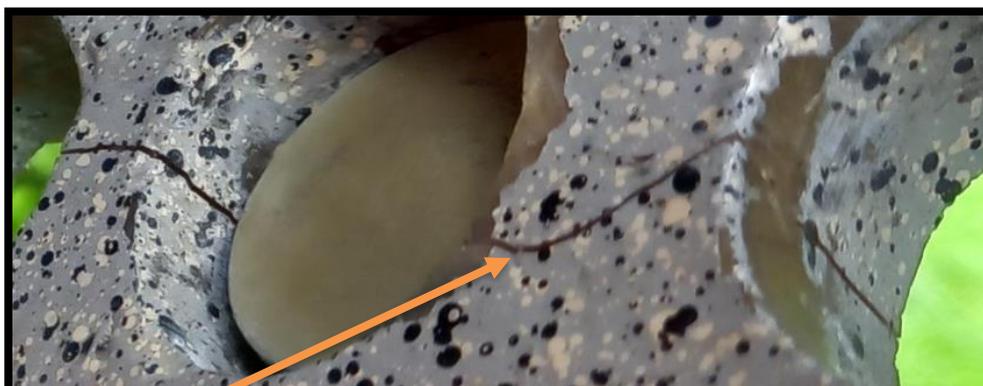
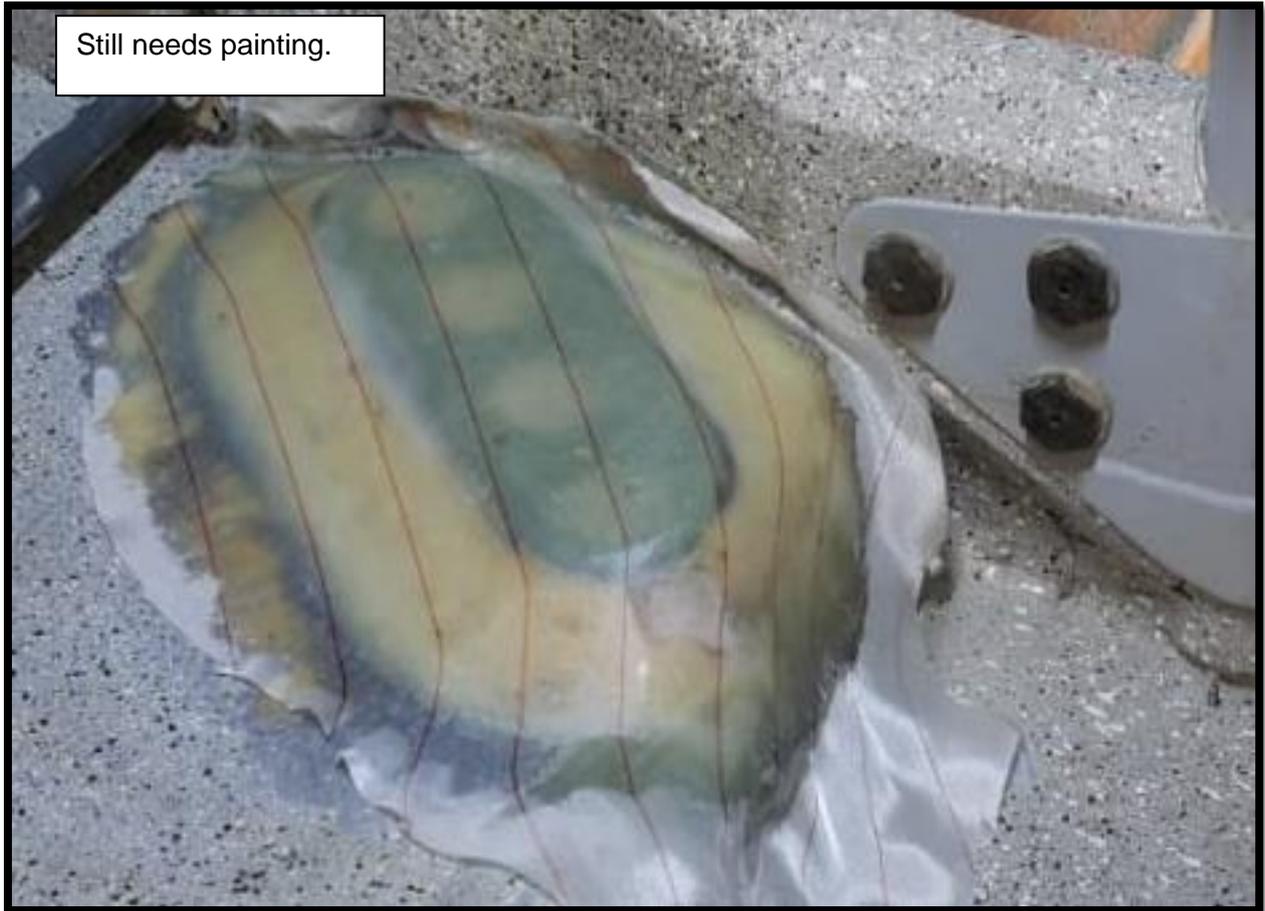
**8 Allstar SZD 50 Puchacz rear seatback support cracks This will become an EASA AD Mandatory**

All owners were notified of this and the repair scheme. We found many broken seat-back supports (port side of fuselage). Do not make your own repair scheme. Allstar are working on an AD and have supplied a repair scheme

These cracks open up when the metal bar is inserted and lightly flexed.

that should comply with the AD when published. Contact me for the official repair scheme if required. The repair should look something like the image below.

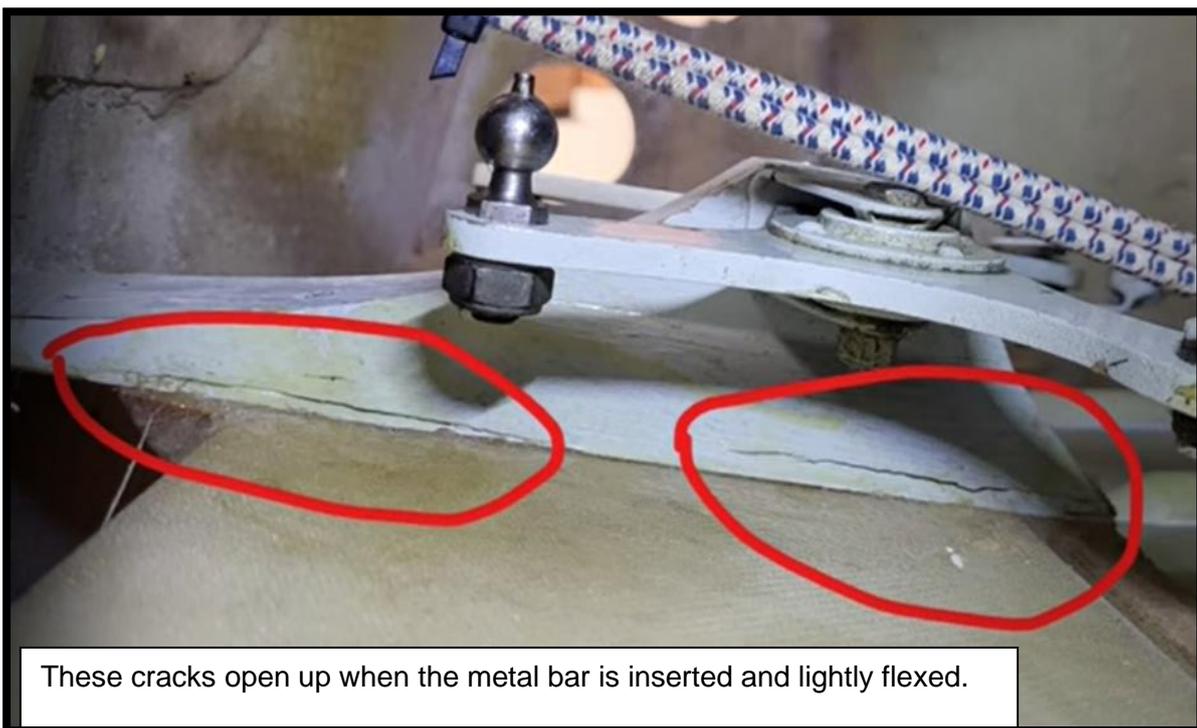
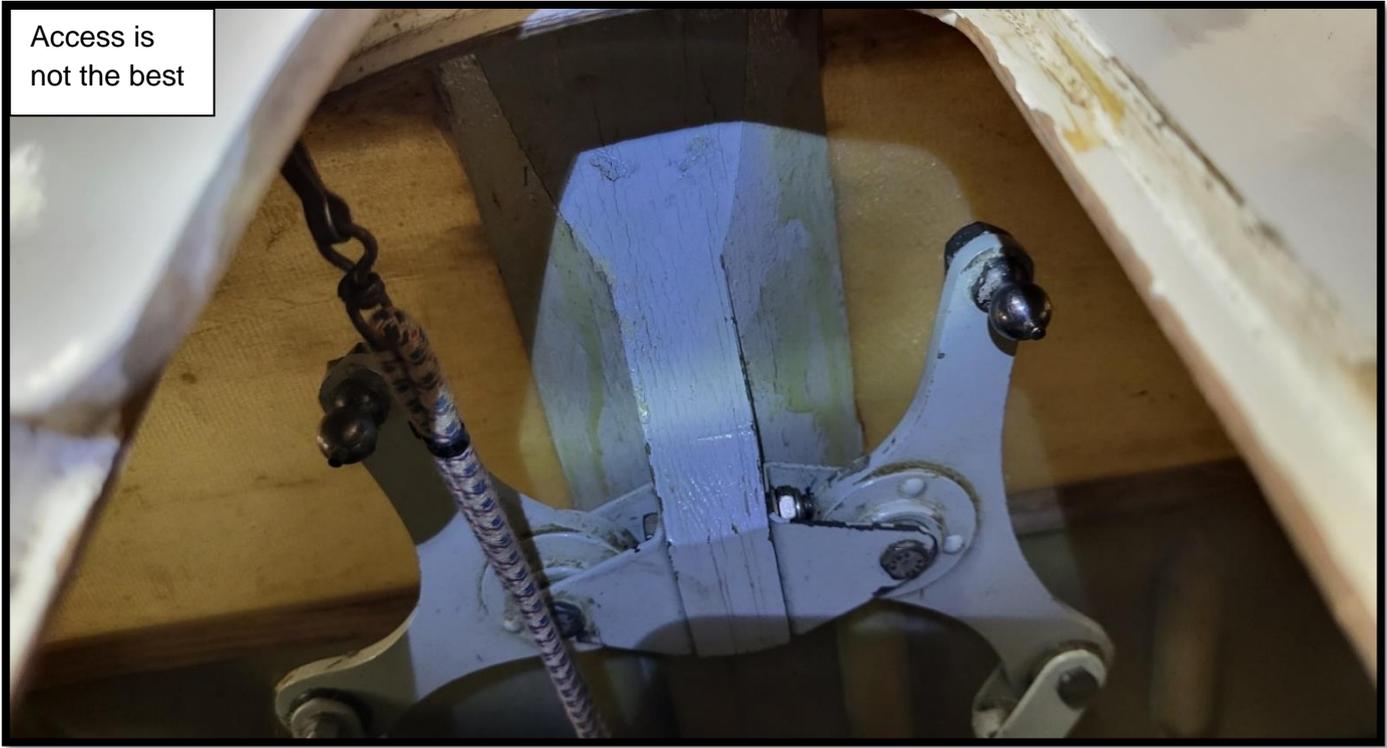
9 ASW15 airbrake wooden support bracket in the fuselage

The video and images show the problem. We have had 2 reports of a loose or broken wooden block. Access to repair

it properly is not great! Please report any problems to the BGA so we can monitor this possible trend.

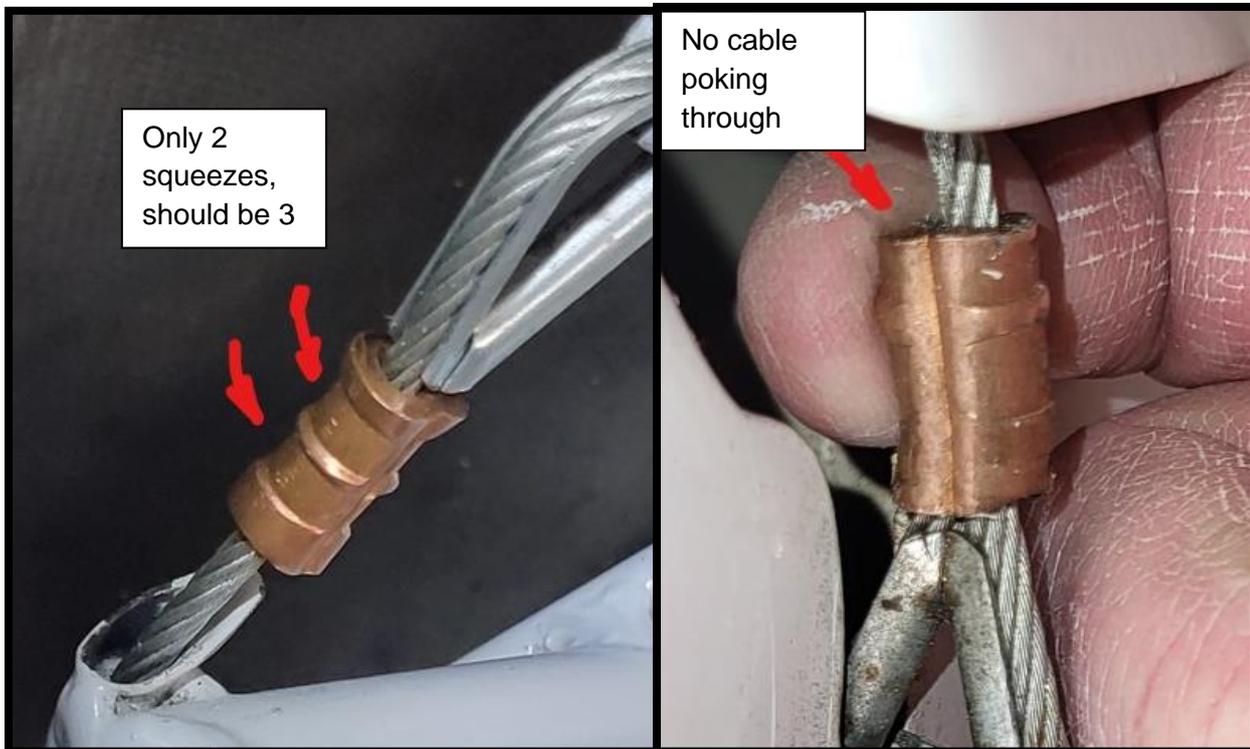
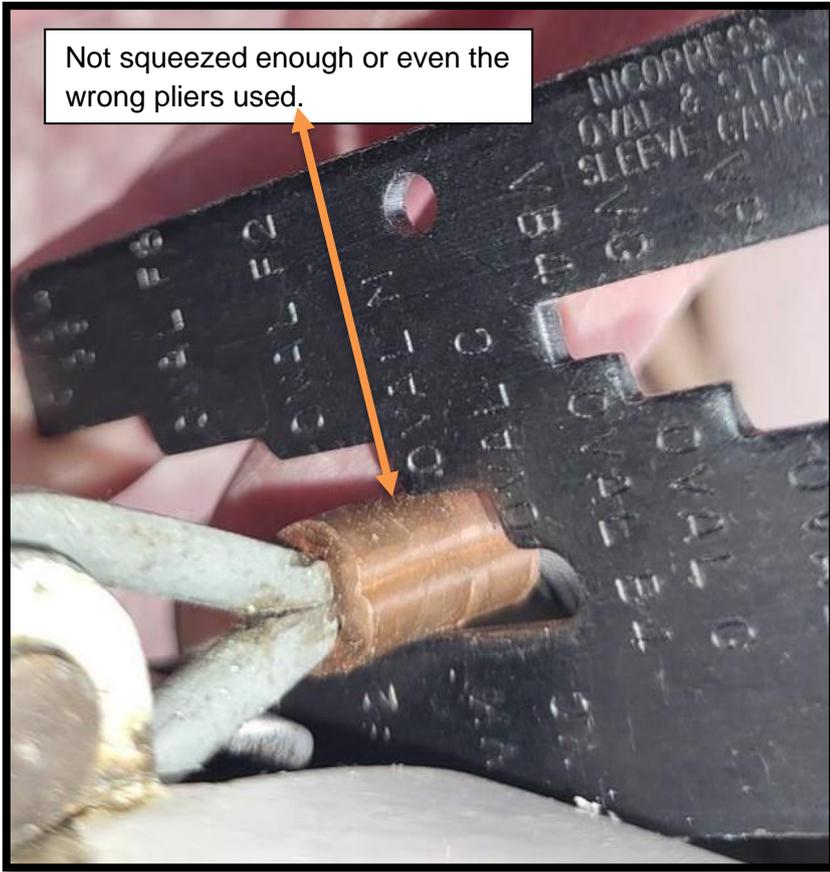
10 Nico press cables swages not fitted in accordance with the AD

We are still finding poor quality swages that should be replaced. All of these cables should have been replaced.

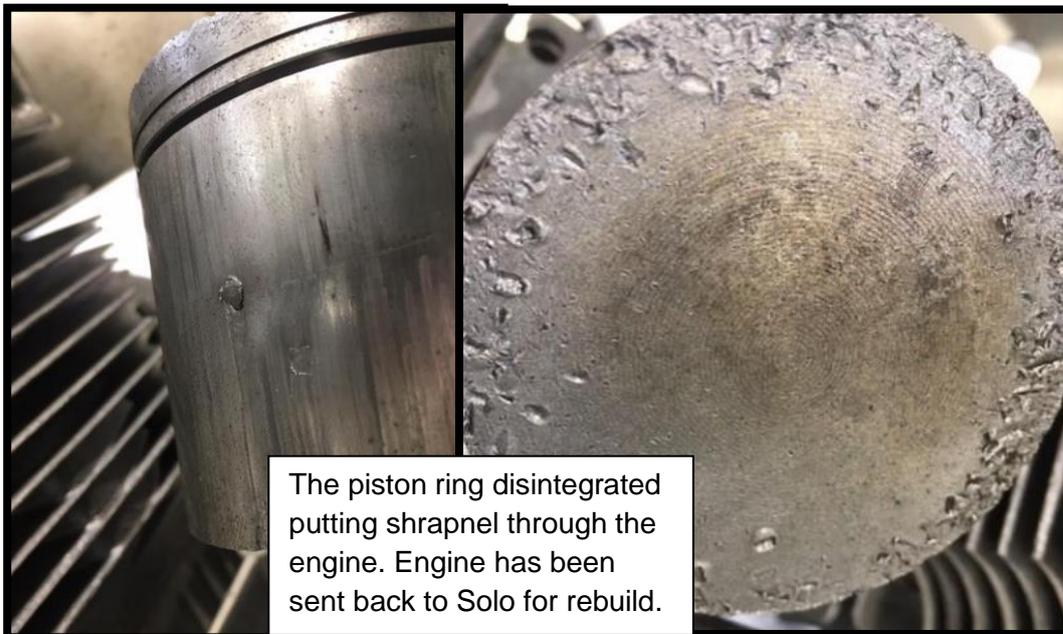
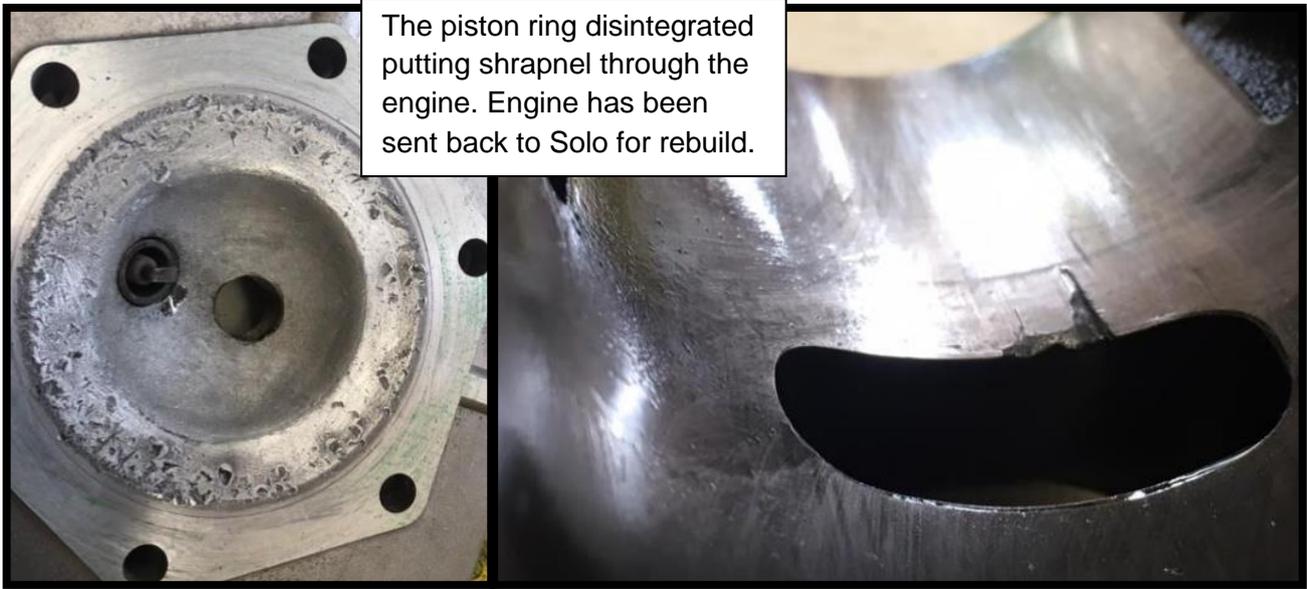
**11 Solo 2350D 2 stroke engine failure (Applies to all 2 stroke engines)**

Generically 2 stroke engines are not as reliable as 4 strokes. In this case a 2-stroke solo 2350D engine progressively failed over 1 minute. It started at 6000 rpm and eventually slowed down to 4000rpm, where it was shut down. It has all been maintained as per the manual and had a total of 22 hours. It was 14 years old and had had 187 cycles.

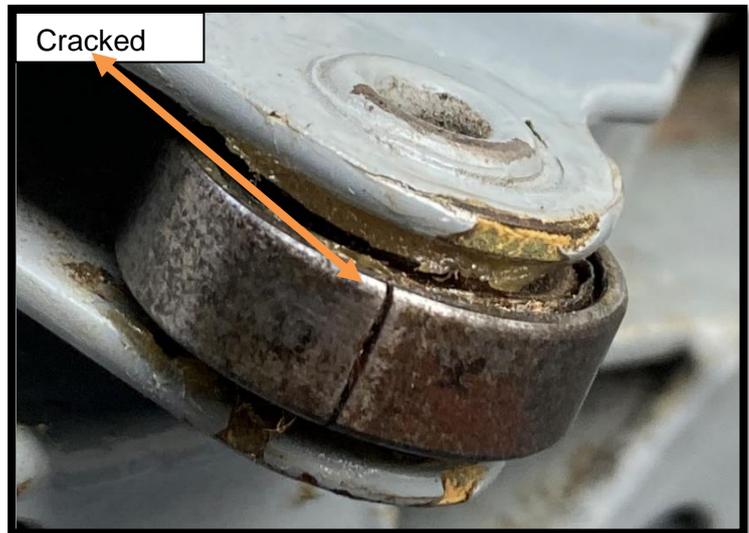
**12 ASH26 airbrake fuselage bell crank (But also applies to many other types)**

This has been seen on many bearings of many aircraft. Please check them **every** annual – particularly the elevator bearings.

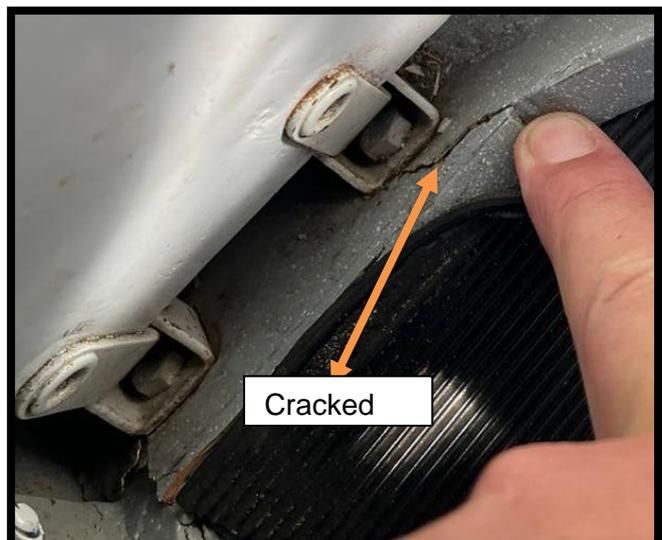
**13 Glue failure of K6 rudder pedal mount**

It would be very easy to miss this during the annual inspection/glue inspection.

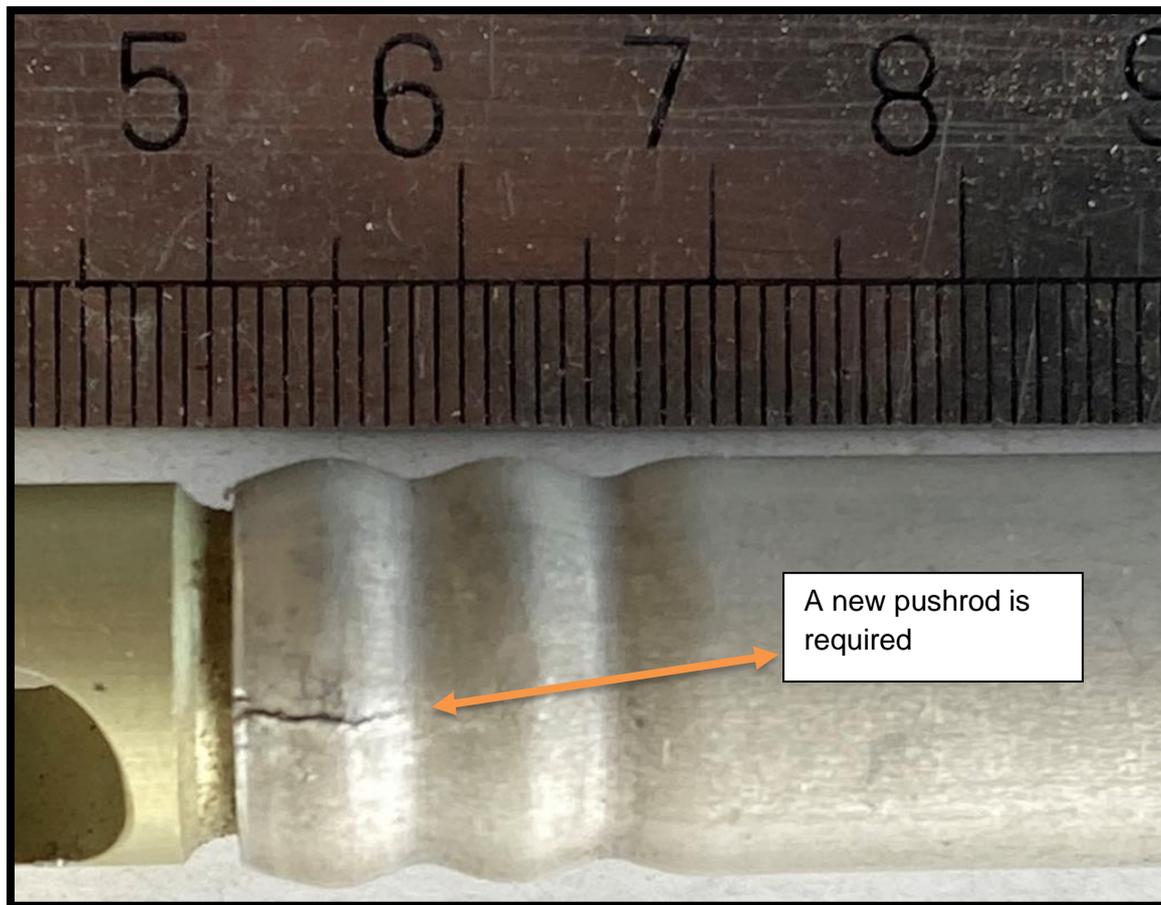
**14 Junior airbrake pushrod end**

Have a careful look at the next annual. It would be very easy to miss this.

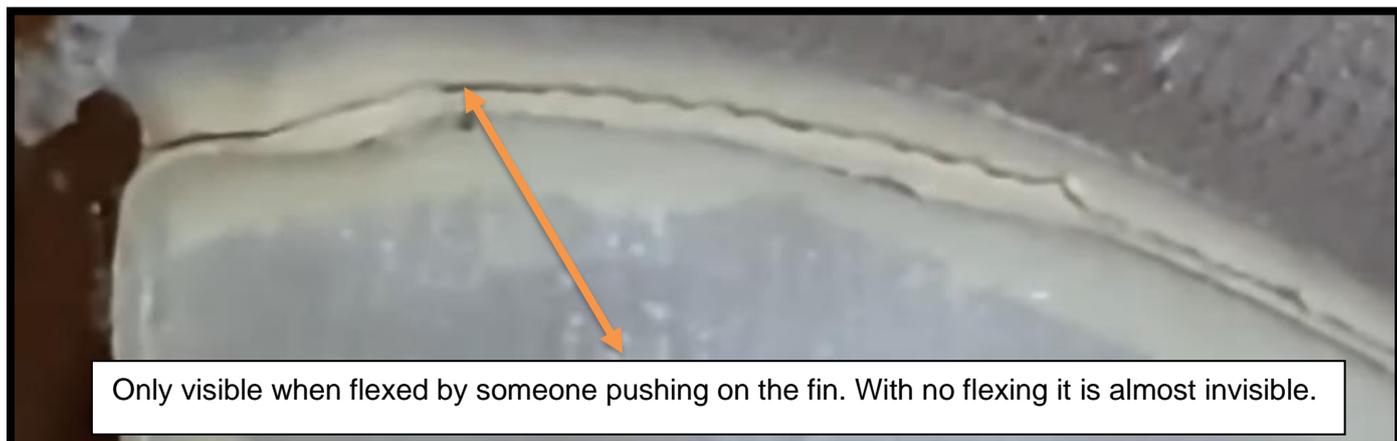
**15 Junior unbonded frame**

Watch the video. Found on an annual inspection. This is unreported accident damage.

This damage would be very easy to miss on an annual or post incident inspection. This is quite a big repair as holes were required to be cut for access to the broken frame as well as to check the entire fuselage structure. Judging by how much dirt and dust was found under the frames, this was old damage.

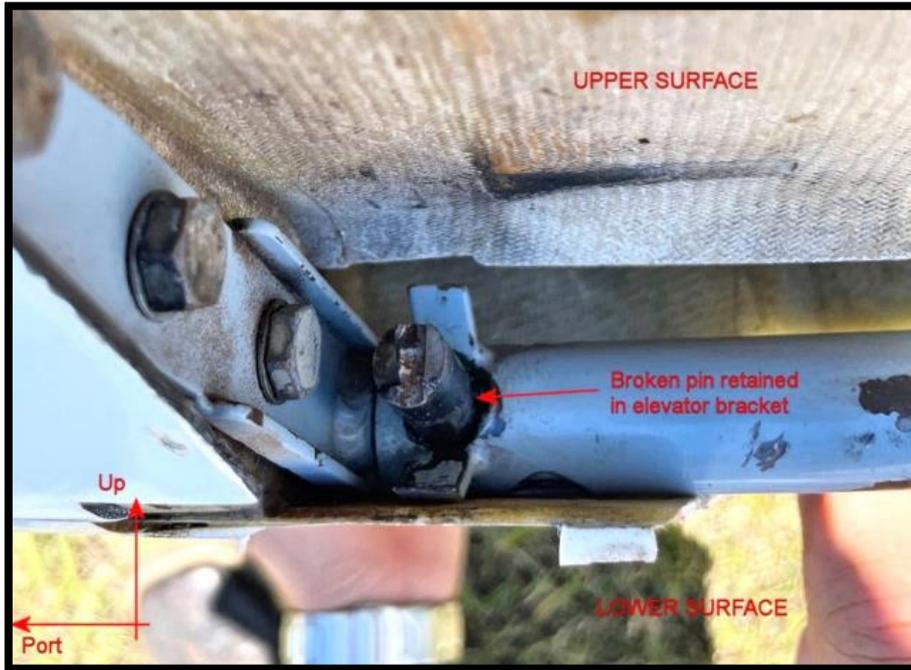
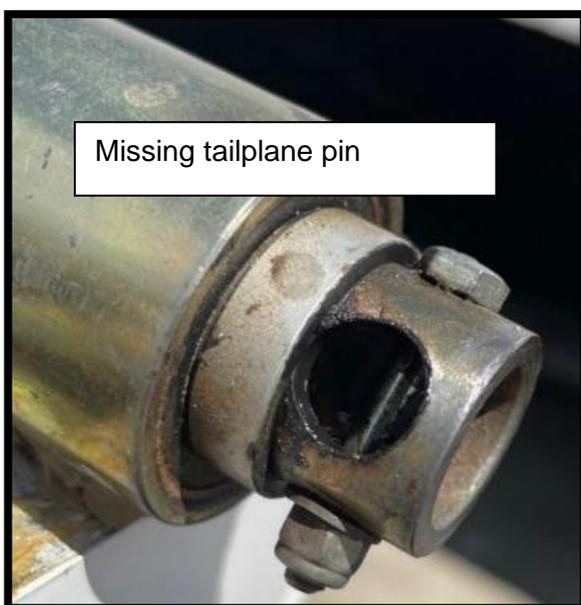
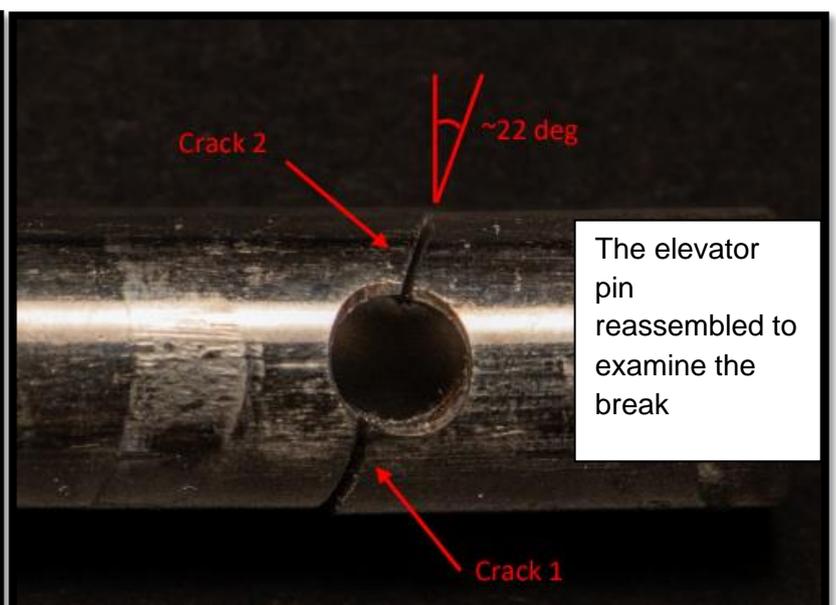
## 16 Duo Discus tailplane pin failure

During the Daily Inspection, the pilot noted that the tailplane had an amount of free play but considered it to be within acceptable limits. During the pre-flight walk around the pilot noted that the tailplane free play had increased. The tailplane was removed and the port elevator mounting pin was found to be broken. The pin had cracked through the retaining bolt where the pin is mounted in the fin torque tube. The broken pin was retained in the elevator bracket, whilst the aft stub of the pin was retained in the fin torque tube.

The conclusion was that no play is ever allowed between the tailplane pin and the tailplane fitting it's bolted to.

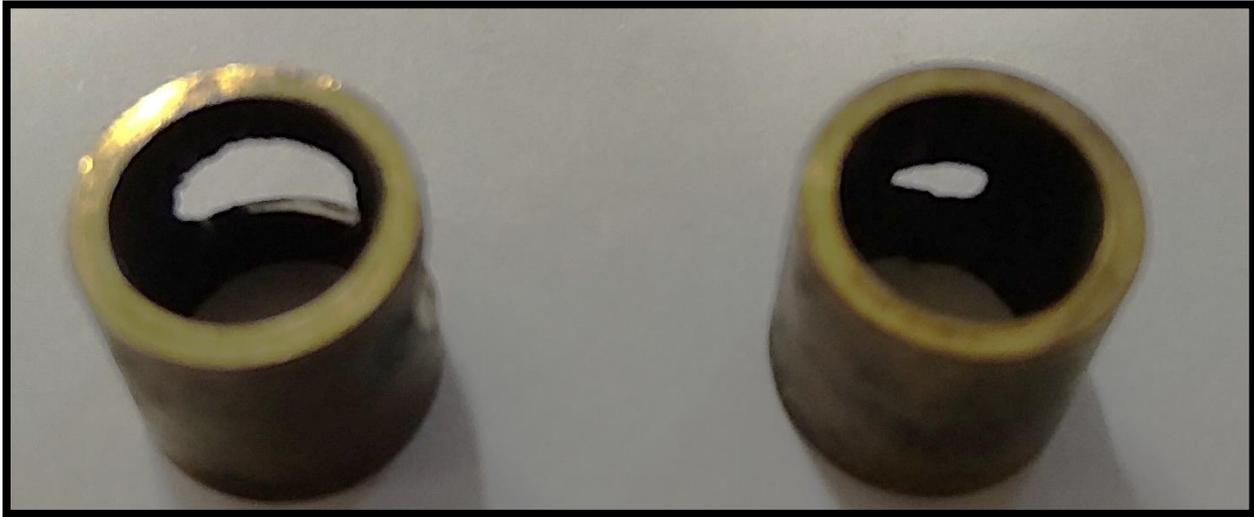
**17 K21 Rudder hinge cable bushes very worn (applies to many other types)**

These bushes with holes worn through them had done 2300 hours from new. The rudder needs to be removed more often than that to inspect bushes, stern post, hinges and various other parts.
