**Airworthiness  
Directive  
1993-001/3**

**L`Hotellier ball and socket connectors**

L`Hotellier ball and socket connectors with lock plates if installed in sailplanes, powered sailplanes and aeroplanes

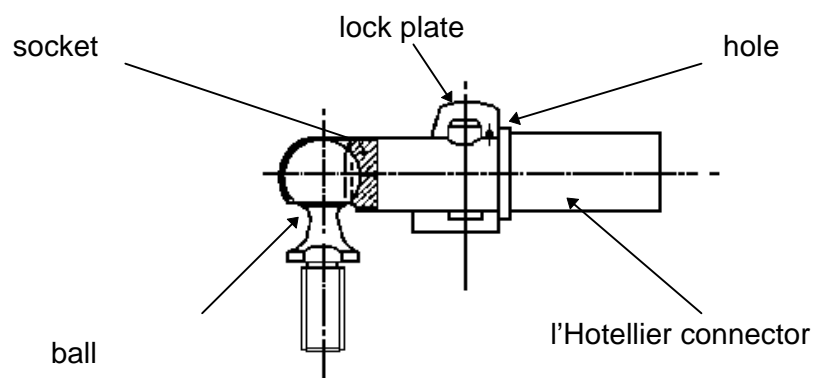
### Section I

If the connectors are not yet equipped with safety pins (e.g. l'H 140-31 made by Hotellier), these safety pins have to be retrofitted. In certain cases it may become necessary to rebores the hole in the lock plate, which is provided for visual inspection, to  $\varnothing 1.2$  mm so that the safety pin can be inserted.

Warning!

Unsecured ball and socket connectors may open automatically in flight!

1. Safety pins (e.g. L`H 140-31 made by Hotellier), have to be retrofitted, if not yet installed. In certain cases, it may become necessary to rebores the hole in the lock plate, which is provided for visual inspection, to  $\varnothing$  1.2 mm so that the safety pin can be inserted (see attachment section I).

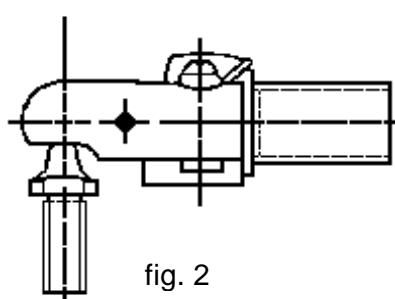
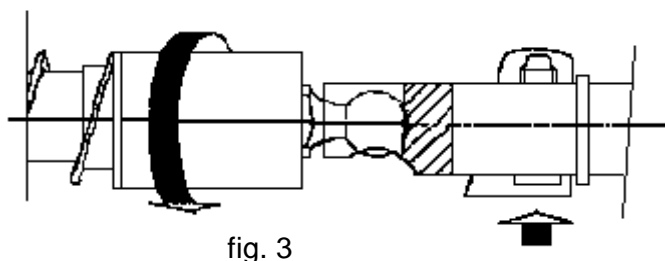
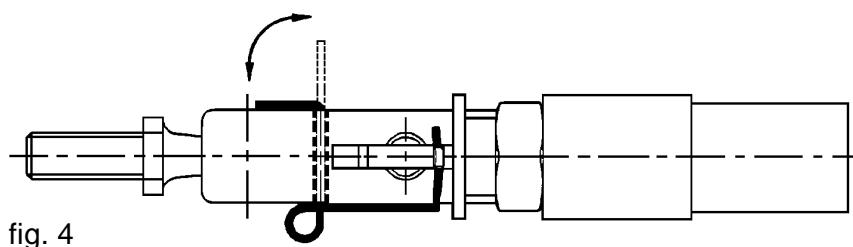
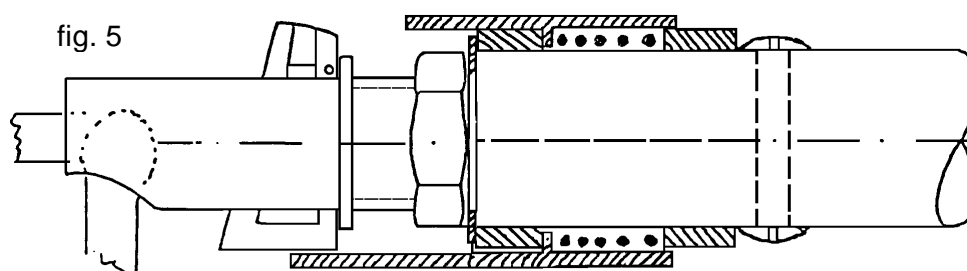
#### LBA-approved locking systems

The following systems to secure L'Hotellier ball and socket connectors are LBA-approved: Uerlings sleeves or Uerlings type sleeves (see section III), safety pin (figures 2 and 2a), LS-safety sleeve (figure 3), Schempp-Hirth spring (figure 4) and Wedekind locking system (figure 5).

The use of a safety pin can be waived if the L`Hotellier ball and socket connector is already equipped with an approved locking system (e.g. Uerlings type sleeve, LS locking sleeve, Schempp-Hirth spring or Wedekind locking system) or if such a system is to be installed.

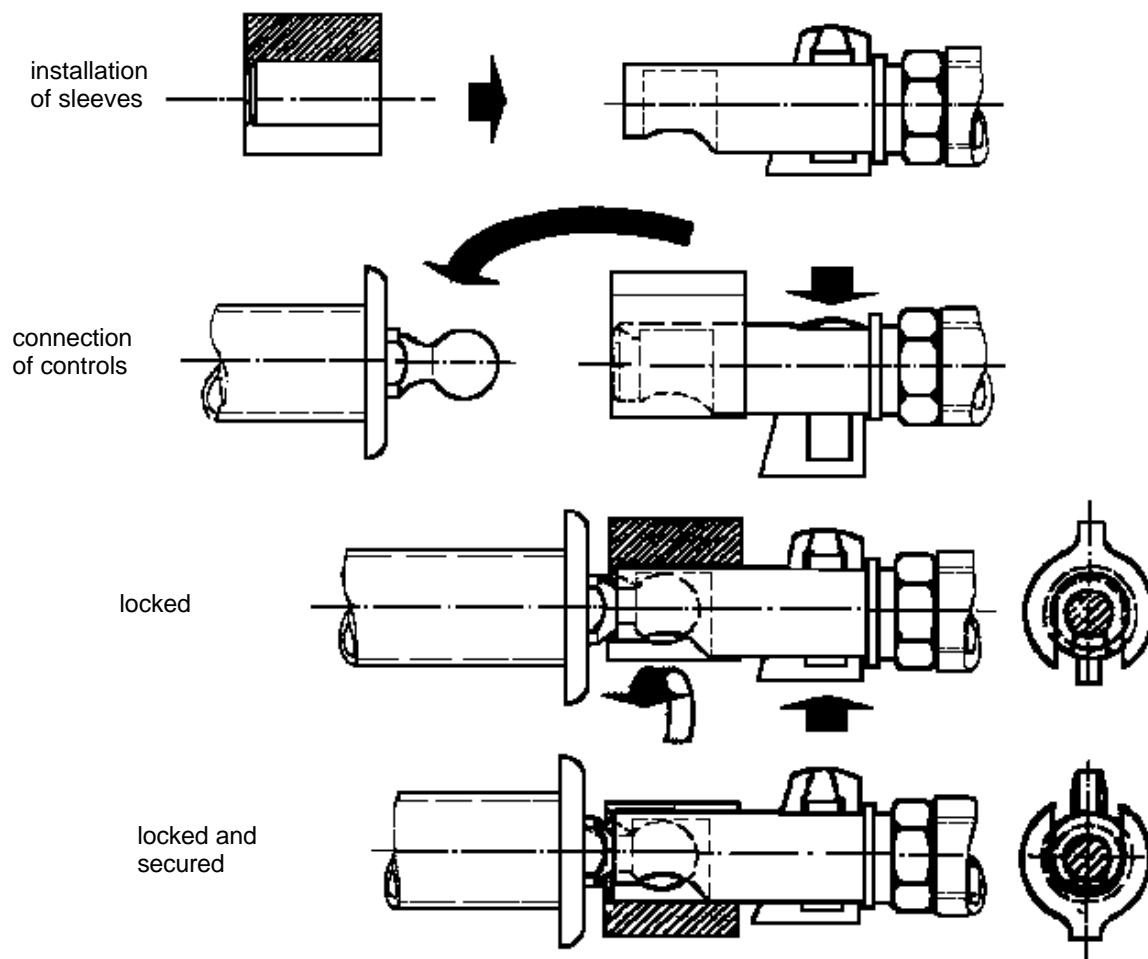
**Installation instruction for Uerlings type sleeves**

They may by no means be clipped radially onto the l'Hotellier ball and socket connector. Radial clipping (excessive opening of the sleeve) may lead to cracks or ruptures due to overstressing so that the sleeve cannot function properly any more.

Inspection of these sleeves for the absence of cracks and sufficient locking force (self-locking ability), replacement of the sleeves, if necessary (see attachment part III).

For installation, the sleeves have to be slid axially onto the l'Hotellier ball and socket connectors.

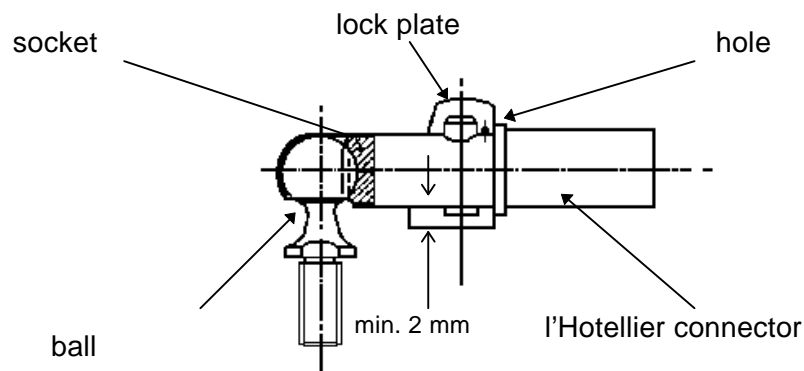
**L'Hotellier ball and socket connectors**

The socket is to be slid completely over the ball with the lock plate pressed down. During locking the lock plate moves back slightly so that in a correct connection the hole on the narrow edge of the lock plate becomes visible.

Warning!

Unsecured ball and socket connectors may open automatically in flight.

The safety pin is to be inserted in this hole thus securing the ball and socket connector.

By loading the connection full engagement of the ball is to be verified!
