## CAA and EASA Airworthiness Directives (ADs) all owners notified.

## Safety Information

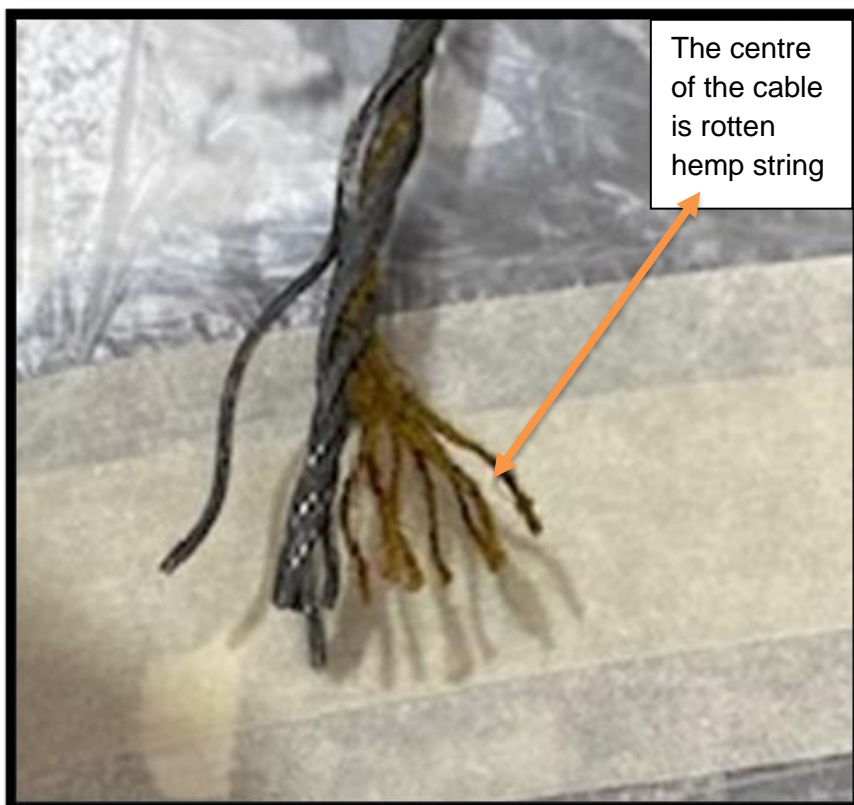
**14 Libelle (might apply to other types)****LBA AD 87-83****Mandatory**<https://streifly.de/wp-content/uploads/2022/08/TN201-26.pdf>

A Libelle that had recently passed a 3000-hour inspection was found to still have Hemp rudder cables that should have been changed by 1987. The link above is to the AD that mandated this inspection.

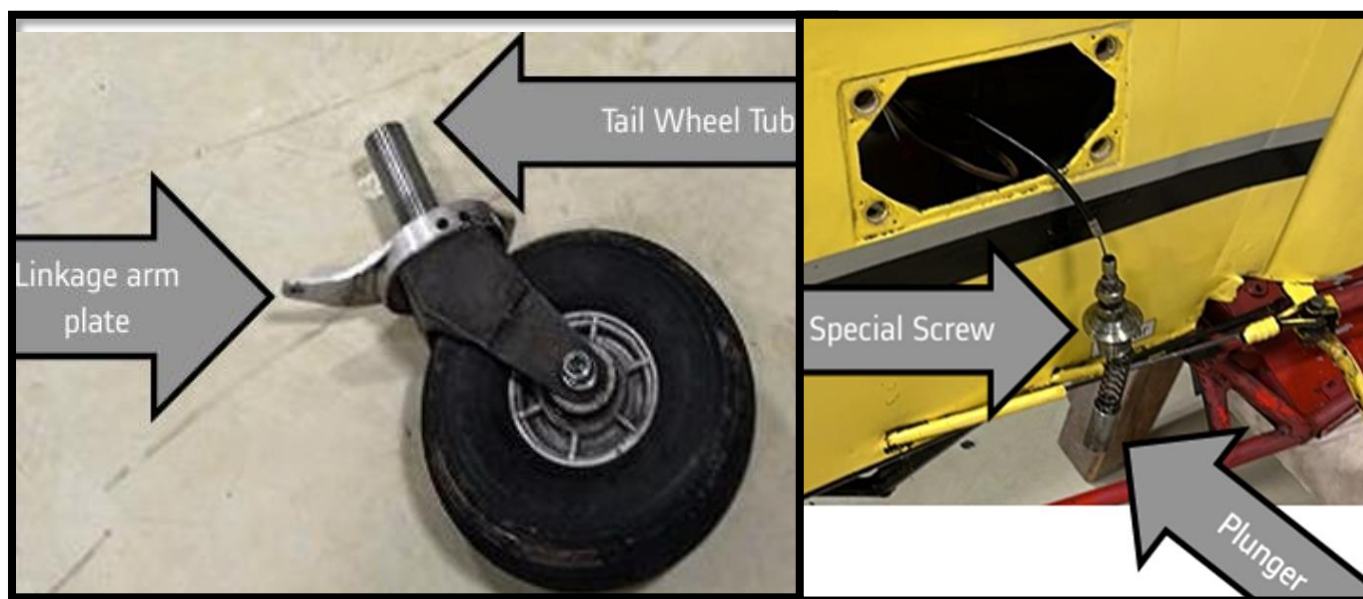
15 SF25c fully swivel tailwheels

The SF25c (mostly the newer ones fitted with Rotax engines) have a fully swivelling tailwheel. But you must lock it to match the rudder movement prior to take off. Failure to do this means there is higher chance of tailwheel shimmy. But the plunger that locks it can seize. This is common issue caused by the lack of access to lubricate the parts that need lubrication. I was involved in maintaining one of these on a SF25C that was flying 500 hours year, and it seized in service a few times. To prevent it happening, we found the tailwheel mechanism had to be fully removed, cleaned, checked for wear and reassembled with good lubrication every 200 hours. This is many hours work. And ideally will be an annual event. I recommend you write it into the maintenance program.

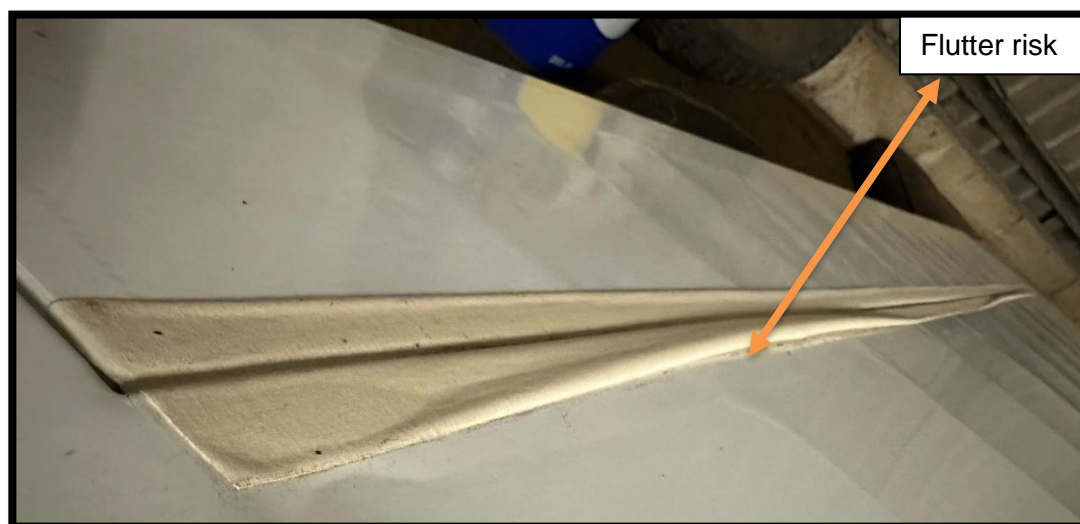
### 16 Tessa Fabric tape

In all my BGA refresher lectures, I advise not to use Tessa Fabric tape. This picture below is all to frequent and explains why. Tessa Fabric tape shrinks hugely in the space of 12 months. Almost everyone that I/quality team checked is found to have restricted control movements. Plus, there is the potential flutter issues if it falls off in flight (like on an ASW20). Some manuals (K21 perhaps) recommend use of Tessa fabric tape. They were written before better tapes (Teflon oven lining tape) and mylar were options. You can deviate from Tessa fabric tape in your maintenance program. Student pilots should be taught that tape in poor condition, like below should not pass a daily inspection.

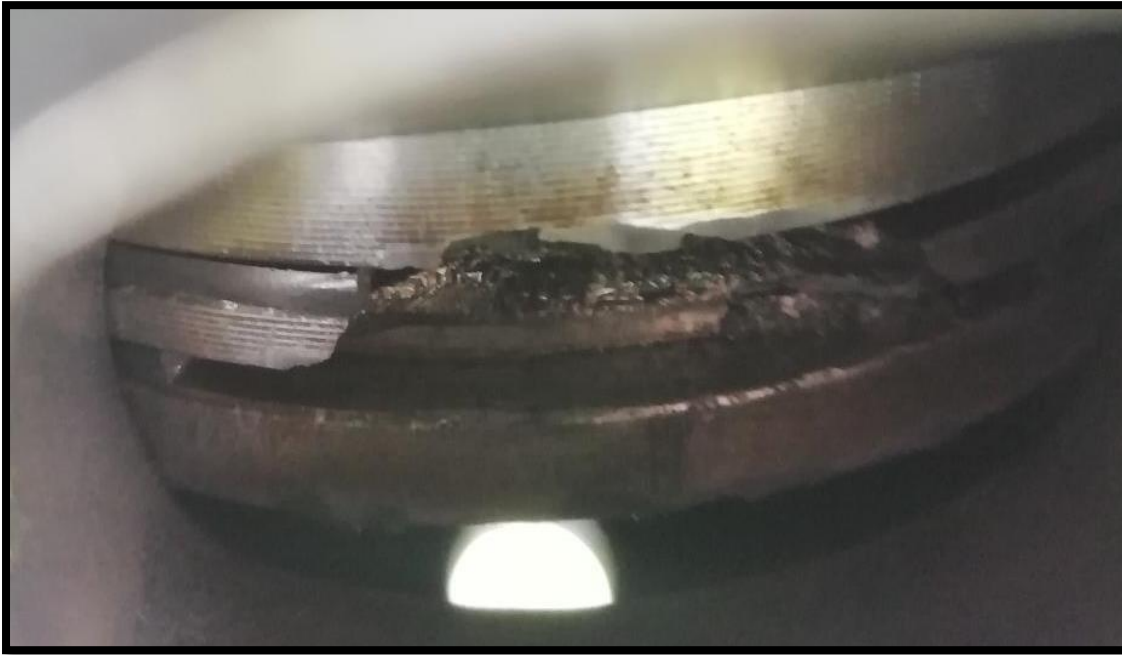
## 17 Solo 2350 inflight catastrophic engine failures

We have 2 reports of inflight failures of the actual engine. CS 22 (the EASA design code for sailplanes) only requires 1 engine to do 50 hours of total running (of which very little is inflight) to become EASA approved. These engines are very unlikely to ever get near their TBO, not because they are not good engines, but due to the huge vibrations and precession loads they suffer in flight (for which they have almost no inflight testing) compared to being on a bench test. Cracks of exhausts, brackets, propellers, pylons, cables are all common findings on daily and annual inspection. Ignition systems also suffer from failures caused by vibration. With more and more gliders now using this engine, we are now having the occasional actual engine failure. The piston ring failure in the image below engine had only ever flown 1h 47 mins and was less than 2 years old.

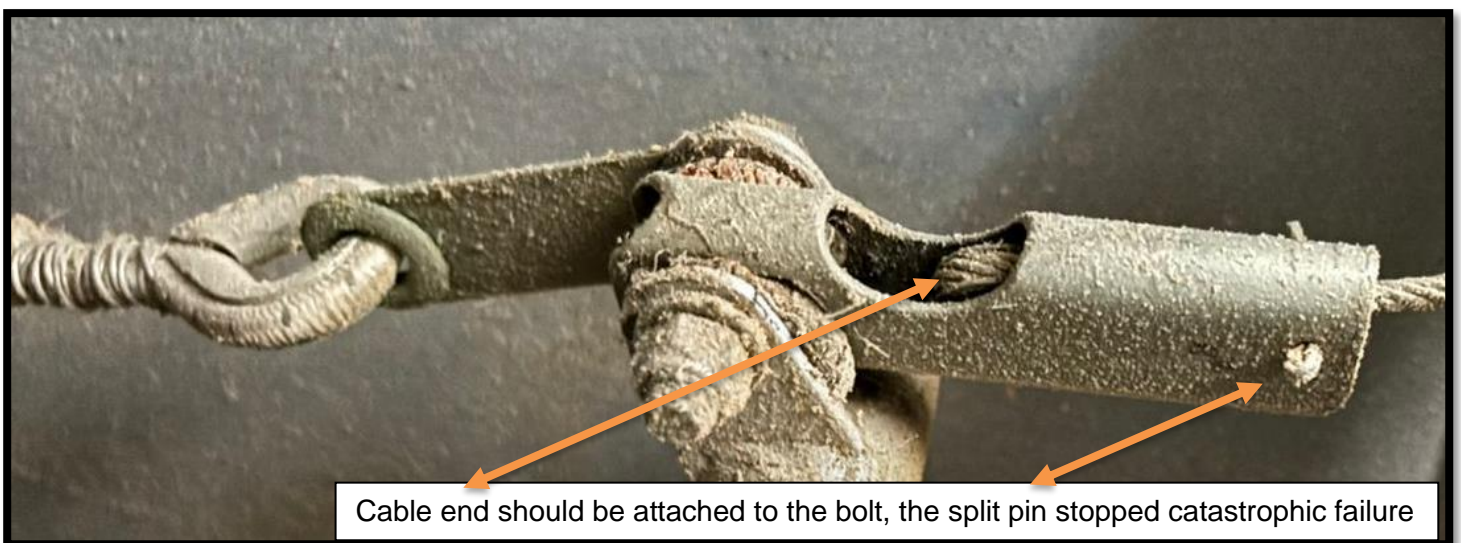
## 18 Standards for annual maintenance inspection

Look at the image below. Apart from being filthy can you see what's wrong? The righthand cable inside the tube was never put into the bolt on the left. This is not the first time we have ever seen this legacy error.

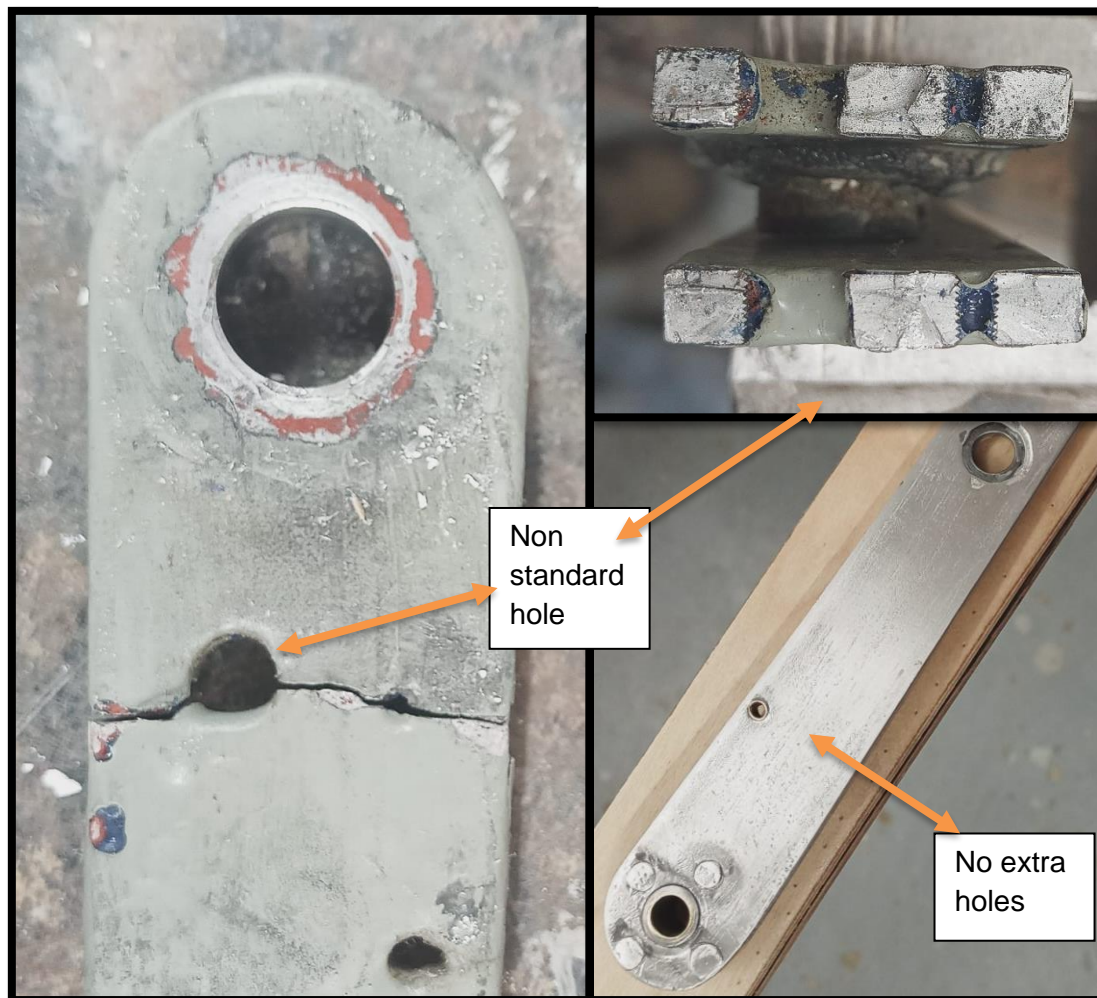
## 19 K8 Airbrake handle snapped due to nonstandard extra hole drilled in it

The non-standard extra hole was a factor in the fatigue failure of the handle. The good news is that there are enough K8s parked up that spares are still plentiful.

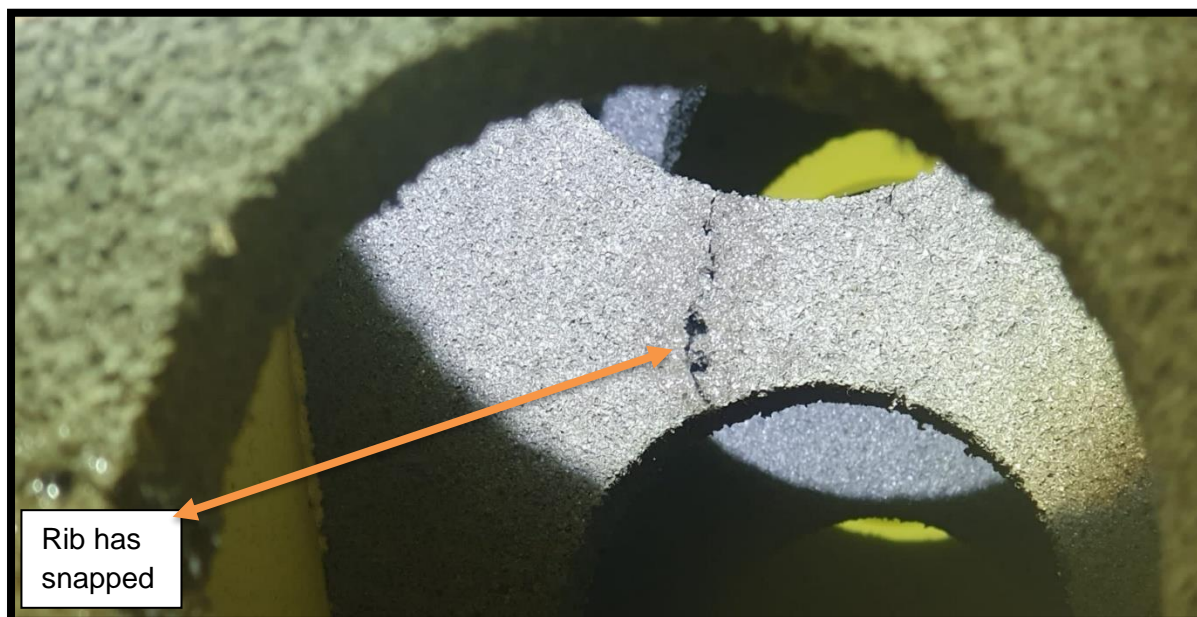
## 20 Pilatus B4 broken rib

The Pilatus is not an all-metal glider. It relies on foam ribs that are bonded into place to add stiffness. Every annual **must** include inspection of the accessible ribs. The repair scheme was inject resin in it to bond back together.

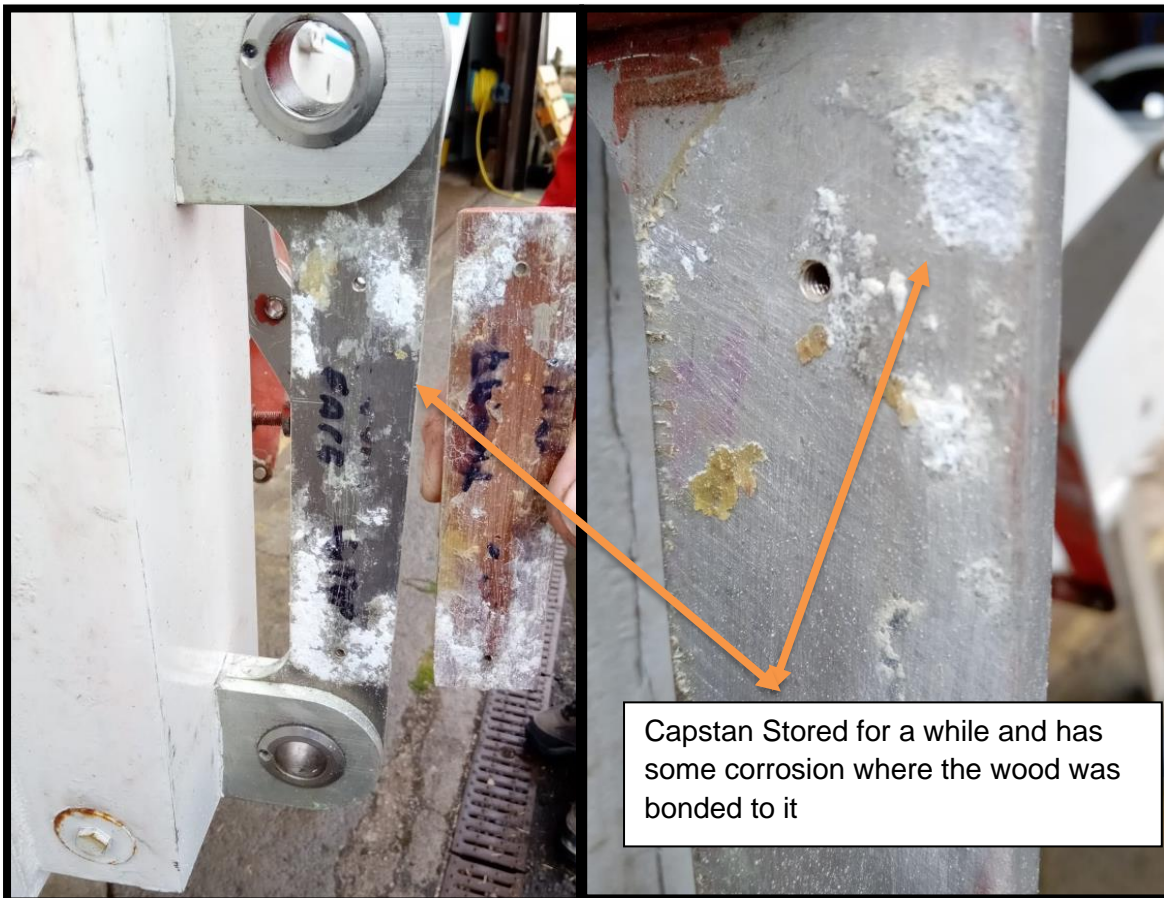
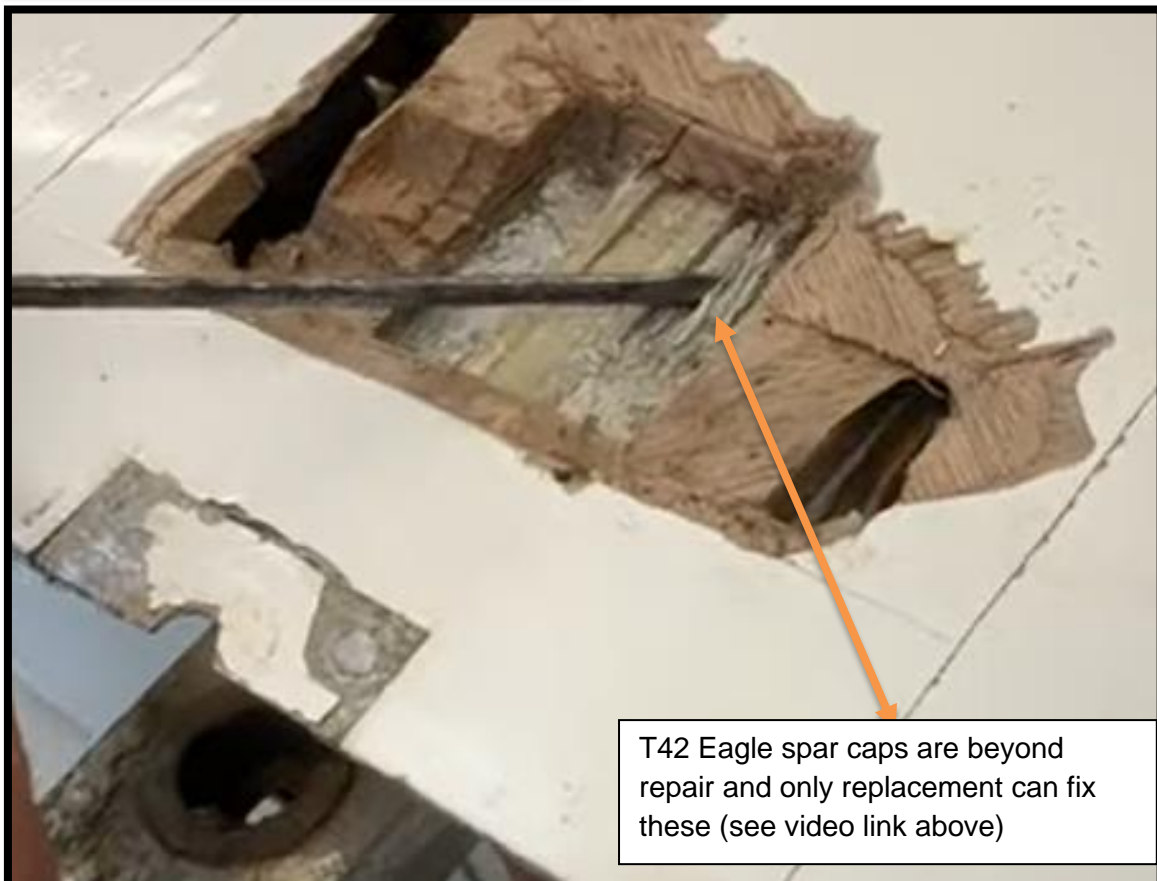
The Eagle was stored for 30 years in a barn. The wood and glue were fine, but the aluminium was not. The Capstan was stored for a much shorter period, and with some TLC can still be saved. See link to video below of the T42 Eagle spar damage. [Slingsby Eagle corrosion after 30 years plus of barn storage](#)
