CAA and EASA Airworthiness Directives (ADs) all owners notified.

Safety Information

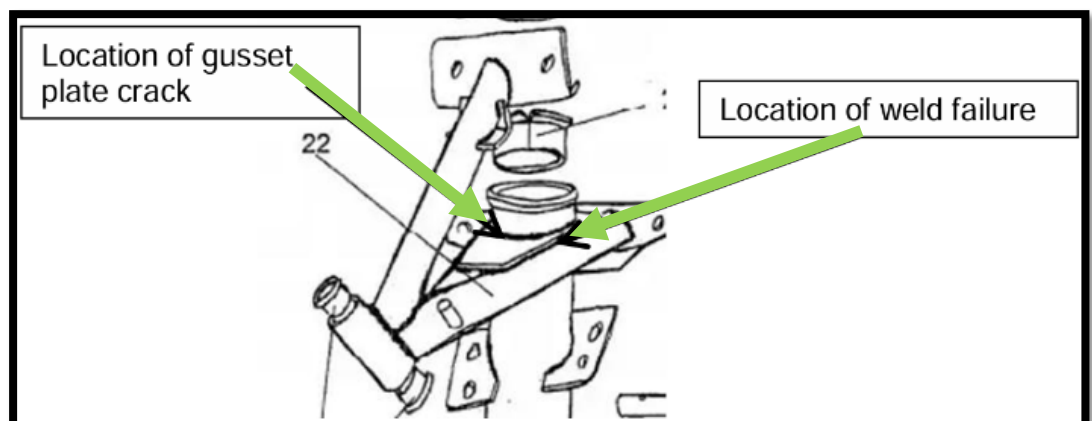
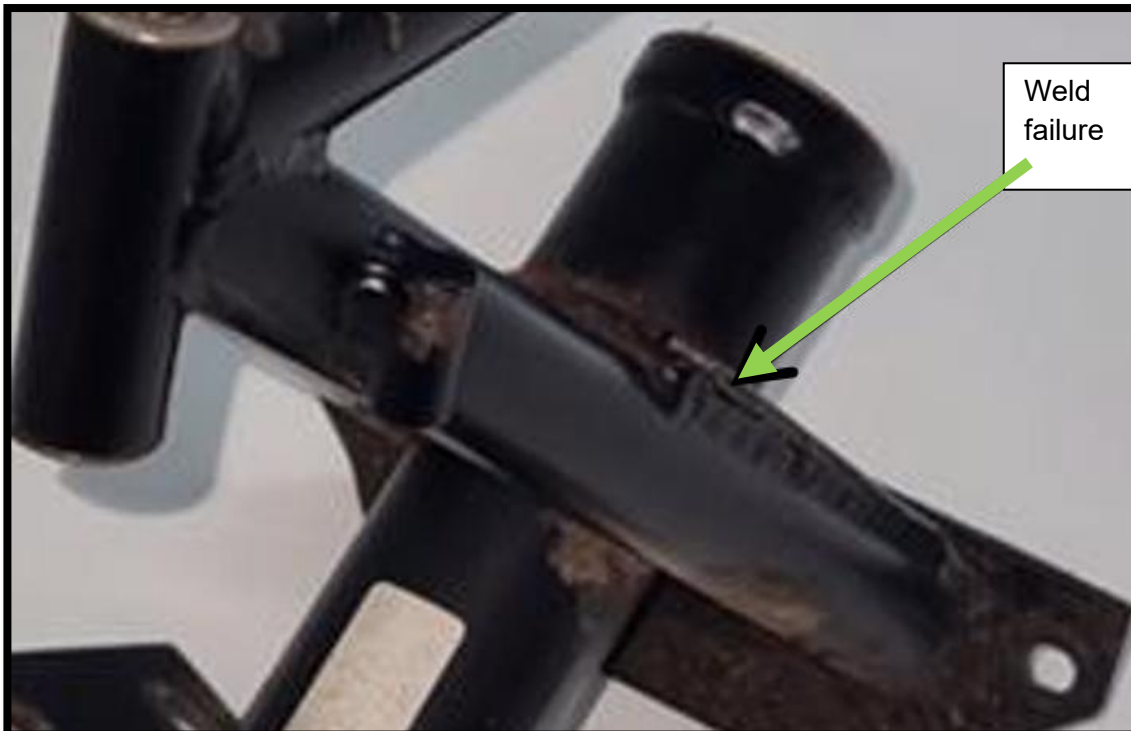
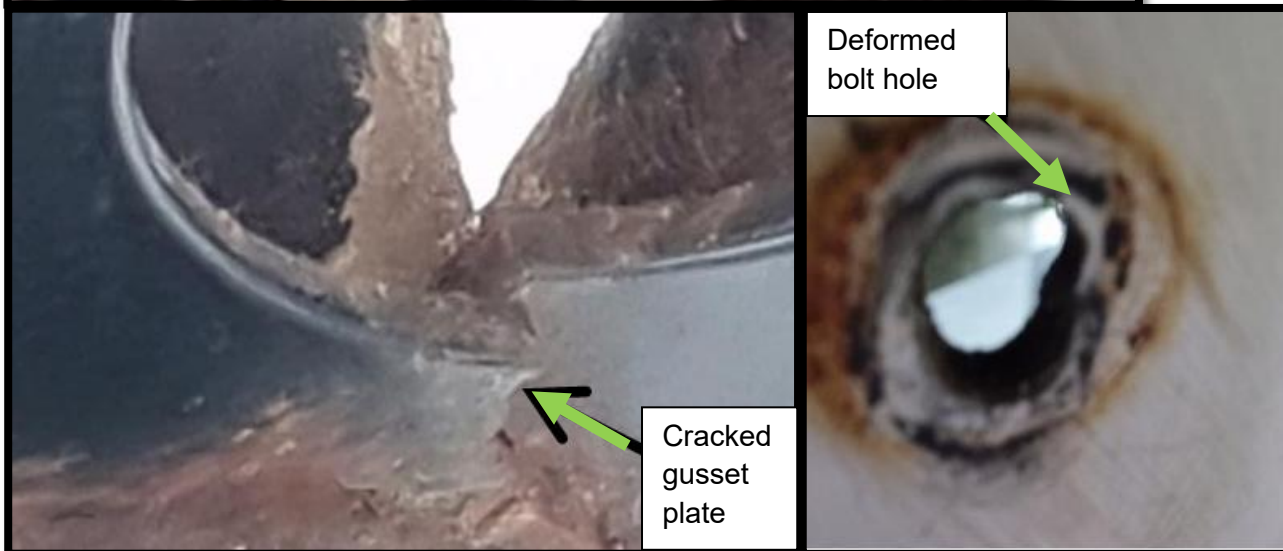
| <p>07 HK36R Super Dimona tailwheel weld failure

Reported by Matt Stickland. During the annual inspection the tailwheel steering tube pedestal was found to have broken. The weld on the starboard side of the gusset plate had failed and the gusset plate at the top of the pedestal tube had also failed. Failure was probably caused by one or more heavy landings on the tailwheel causing the lower fuselage onto which the pedestal was attached to flex. This movement would create high loads on the gusset plate weld which, having failed, would lead to failure of the gusset plate. Deformation of the lower fuselage boltholes was also evident and also probably caused by heavy tail first landings.</p> | <p>Advisory</p> |

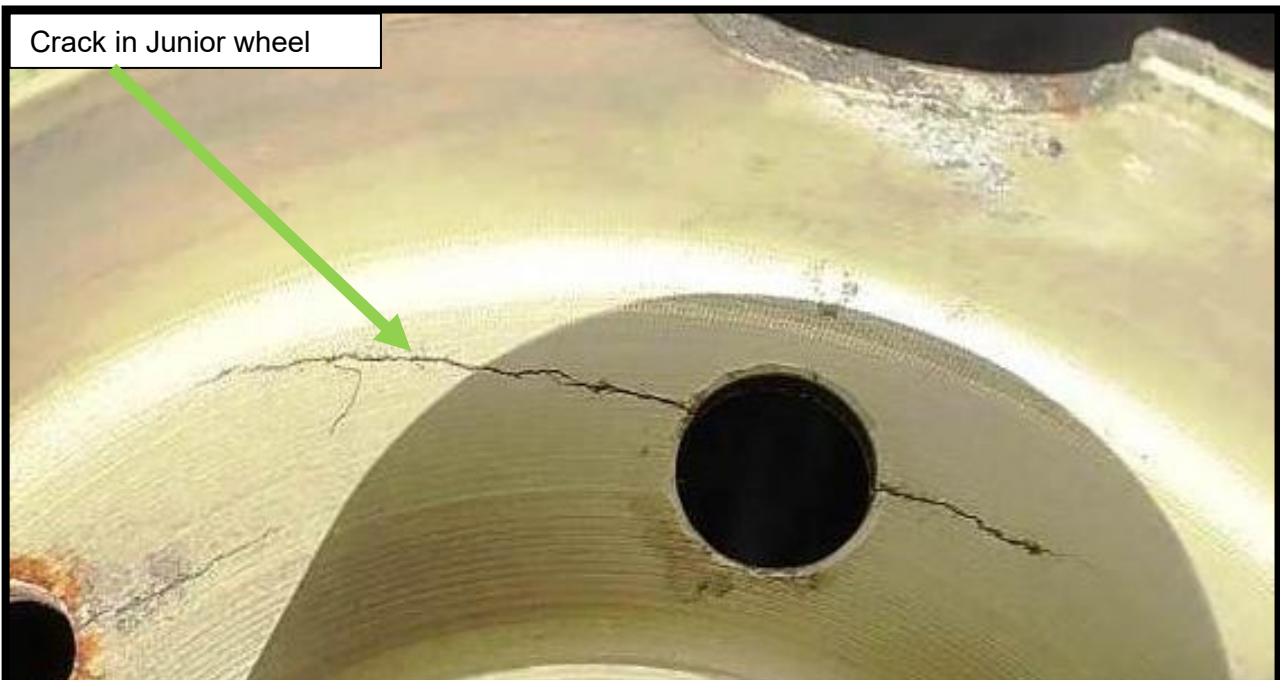
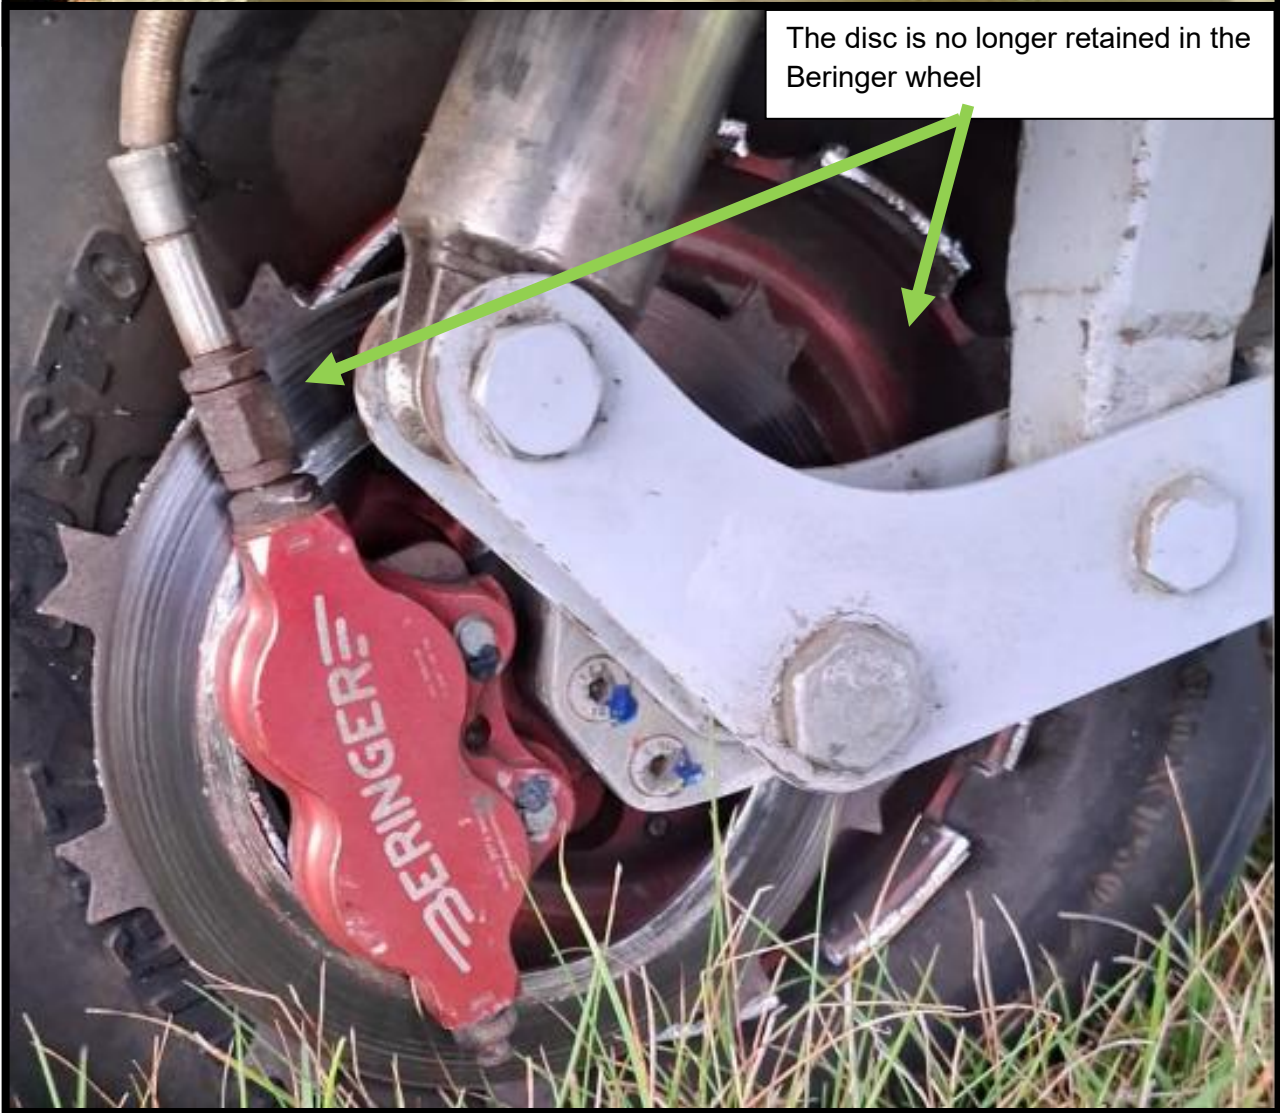
We have had a spate of wheel issues on Tost, Polish and Beringer. Wheels, spacers (and their bearings) often get overlooked on maintenance and after heavy landings. Beringer wheels add level of complexity that you must be familiar with before working on them.

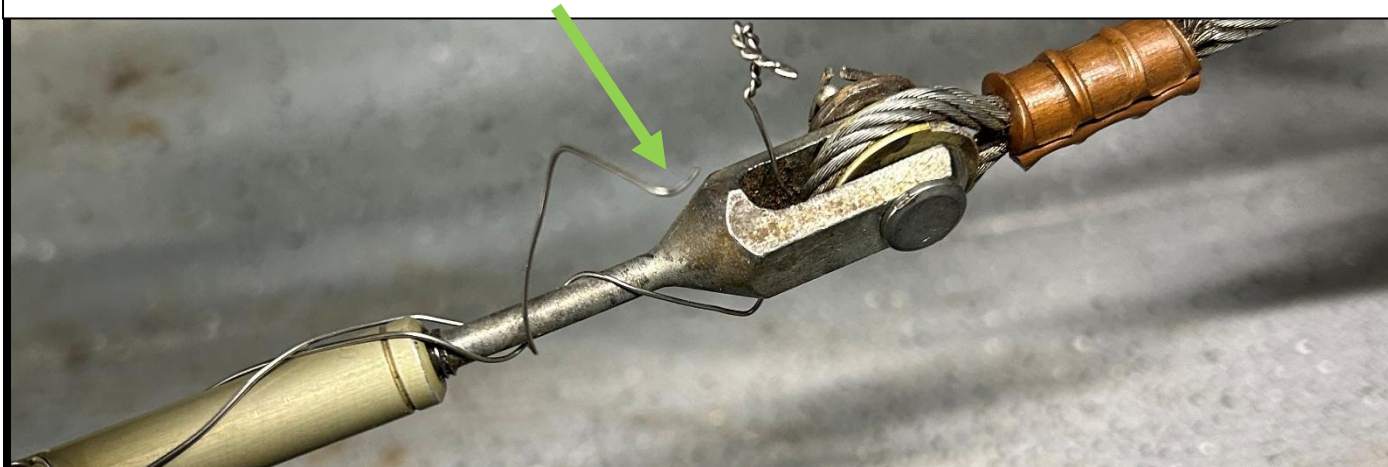
Found in Junior. The locking wire is too thin. It was not stiff enough and allowed the turnbuckle to rotate.

These 3 pictures have all been taken in recent months. The older and more difficult to get to the cables are, the more likely they overdue a good look at. Locking wire does not last forever and turnbuckles have been known to corrode and fail due to fatigue. Only use good quality locking wire.

Schleicher in some of their 3000 hour check schedules on ASK21 suggest changing the release cables from galvanised to stainless steel. When this has been done they all appear to fail well before 1500 hours. I recommend you use galvanised.

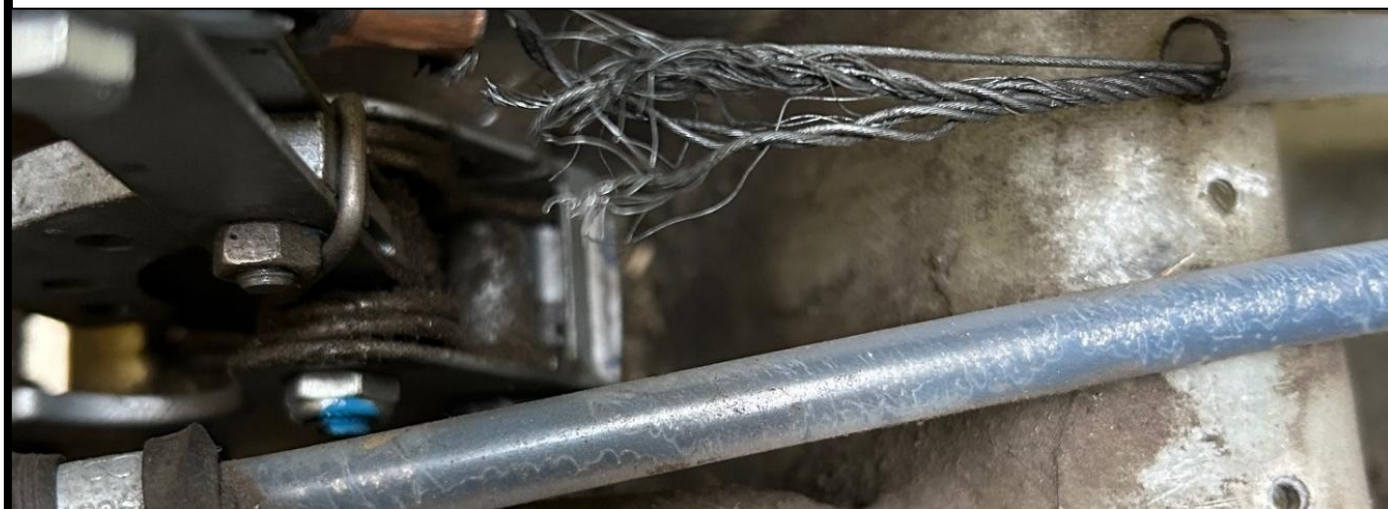
K21 rear cockpit release cable. Some k21 can fly 600 hours year between annuals. On highly utilised gliders this not enough to ensure they are reliable.

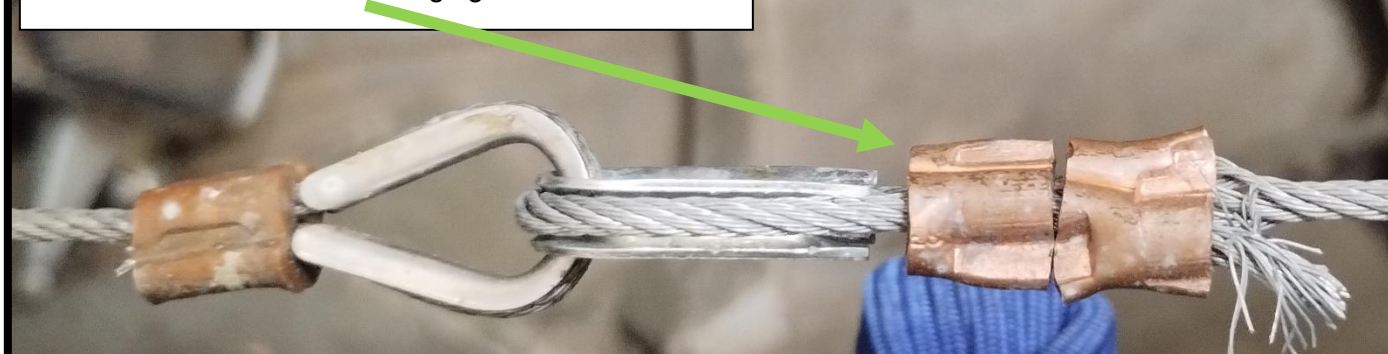
Found in Pirat. The worst swaging I have ever seen

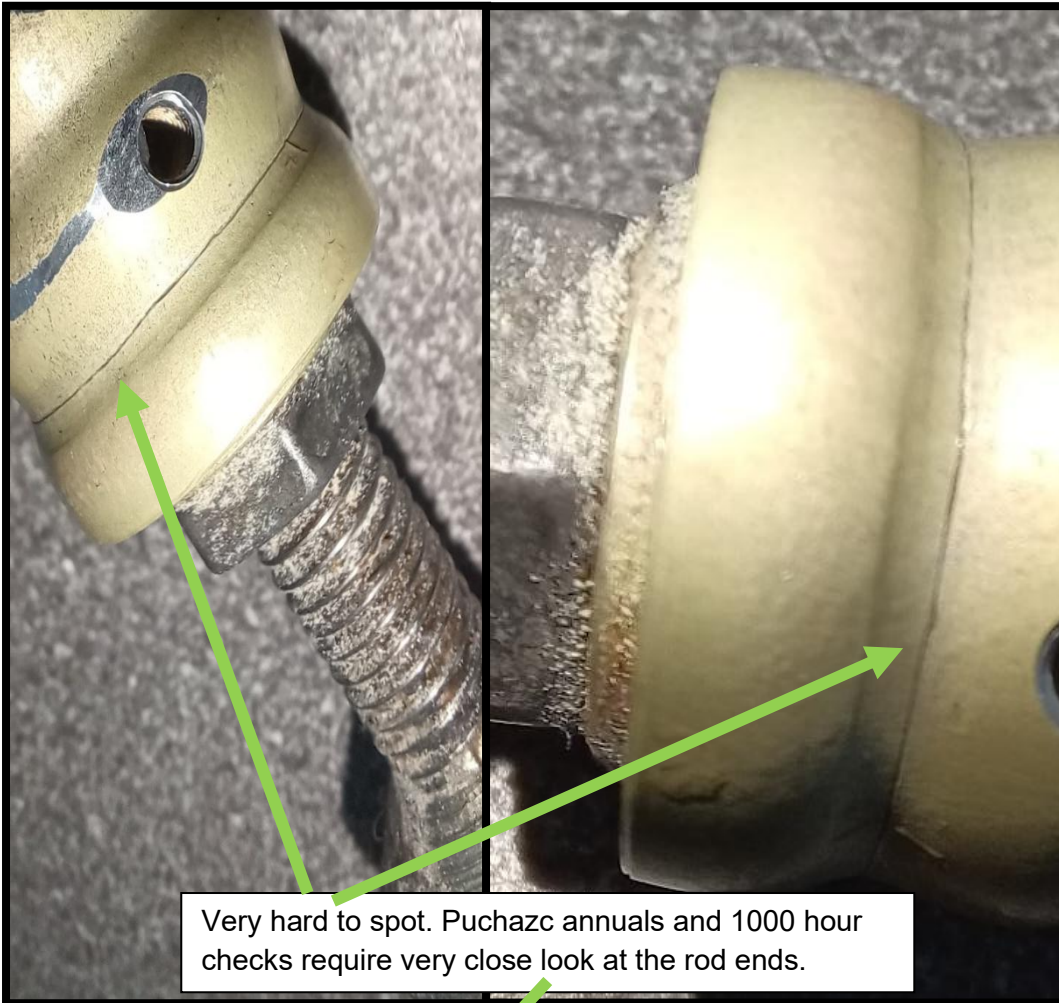
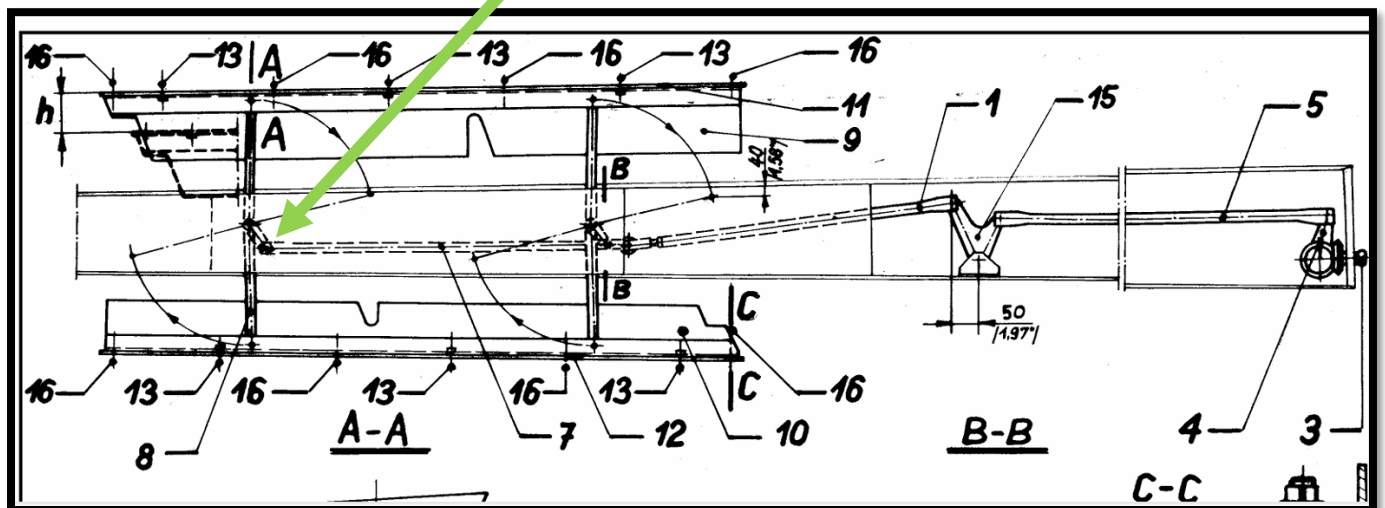
Puchazc airbrake box control rod which connects between the two airbrake arms. See drawing below of airbrake connecting rod. The swaged end fitting shows a crack. It's worth a good check of other push rod ends which use this type of pressed/ swage fittings on Puchazc and other types.

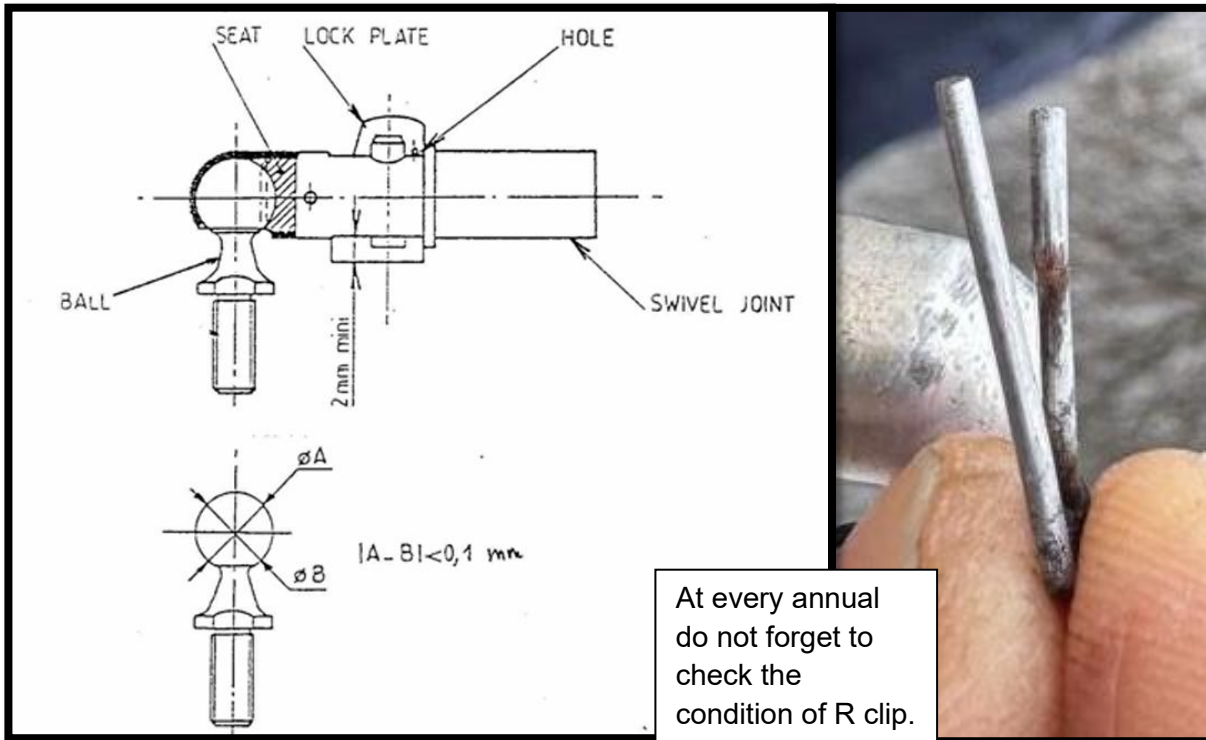
10 L'Hotelier fitting R clips

Several TC holders only publish the first part of the L'Hotelier AD to check the sphericity of the L'Hotelier balls. But there is lesser published 2nd part is useful assessing wear and tear of ensuring the lower part. See diagram below. But

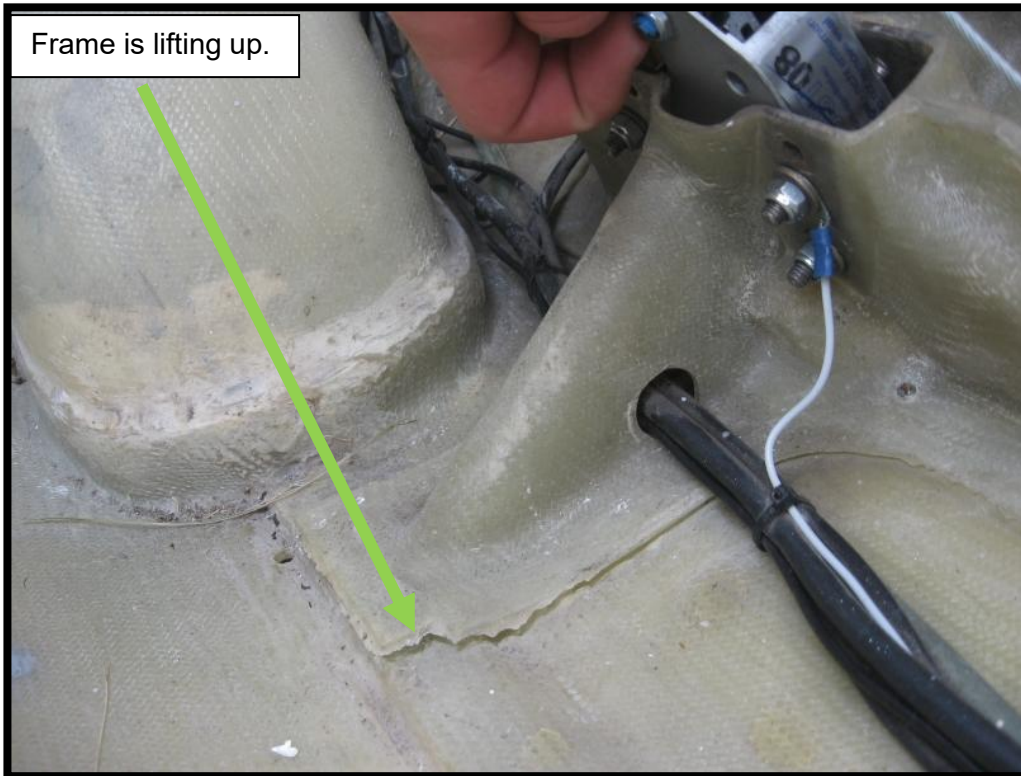
13 Junior broken winch hook frame Reported by Eric Munk
See image, it would be so easy to miss this damage.

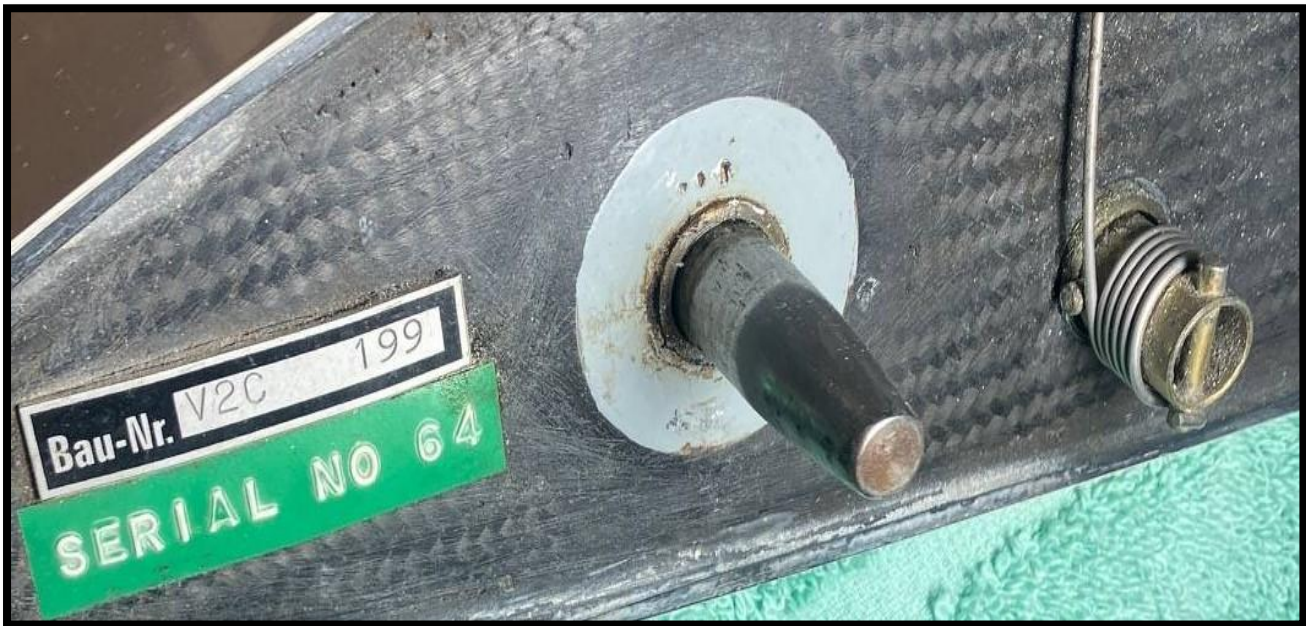
You can see in the above picture that there is some thickened resin sitting on top of the carbon cloth around the spigot top hat. It is advisable to carefully grind out a very small channel around the top hat using a dremel etc to ensure that there is no resin overlapping. Don't go deep enough to cut into the cloth.
