BGA ENGINEERING NEWS

Number 9, November 2001

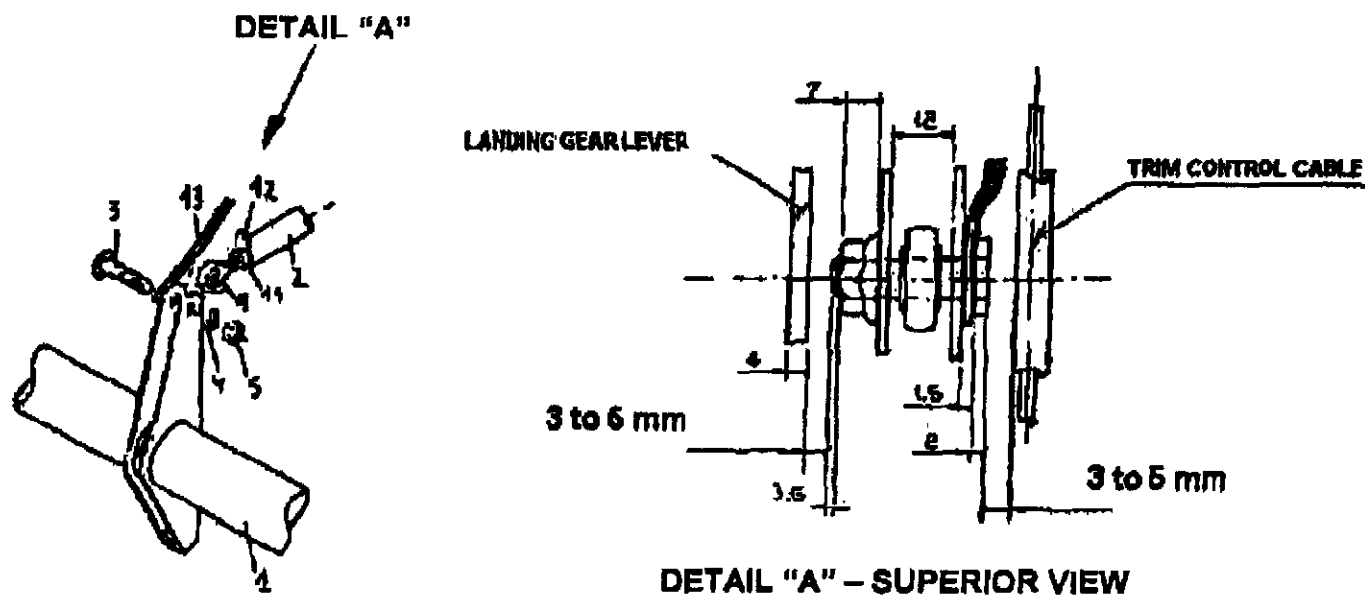
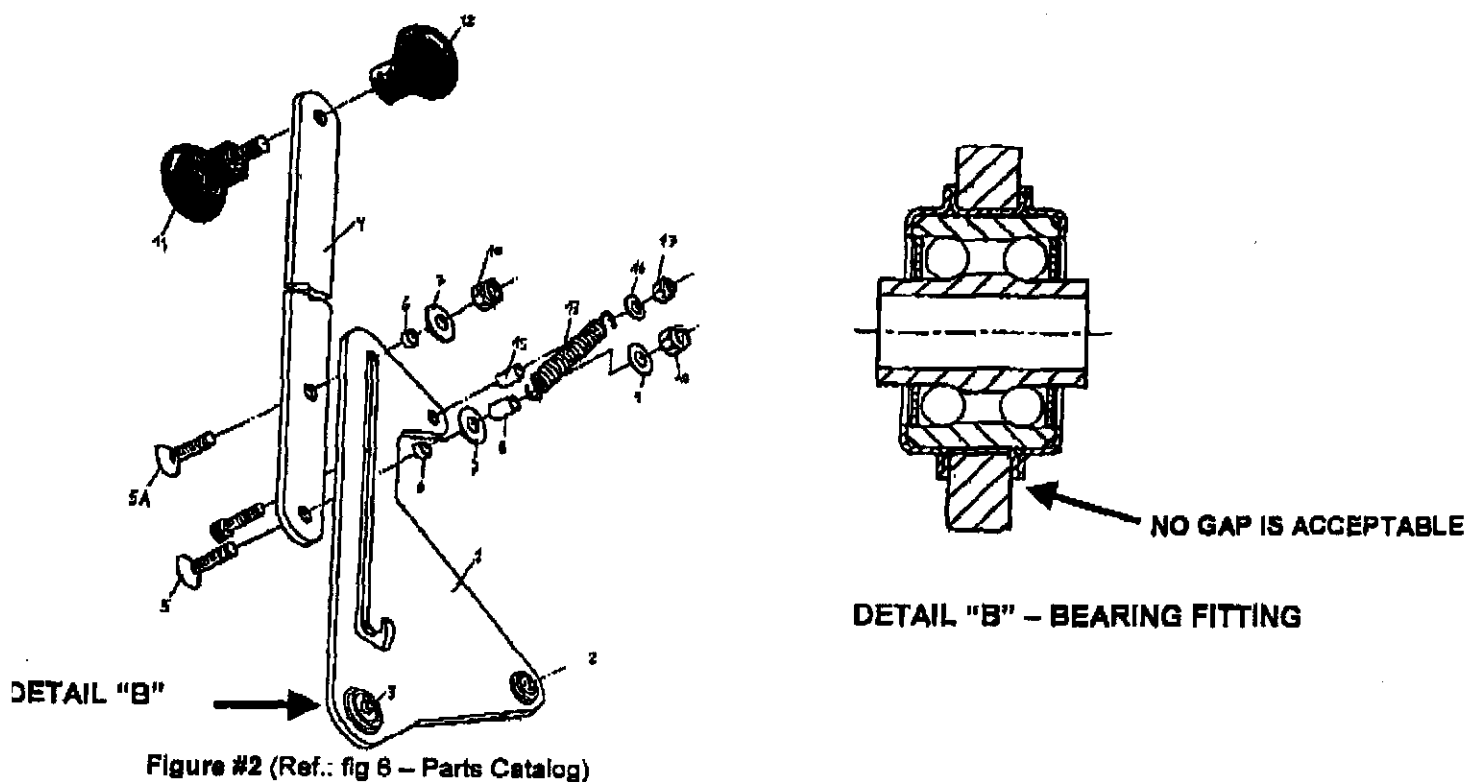
Figure #1 (Ref.: fig 16– Parts Catalog)

REASON: It has been found in flight the occurrence of elevator control jamming due to interference between the main landing gear lever and the nut that fix the rod end of elevator control rod. Since this condition may occur in other airplanes of the same type and affects flight safety, an immediate corrective action is required. Thus, sufficient reason exists to request compliance with this EAD in the indicated time limit without prior notice.

2.7 Check if there are signs of chafing of nut (that fix the terminal of rod of elevator driving) in the landing gear lever P/N 15316; if there are signs of chafing, remove the support guide P/N 15315 and inspect its flatness and if there is gap in the bearing fitting (See detail B of figure #2). Replace non conformance parts .

- 2.8 If no interference or warping is found in the main landing gear lever and the gaps are in accordance with dimensions specified in figures in attached, the airplane can be approved to flight.

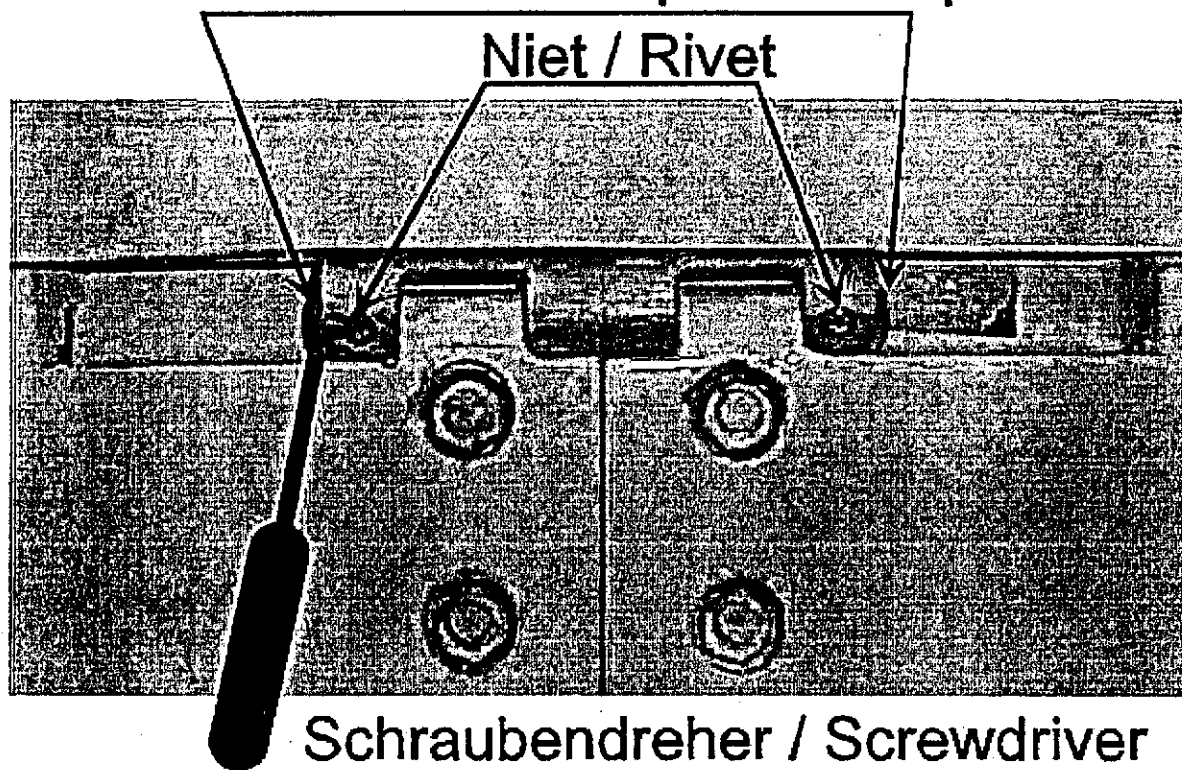
Fig. 1 QR-Antriebslager / aileron actuator
Bolzen mit kl. Kopf / Clevis pin

Reason: During an annual inspection loose safety rivets were found, which secure the aileron hinge pins. There is the danger, that some hinge pins may move in span direction, so that they may be pushed out of the hinge in a worst case.

Action: 1) For inspection of the aileron hinges the Mylar cover on the lower wing surface must be carefully lifted. The sealing Teflon tape underneath must be cut in flight direction with a sharp knife between the head of the clevis pin and the wing side hinge fitting, just big enough, that a screw driver can tried to be entered between pin head and fitting and when entering is possible, by rotation of the screwdriver attempting to move the pin in span direction. Check at the same time, if the safety rivet is loose (see Fig. 1 & 2).
When the screwdriver can not be entered and the safety rivet is tightly in place, no further action is necessary.
When all hinge pins can not be moved, the ASW 28 can be put back to operation. The small cuts in the Teflon tape can be sealed by some grease and the elastic Mylar cover must not be distorted.

2) Loose and/or not correctly engaging safety rivets must be exchanged against new blind rivets with flat round head (= Flachrundkopf in German) of the dimension diameter 2,4mm x 5 mm long, according to DIN 7337 A to secure the hinge pin. During setting the rivets apply some force to the rivets, so that they are additionally pushed into the holes. Reset the tool when necessary. Check the hinge pin and safety rivet. Now apply a new Teflon sealing tape as well as a new Mylar cover as it may have been damaged too much. Partial replacement in sections is possible.
