Technical News Sheet

Issue 3-2012

Airworthiness Information

BRITISH GLIDING

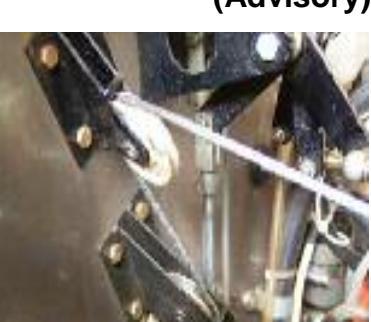
As previously reported problems with Grob sailplane nylon pulleys cracking. The picture is a Grob G109b with two broken pitch change pulleys. If any nylon pulleys are found on any Grob aircraft they must be checked for cracks.
