British Gliding Association Aircraft Inspection

Number:
042/07/2004

Subject: Structural inspections

Applicability: Schleicher Ka 1, Ka 2, Ka 2B, Ka 3, Rhönlercher II (Ka 4), Ka 6 series, K7, K7 conversions, K8 series, K10, ASK 13 series, ASK 14, ASK 16, ASK 18 series and all variants of each type.
(This inspection is strongly recommended for the motor glider types listed above)

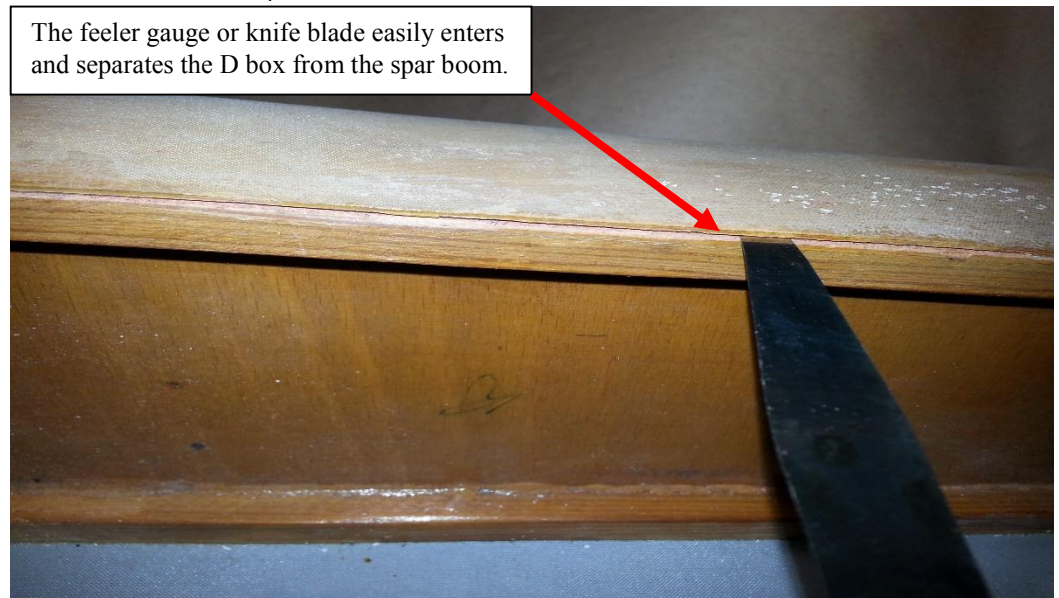
The entire D box can unpeel very easily when the ply gussets that tie the D box skins to the trailing edge ribs are removed. Note the nose rib has unbonded as well.
