APPLICABILITY NOTICE

Subject: Structural inspections

Applicability: Schleicher Ka 1, Ka 2, Ka 2B, Ka 3, Rhönlercher II (Ka 4), Ka 6 series, K7, K7 conversions, K8 series, K10, ASK 13 series, ASK 14, ASK 16, ASK 18 series and all variants of each type.
(This inspection is strongly recommended for the motor glider types listed above)

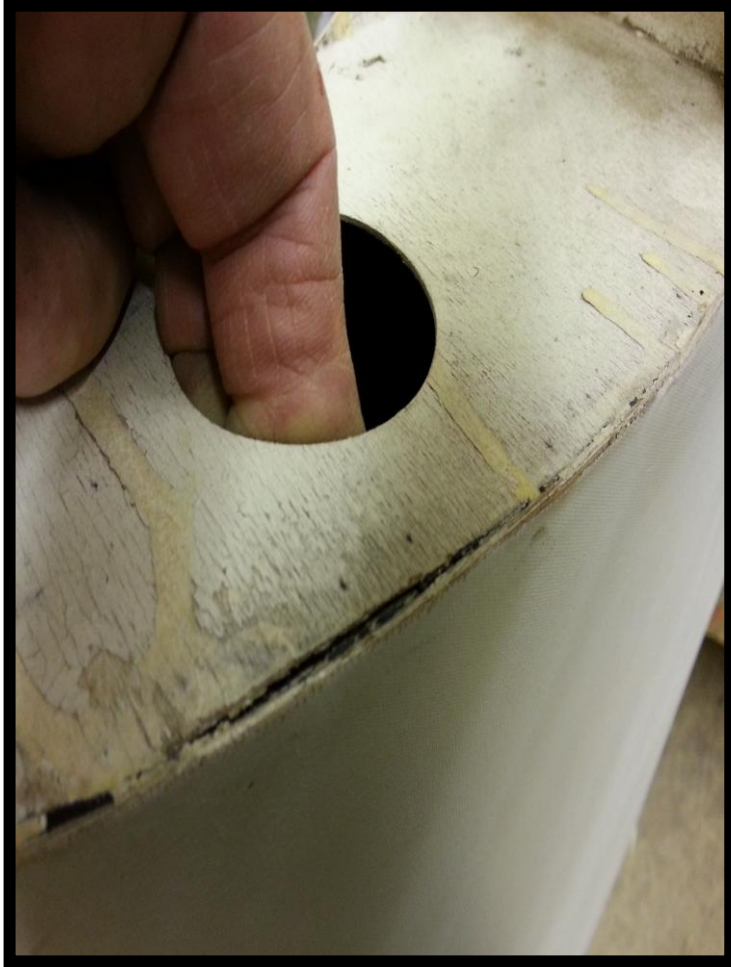
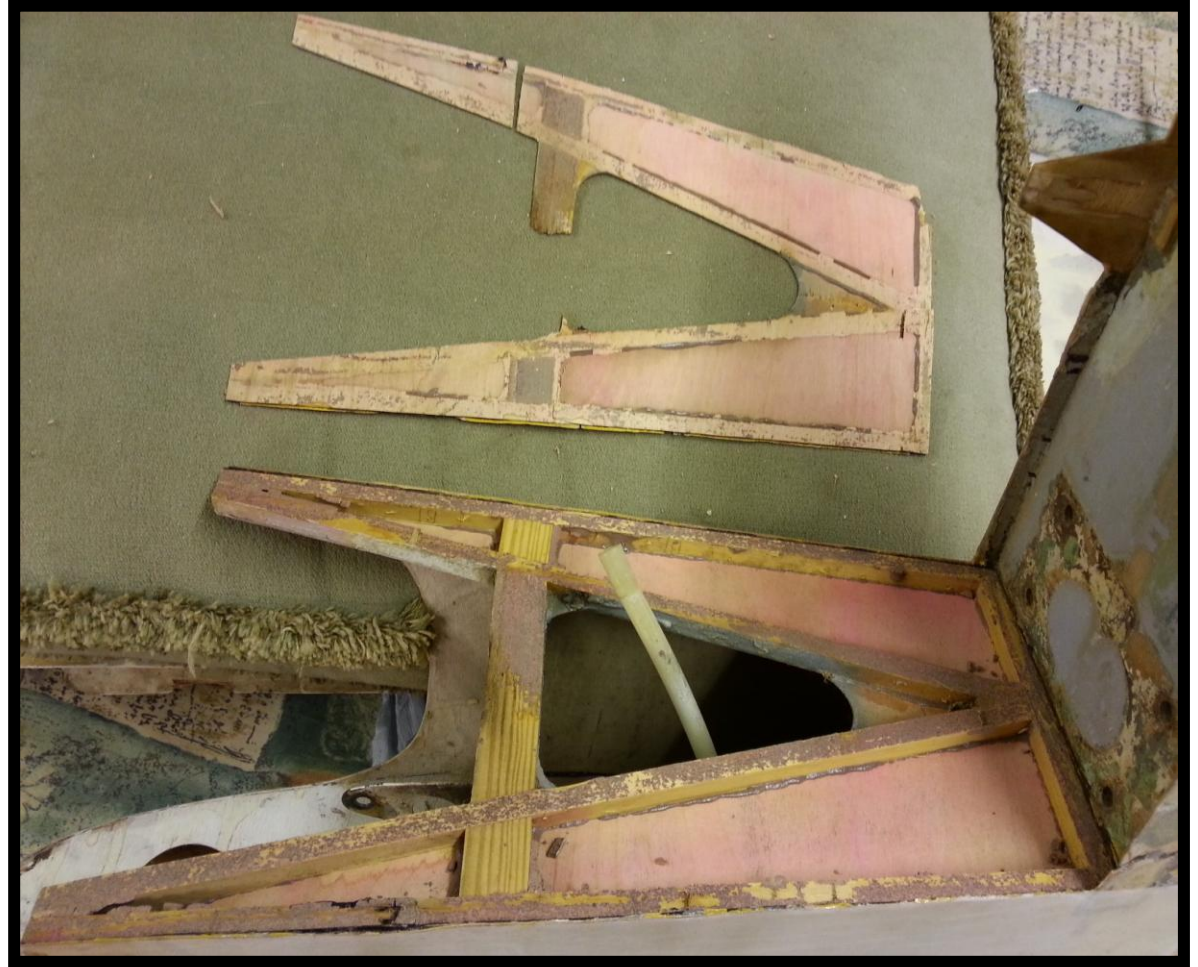
D Fin inspection. You must remove the fin at the next annual after 1st March 2015. If performing the inspection during a fuselage recover then the fin is always to be removed (except K6s) where they are not bolted on) See figure 4 for images of glue failure found previously

Figure 4 Typical Sternpost and base rib glue failure
