CAA and EASA Airworthiness Directives (ADs) all owners notified.

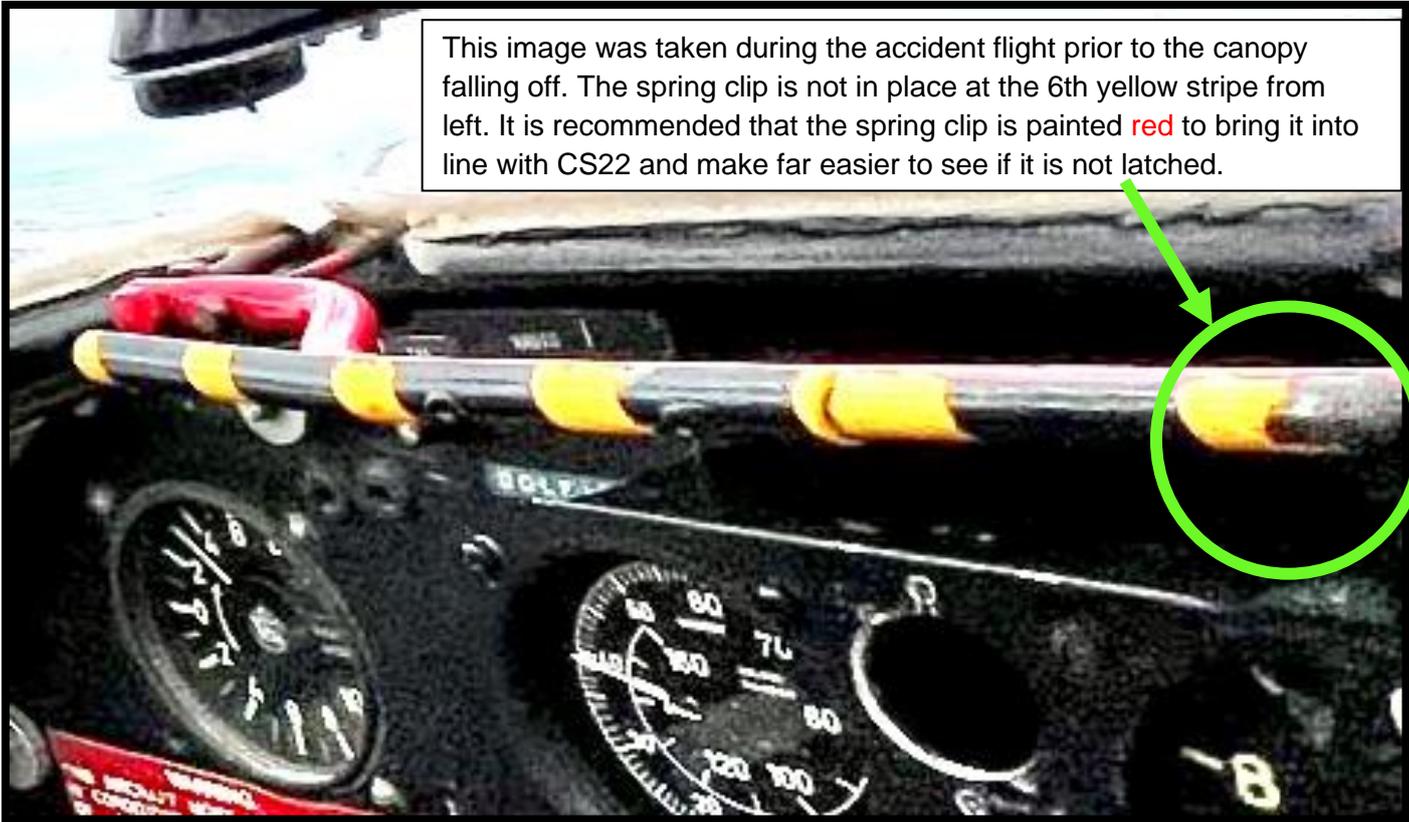
This image was taken during the accident flight prior to the canopy falling off. The spring clip is not in place at the 6th yellow stripe from left. It is recommended that the spring clip is painted red to bring it into line with CS22 and make far easier to see if it is not latched.

It is strongly recommended that the spring Latch is painted red. That way it conforms to current CS22 standards, and it is more noticeable if it is not attached to the canopy jettison handle (which is painted with black and yellow stripes).
